# Risk of failure of Hidroituango dam, Colombia

Sentinel-2 MSI acquired on **07 April 2018** at 15:36:19 UTC  
Sentinel-2 MSI acquired on **07 May 2018** at 15:36:19 UTC  
Sentinel-2 MSI acquired on **12 May 2018** at 15:36:21 UTC  
Sentinel-2 MSI acquired on **22 May 2018** at 15:36:21 UTC

Author(s): Sentinel Vision team, VisioTerra, France - [svp@visioterra.fr](mailto:svp@visioterra.fr)

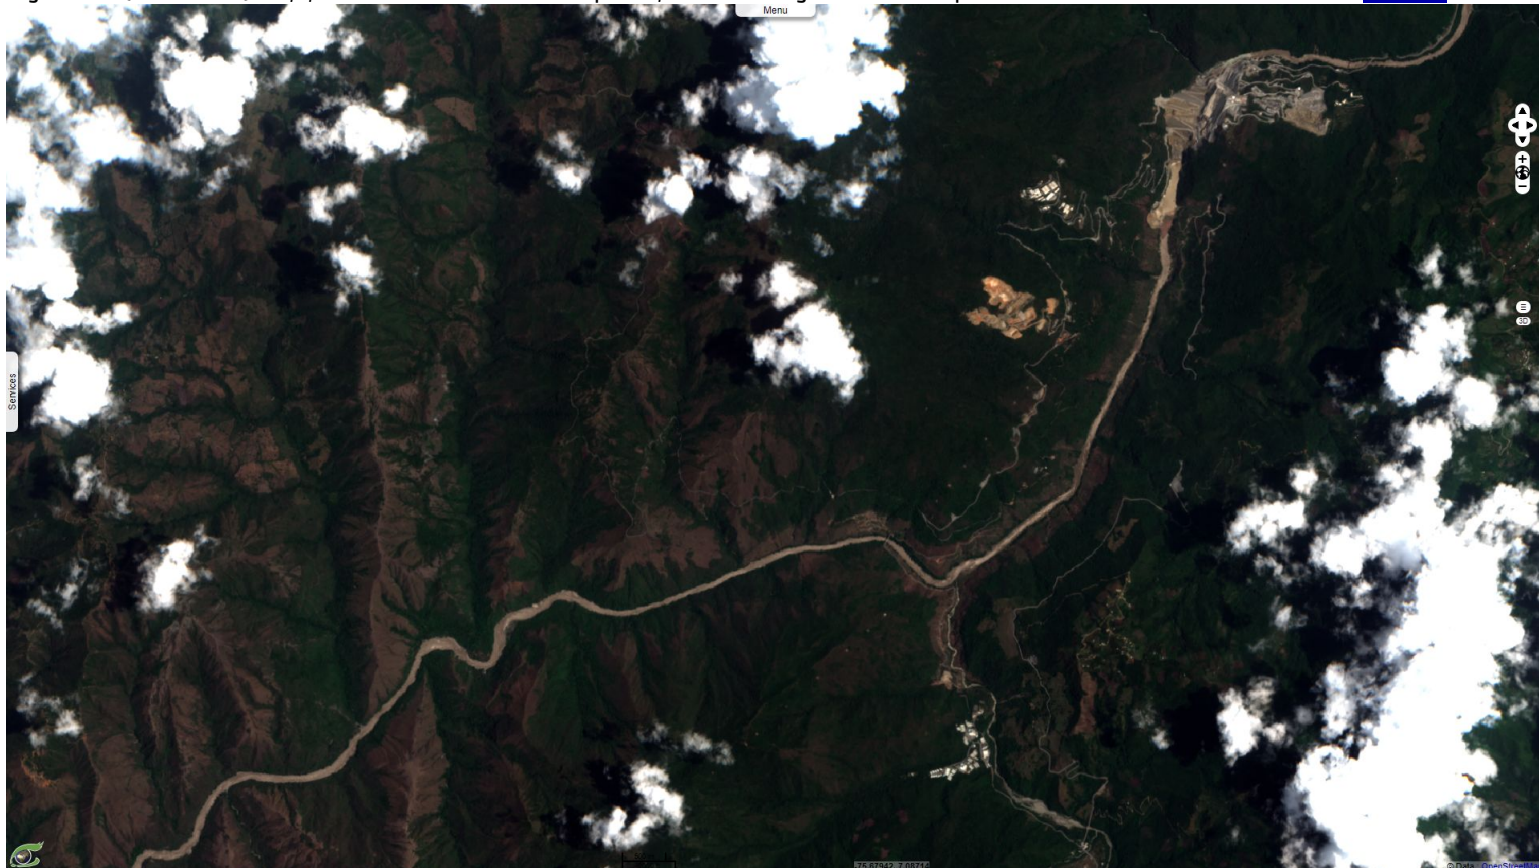
Fig. 1 - S2 (07.04.2018) - 4,3,2 natural colour - Once completed, the 225m high dam should produce 2400MW for a cost of 3.5 G€ - [2D view](#)

Insufficient water discharge endangers the dam. Cheap design has been pointed out. Before that the public tender had been contested as unfair.

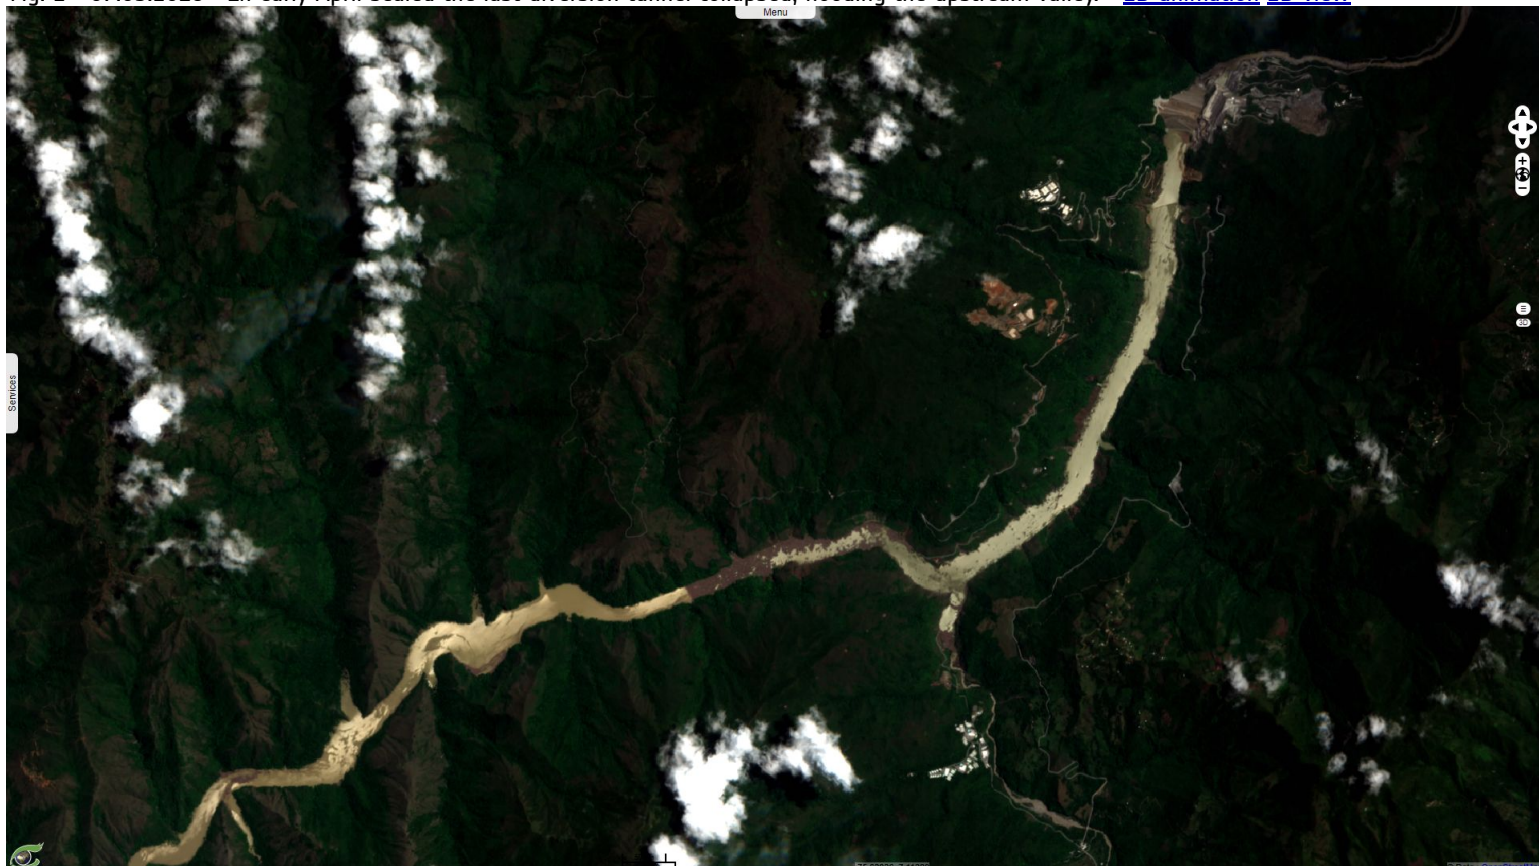
Fig. 2 - 07.05.2018 - In early April sealed the last diversion tunnel collapsed, flooding the upstream valley. - [2D animation](#) [2D view](#)

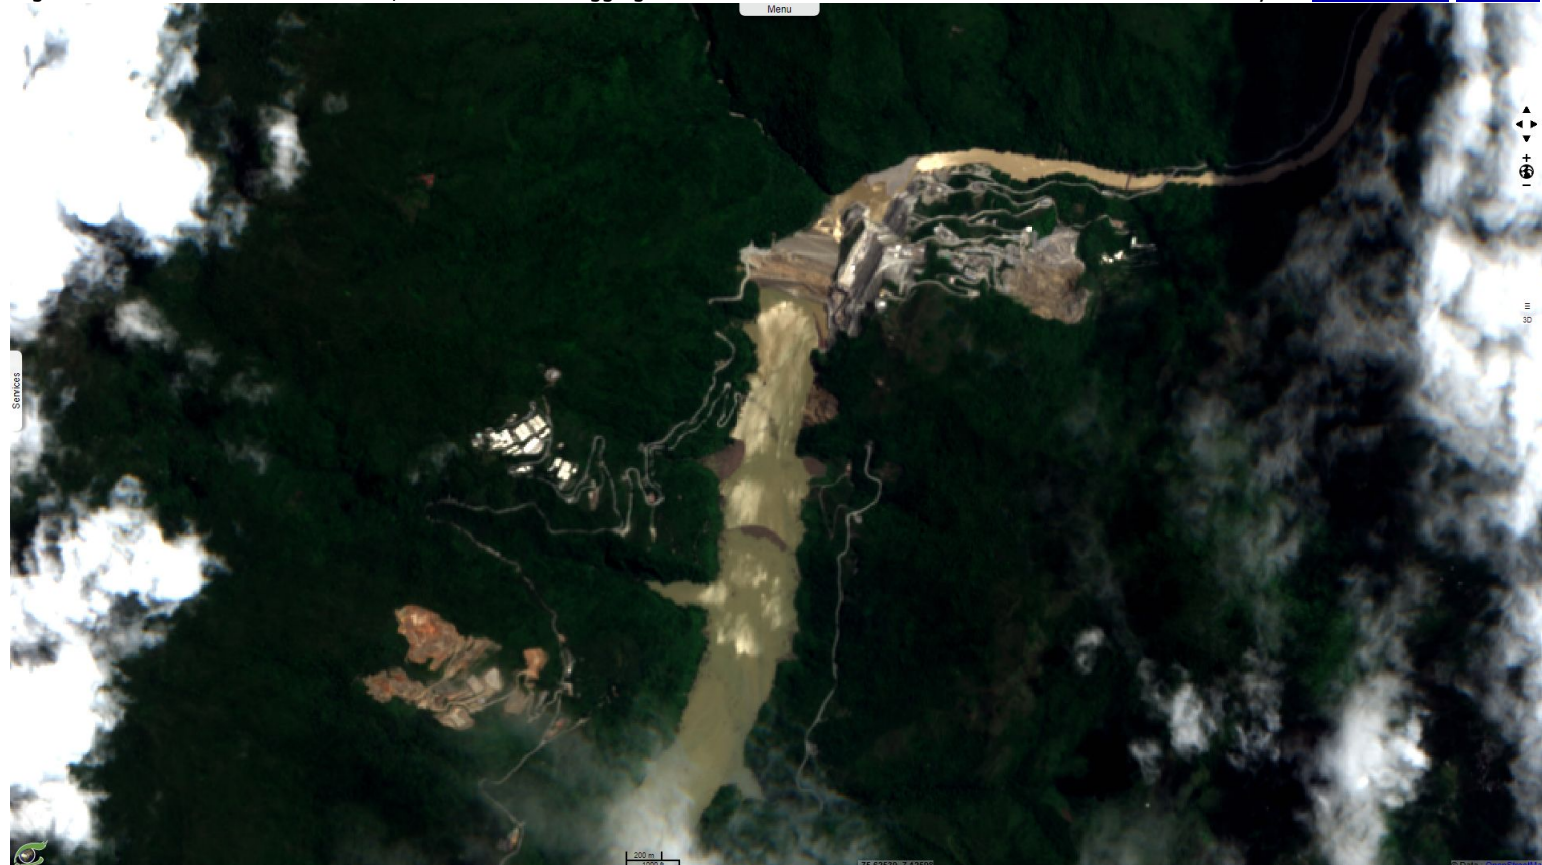
Fig. 3 - 22.05.2018 - The 12.05.2018, uncontrolled unclogging caused downstream flood & eroded the dam wall's drain layer - [2D animation](#) [2D view](#)

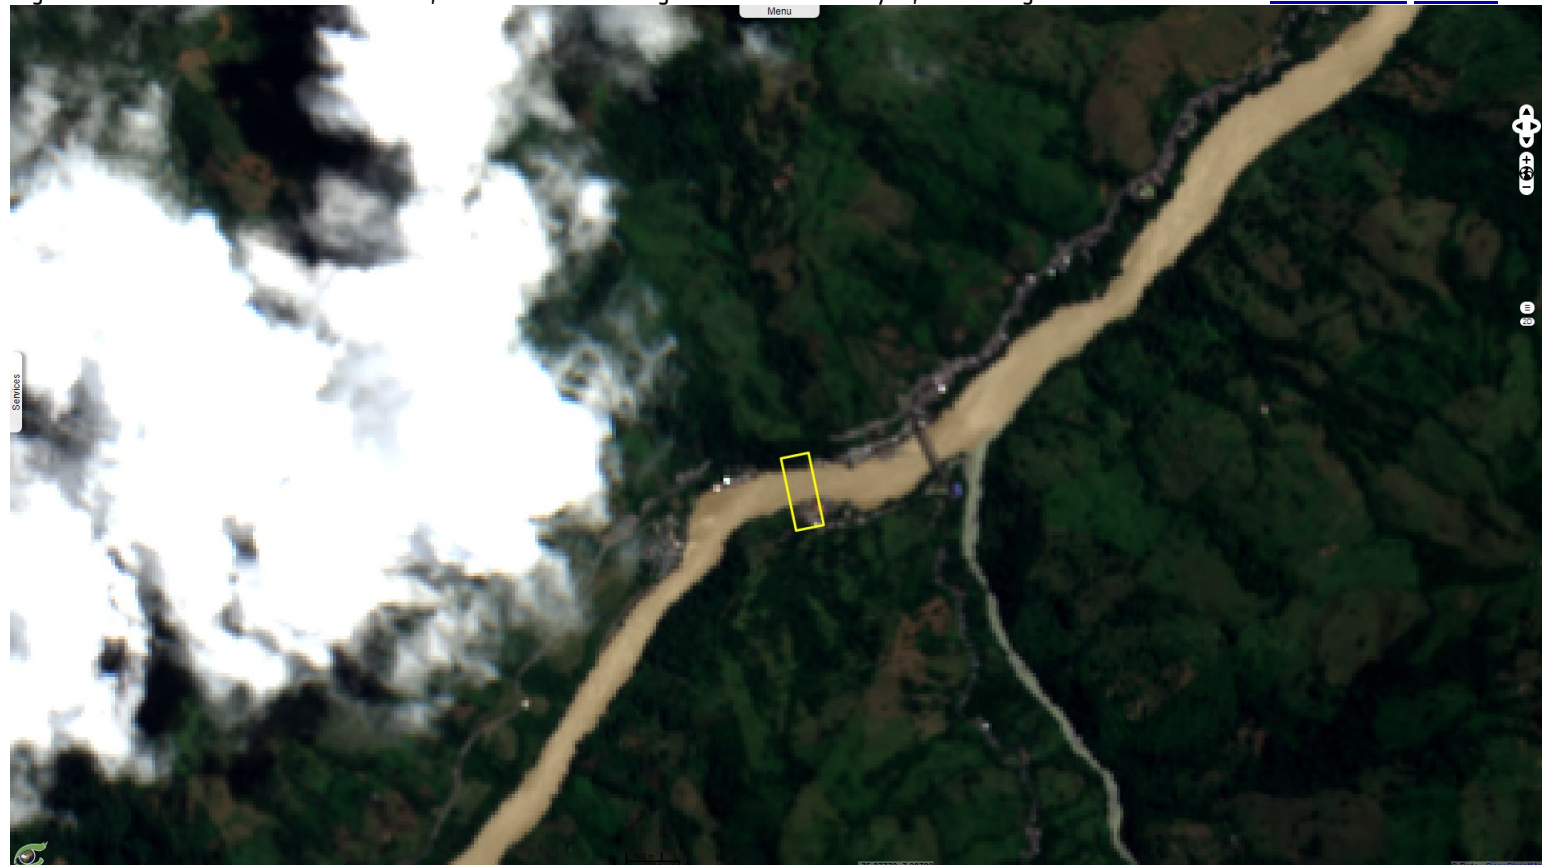
Fig. 4 - 22.05.2018 - Locals of P. Valdidia, where houses & bridges have been destroyed, are among the 25000 evacuees - [2D animation](#) [2D view](#)
