A tailing dam fails at Williamson diamond mine, Tanzania

Author(s): Sentinel Vision team, VisioTerra, France - syp@visioterra.fr

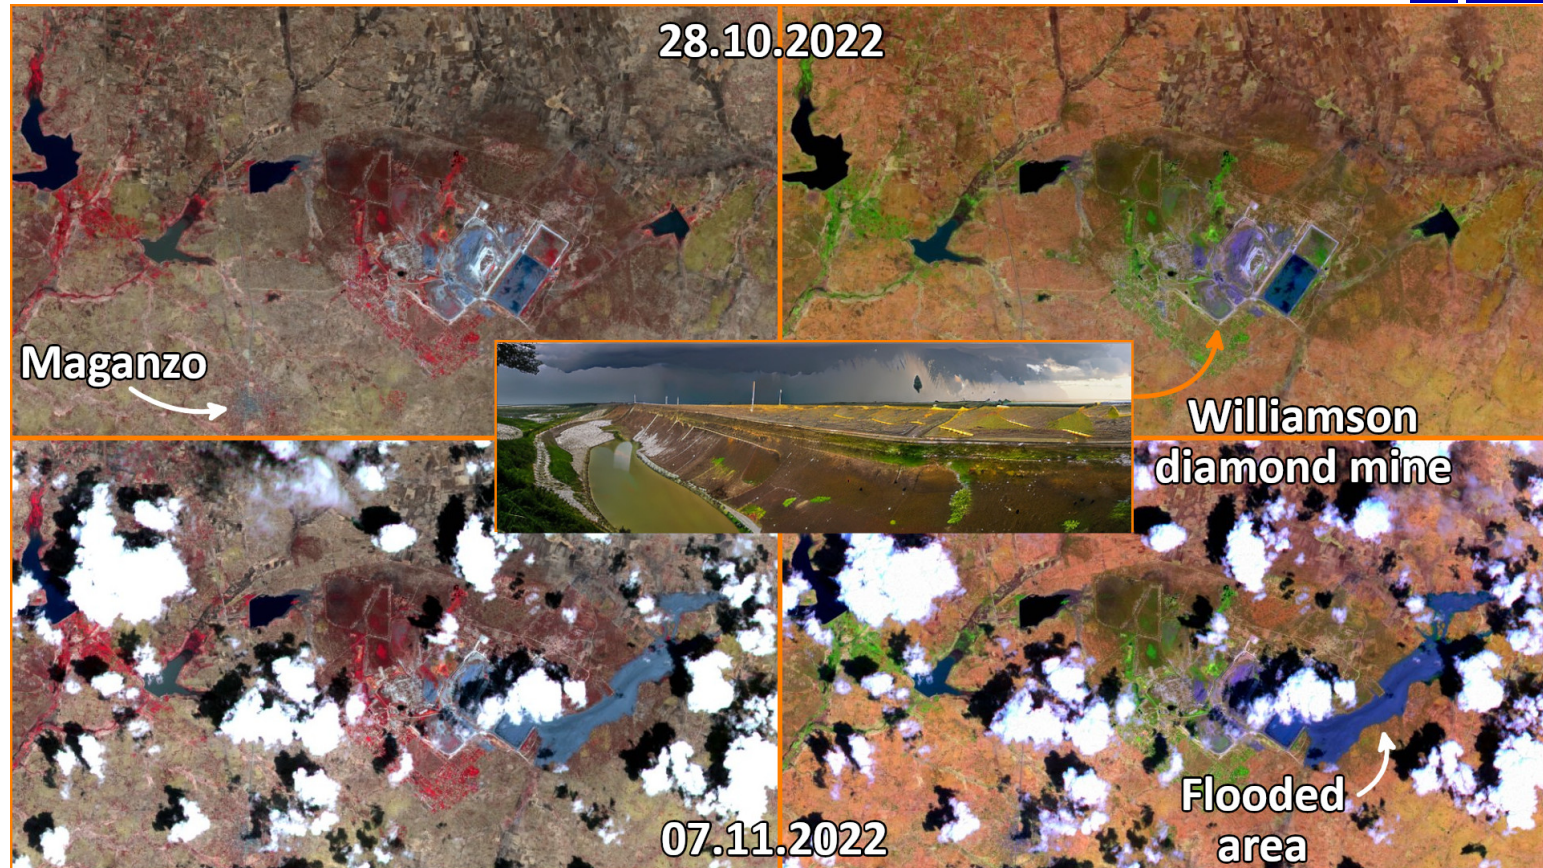
Fig. 1 - S2 (28.10.2022 / 07.11.2022) - A breach in a tailing dam caused a flooding at the largest diamond mine of Tanzania.

The eastern wall of a tailings storage facility at its Williamson diamond mine, in Tanzania, was breached earlier on November 7, resulting in flooding away from the pit and extending into areas outside of the mine lease area. A total of 13 dwellings have been affected by the breach. Three minor injuries have been reported.

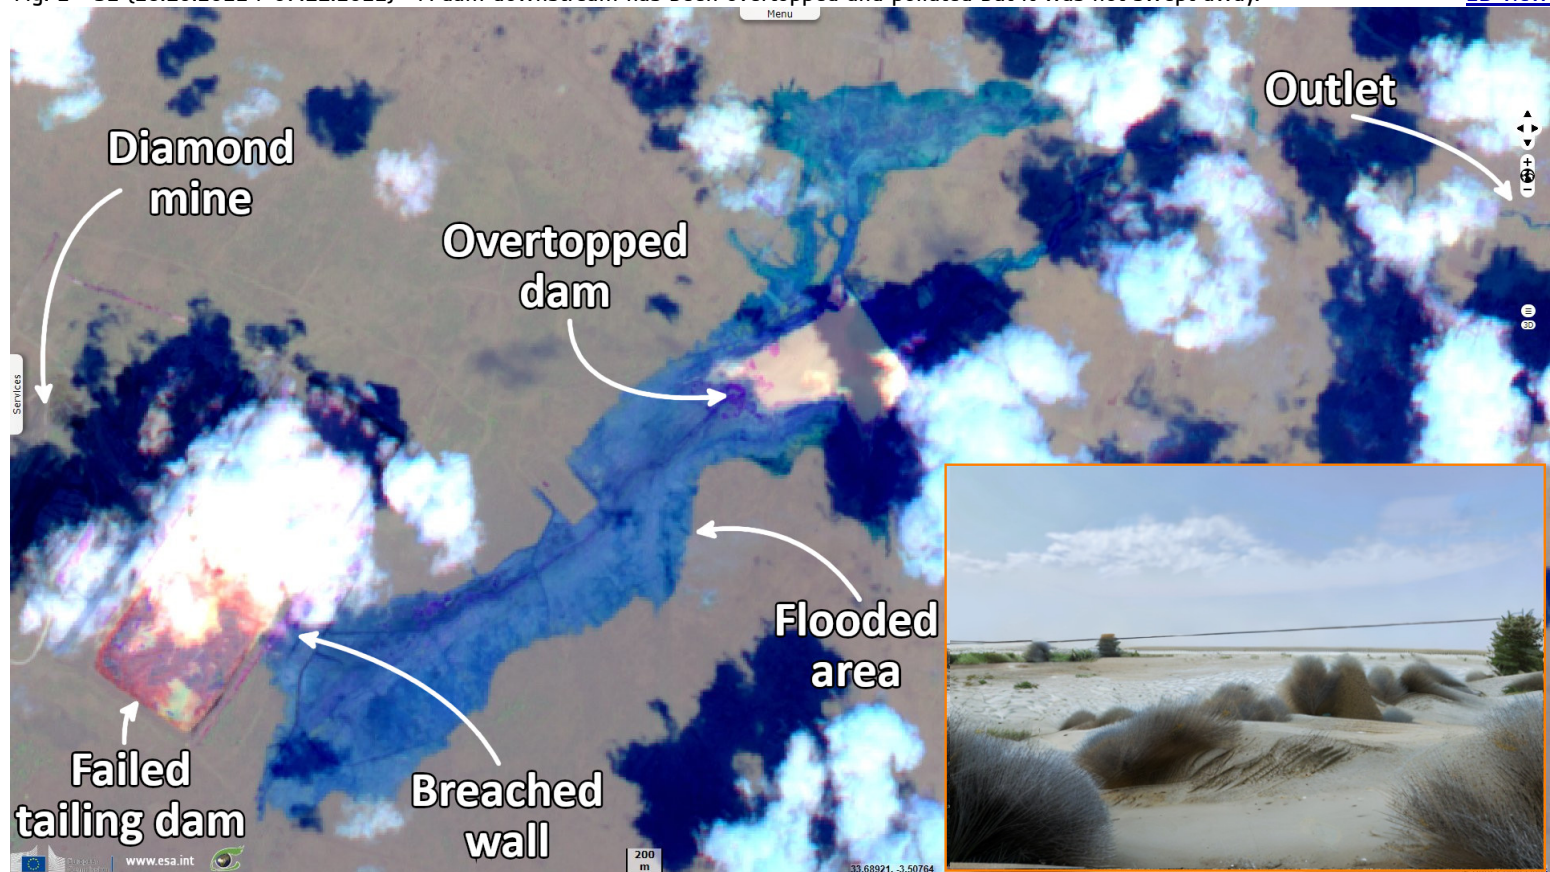
Fig. 2 - S2 (28.10.2022 / 07.11.2022) - A dam downstream has been overtopped and polluted but it was not swept away. [2D view](#)

The whitish plume is over 6 km long and has a maximum width of about 1.2 km. A very rough estimate has a surface area of the plume at about 4.7 km².
