# Flooding in New Brunswick

Sentinel-1 CSAR IW acquired on **03 May 2017** at 10:31:30 UTC  
Sentinel-1 CSAR IW acquired on **16 April 2018** at 10:31:36 UTC  
Sentinel-2 MSI acquired on **22 April 2018** at 15:26:31 UTC  
Sentinel-2 MSI acquired on **02 May 2018** at 15:26:31 UTC  
Sentinel-1 CSAR IW acquired on **04 May 2018** at 10:30:55 UTC

Author(s): Sentinel Vision team, VisioTerra, France - [svp@visioterra.fr](mailto:svp@visioterra.fr)

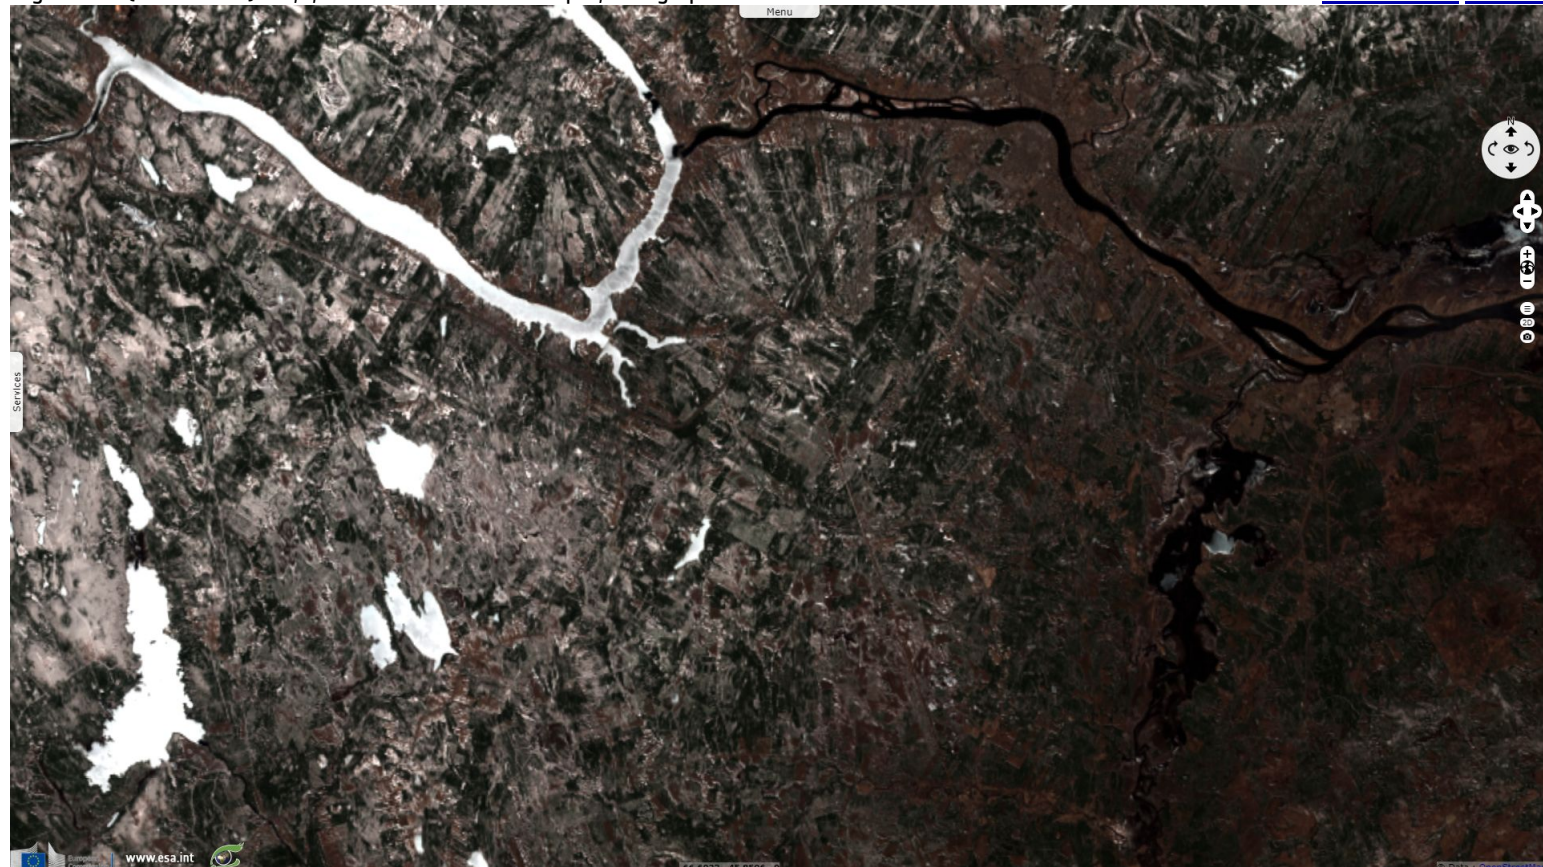
Fig. 3 - S2 (22.04.2018) - 4,3,2 natural colour - Late April, a large part of land & water surfaces around Fredericton are still iced [3D animation](#) [3D view](#)

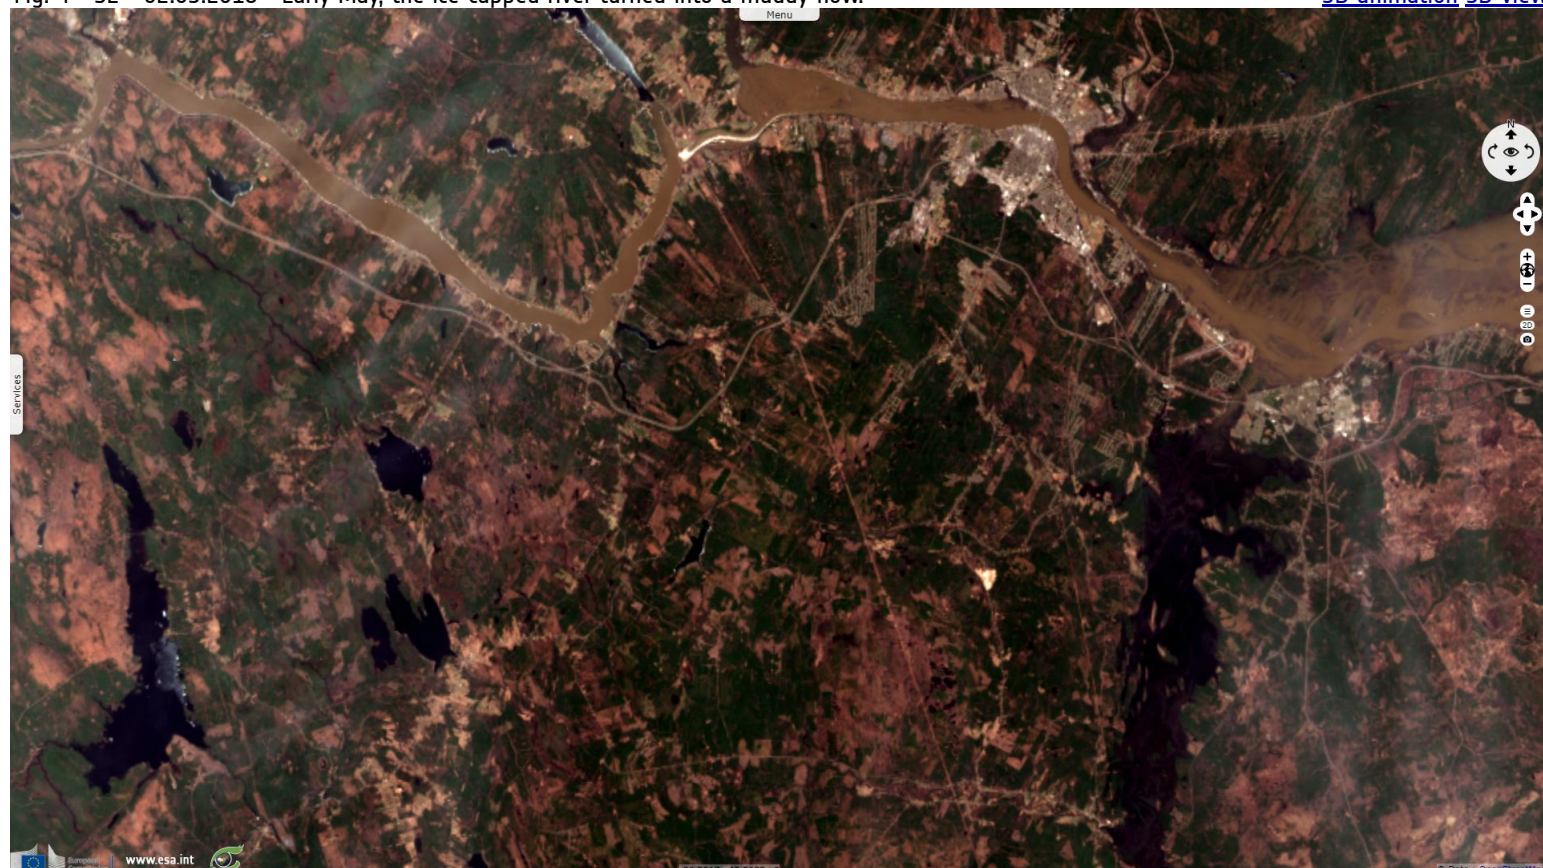
Fig. 4 - S2 - 02.05.2018 - Early May, the ice-capped river turned into a muddy flow.
