# Hundreds evacuate floods in Australian Northern Territory

Sentinel-1 CSAR IW acquired on **06 February 2023** from 20:49:22 to 20:50:37 UTC  
Sentinel-1 CSAR IW acquired on **02 March 2023** from 20:49:22 to 20:50:37 UTC  
Sentinel-2 MSI acquired on **10 March 2023** at 01:36:59 UTC

Author(s): Sentinel Vision team, VisioTerra, France - [syp@visioterra.fr](mailto:syp@visioterra.fr)

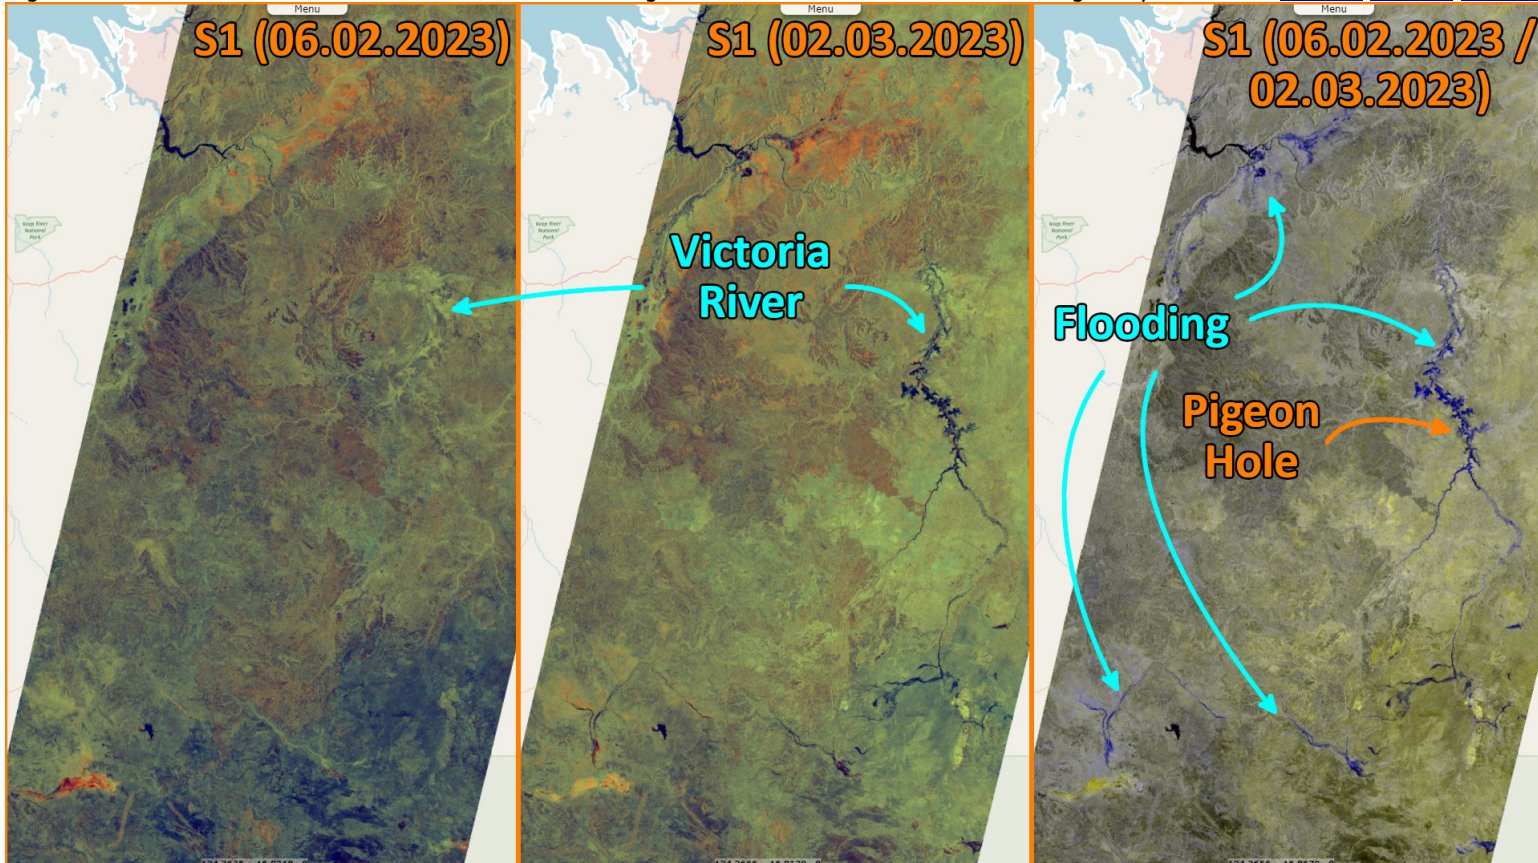
Fig. 1 - S1 (06.02.2023 / 02.03.2023) - Rivers flooded (showing in blue) in north-west Australia following heavy rain.

Authorities in Australia's Northern Territory have ordered the evacuation of communities in the Victoria Daly Region after persistent heavy rain caused rivers to overflow.

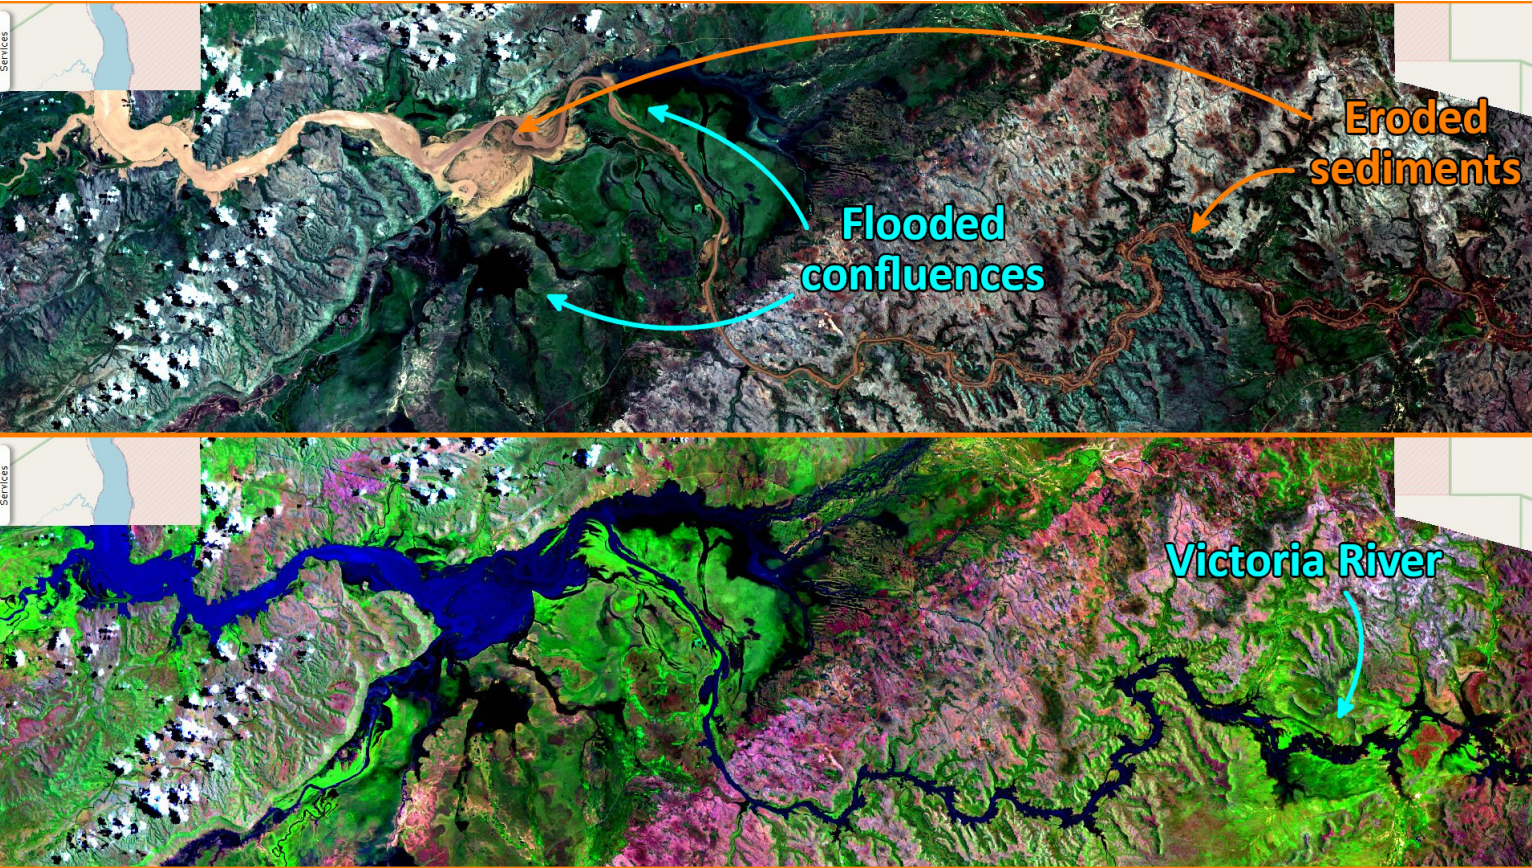
Fig. 2 - S2 (10.03.2023) - The Victoria River stood 3 meters over the major flood stage, endangering settlements built inside the valley. [2D view](#) [2D view](#)

Areas of Pigeonhole are known to be prone to flooding and the Regional Council said it has advocated for the relocation of houses in the community for a number of years.
