# Aftermath of Cyclone Gabrielle on New Zealand's North Island

Sentinel-2 MSI acquired on 21 November 2022 at 22:16:01 UTC  
Sentinel-1 CSAR IW acquired on 09 January 2023 from 07:07:08 to 07:07:37 UTC  
Sentinel-1 CSAR IW acquired on 14 February 2023 from 07:07:07 to 07:07:36 UTC  
Sentinel-2 MSI acquired on 19 February 2023 at 22:16:01 UTC  
Sentinel-2 MSI acquired on 01 March 2023 at 22:16:01 UTC

Author(s): Sentinel Vision team, VisioTerra, France - [svp@visioterra.fr](mailto:svp@visioterra.fr)

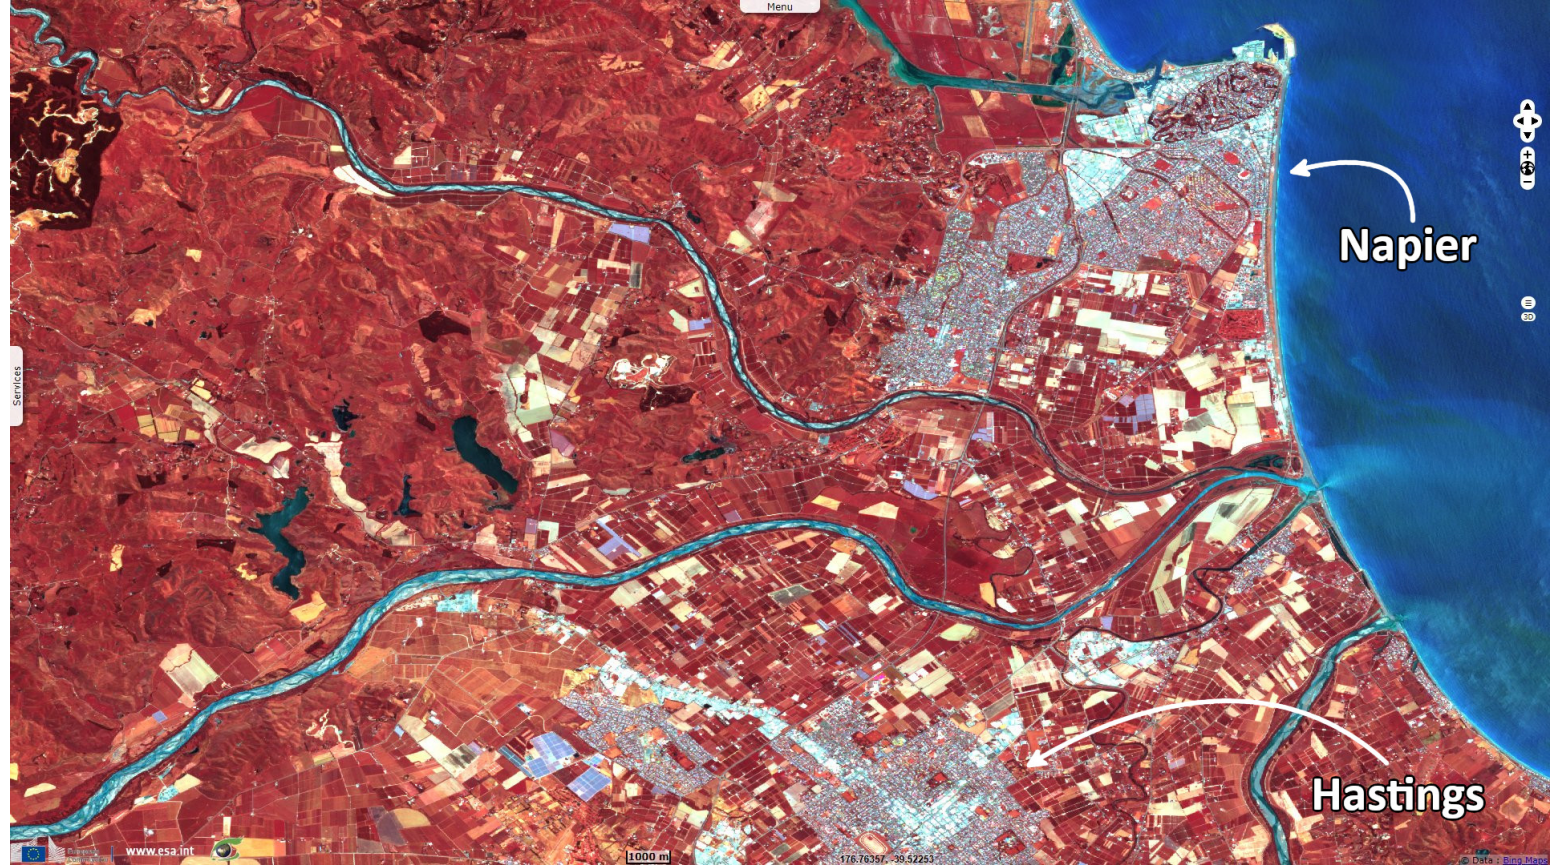
Fig. 7 - S2 (21.11.2022) - Napier and Hastings before Cyclone Gabrielle hit. [2D view](#)

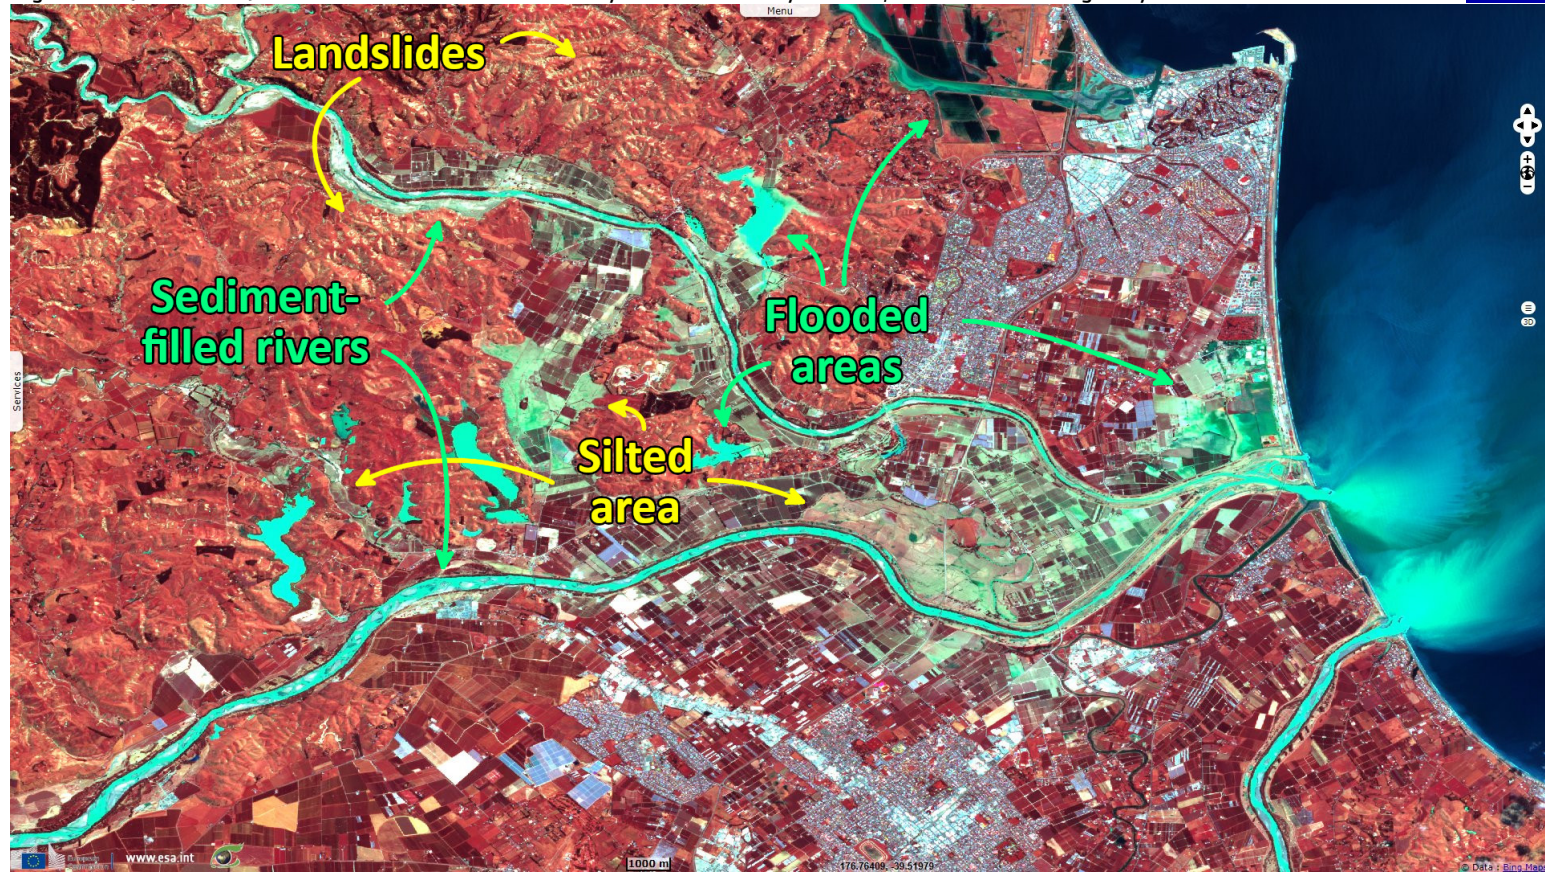
Fig. 8 - S2 (19.02.2023) - Areas were flooded or covered by a metre-thick layer of silt, others were damaged by landslides.

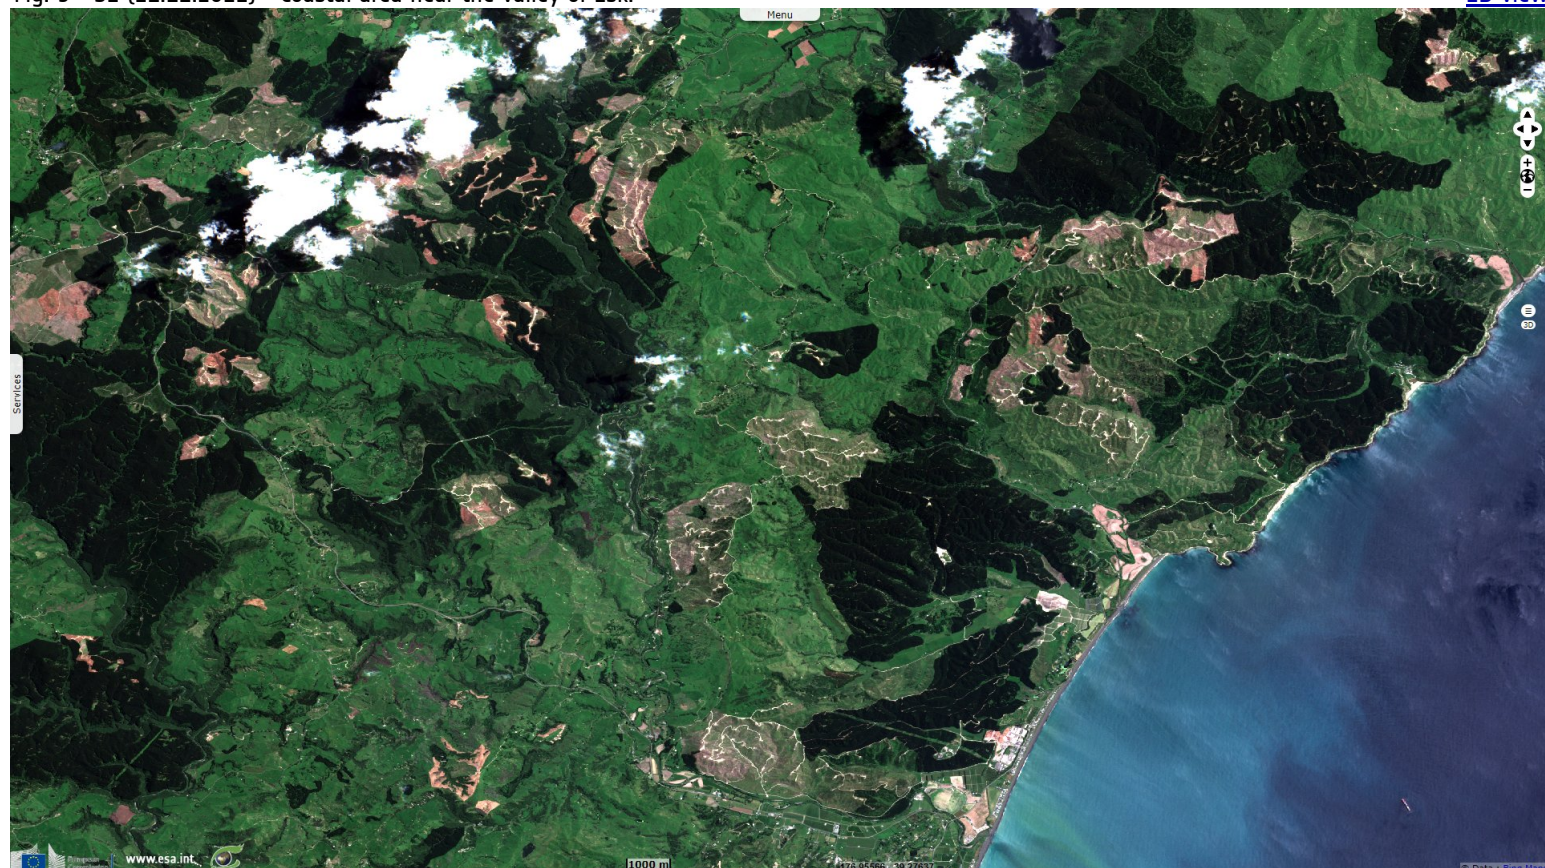
Fig. 9 - S2 (21.11.2022) - Coastal area near the valley of Esk.

A Defence Force helicopter flew over the destruction in the Esk Valley, showing homes with silt all the way to the roofline, with many properties surrounded by silt and little else.

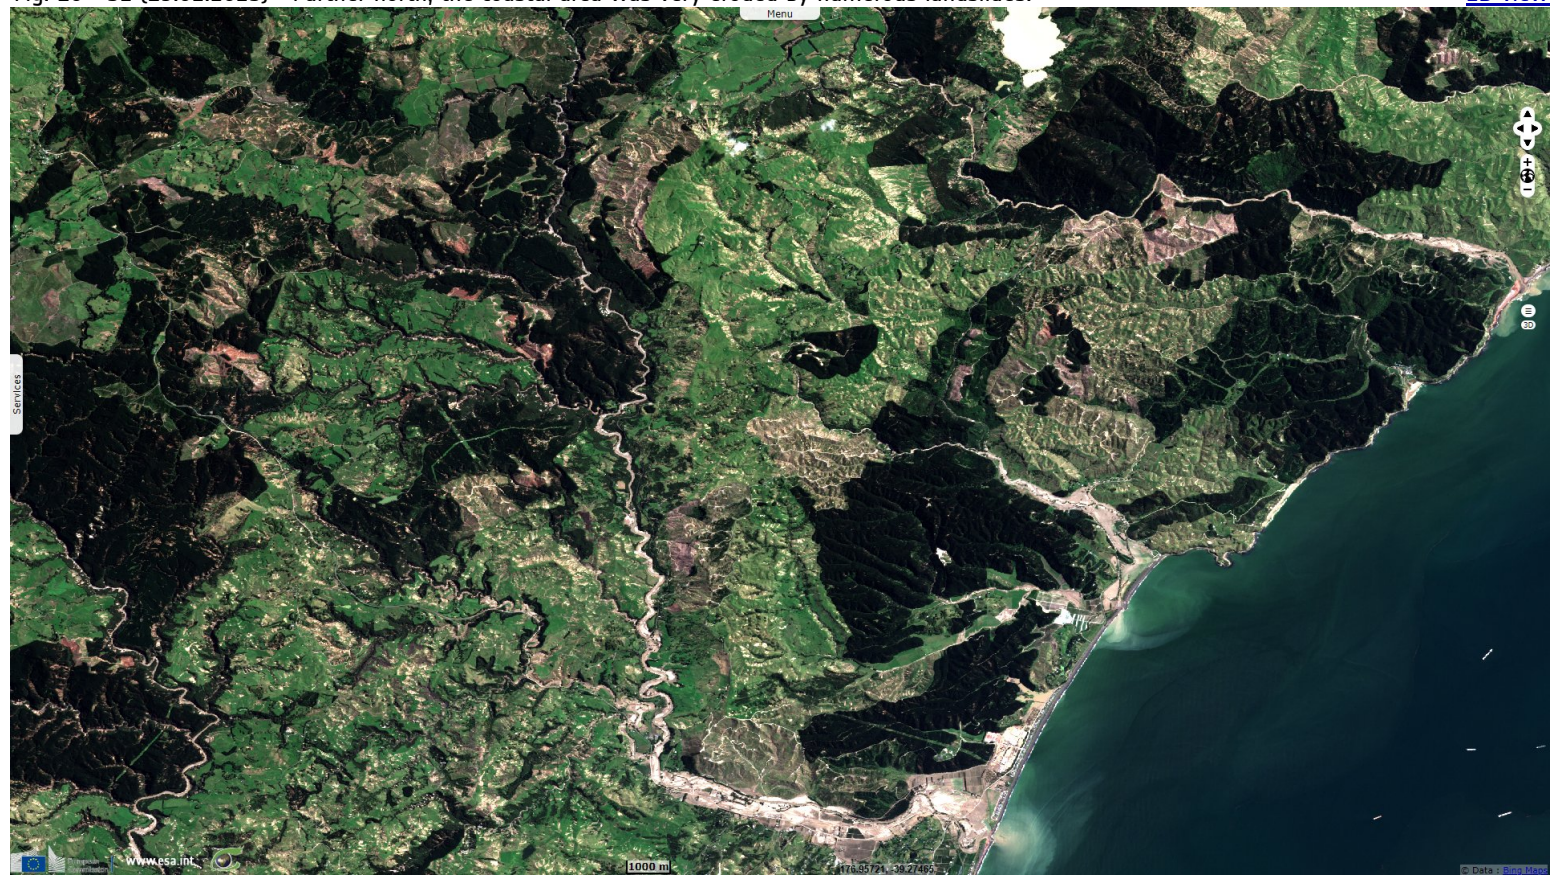
Fig. 10 - S2 [19.02.2023] - Further north, the coastal area was very eroded by numerous landslides.
