# Oil spills in Abo offshore oil field, Nigeria

Author(s): Sentinel Vision team, VisioTerra, France - [svp@visioterra.fr](mailto:svp@visioterra.fr)

Keyword(s): Water monitoring, pollution, atmosphere, oil spill, oil slick, infrastructure, energy, Gulf of Guinea, Nigeria

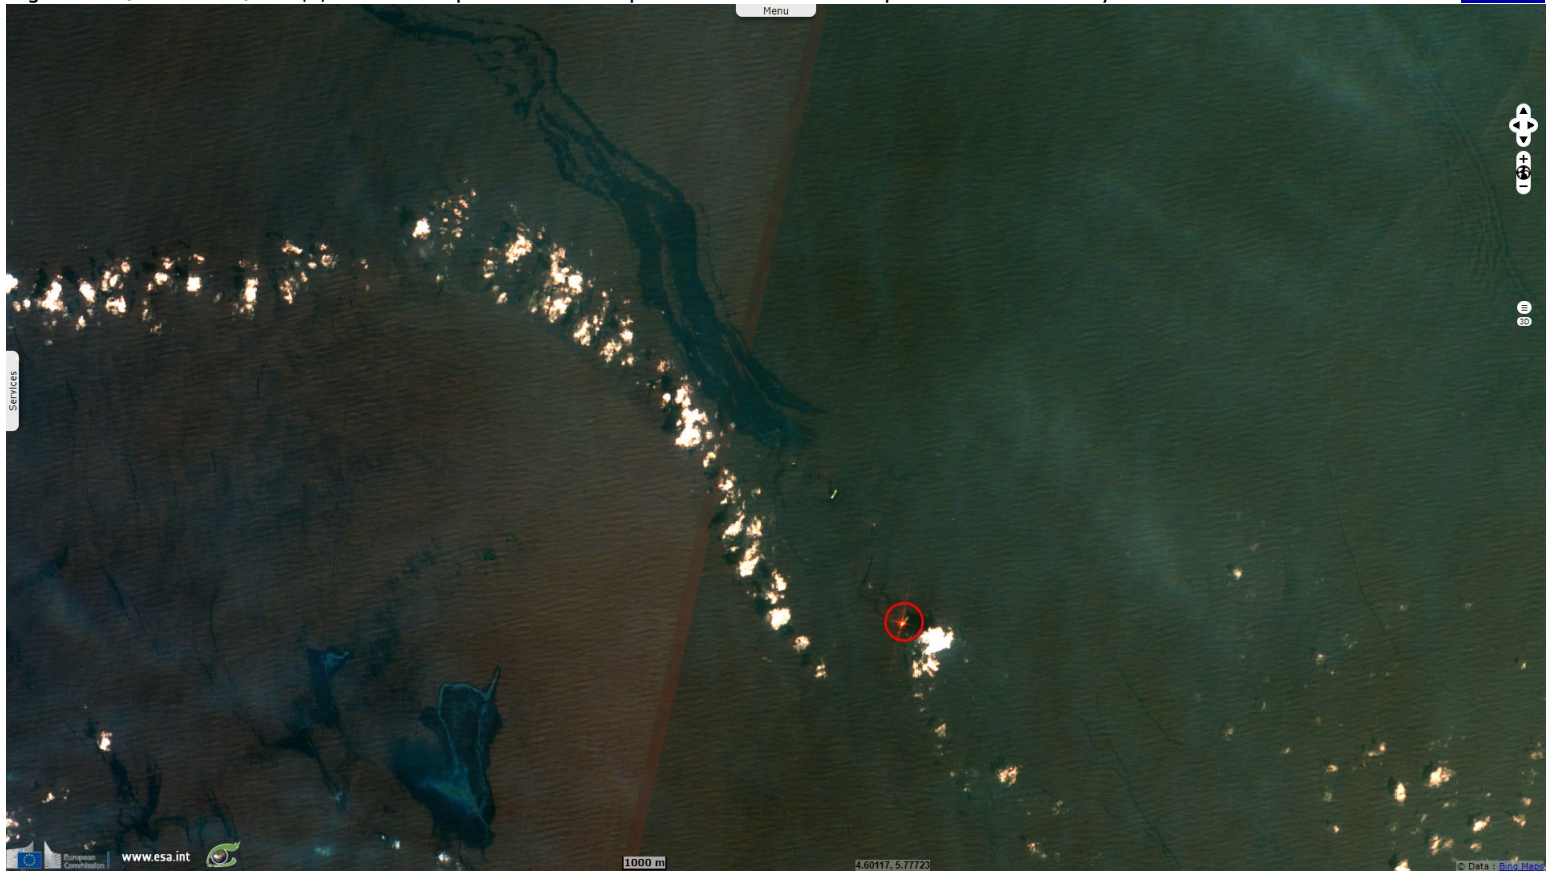
Fig. 9 - S2 (31.01.2019) - 12,4,2 colour composite - The oil spills visible on the S1 acquisition the same day also show on S2.

Depending on the thickness of the oil layer, its optical aspect changes as codified by the Bonn Agreement Oil Appearance Code (BAOAC), allowing a rough estimation of the volumes visualised.

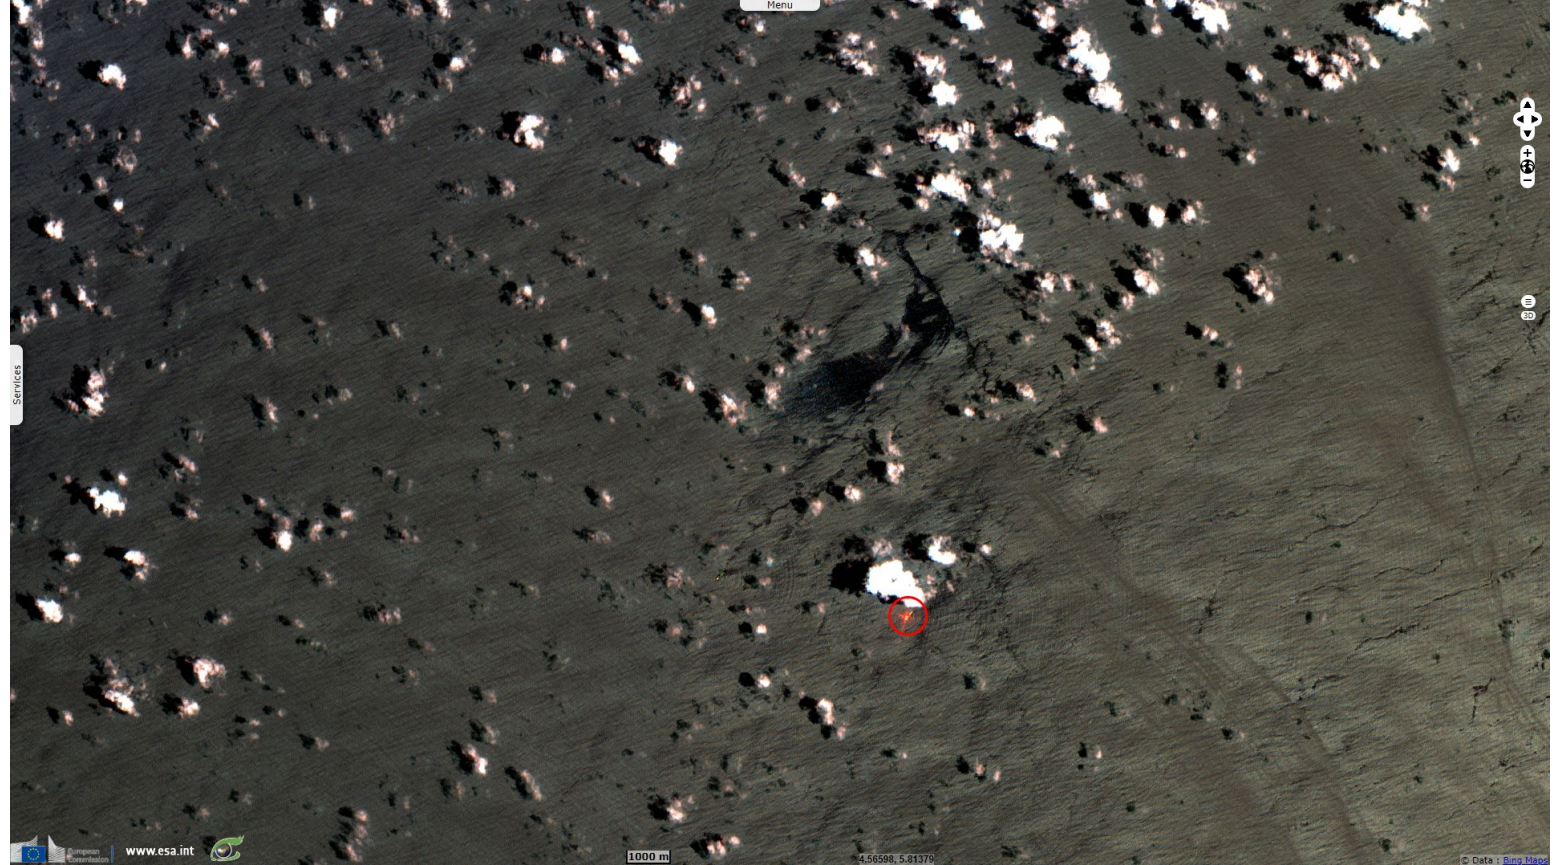
Fig. 11 - 27.03.2019 - ~30% of the annual gas consumption in the EU is flared annually, releasing ~1.2% of the worldwide CO2 emissions. [2D view](#)
