# Deadly flood after a dam failed, Andhra Pradesh, India

Author(s): Sentinel Vision team, VisioTerra, France - [svp@visioterra.fr](mailto:svp@visioterra.fr)

Keyword(s): Emergency, natural disaster, rainfall, lake, dam, hydrology, flood, India

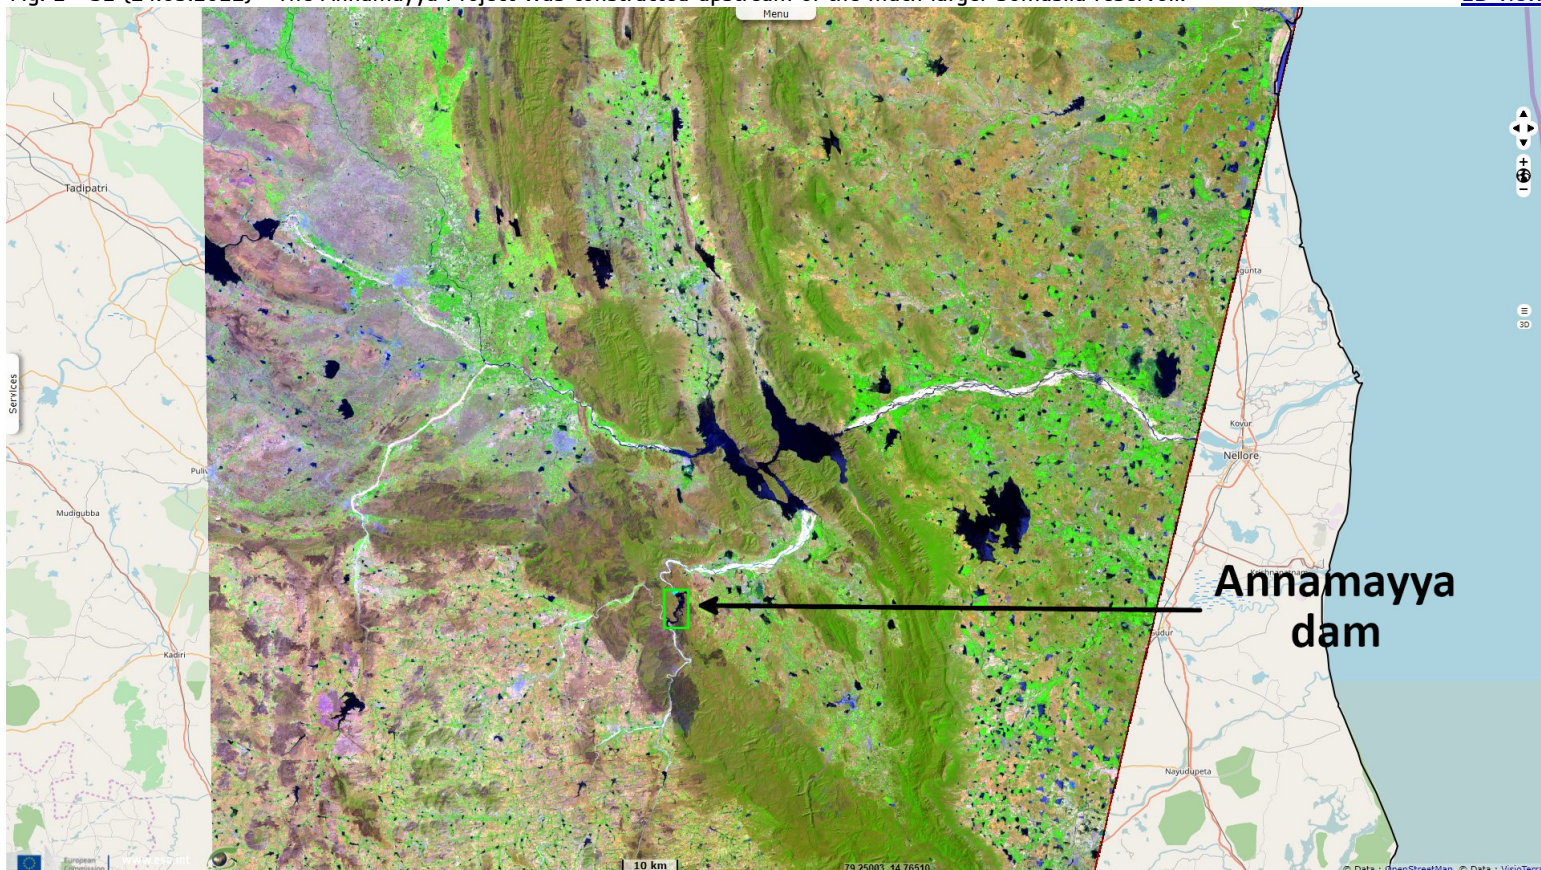
Fig. 2 - S2 (14.03.2021) - The Annamayya Project was constructed upstream of the much larger Somasila reservoir.

"Some of the worst of the flooding was a result of the failure of the earthen dam of the Annamayya project on the Cheyyeru river near Badanagadda village in Kadapa District." The Annamayya Project was constructed across the Cheyyeru river which is a tributary to the Pennar river. "The project is located near the Badanagadda village, Rajampet Mandal, Kadapa District. DMD said that following huge rainfall from 18 November 2021, heavy inflows caused severe damage to the dam, washing parts of it away on 19 November. At least 15 people died in the flooding downstream, with many more missing."

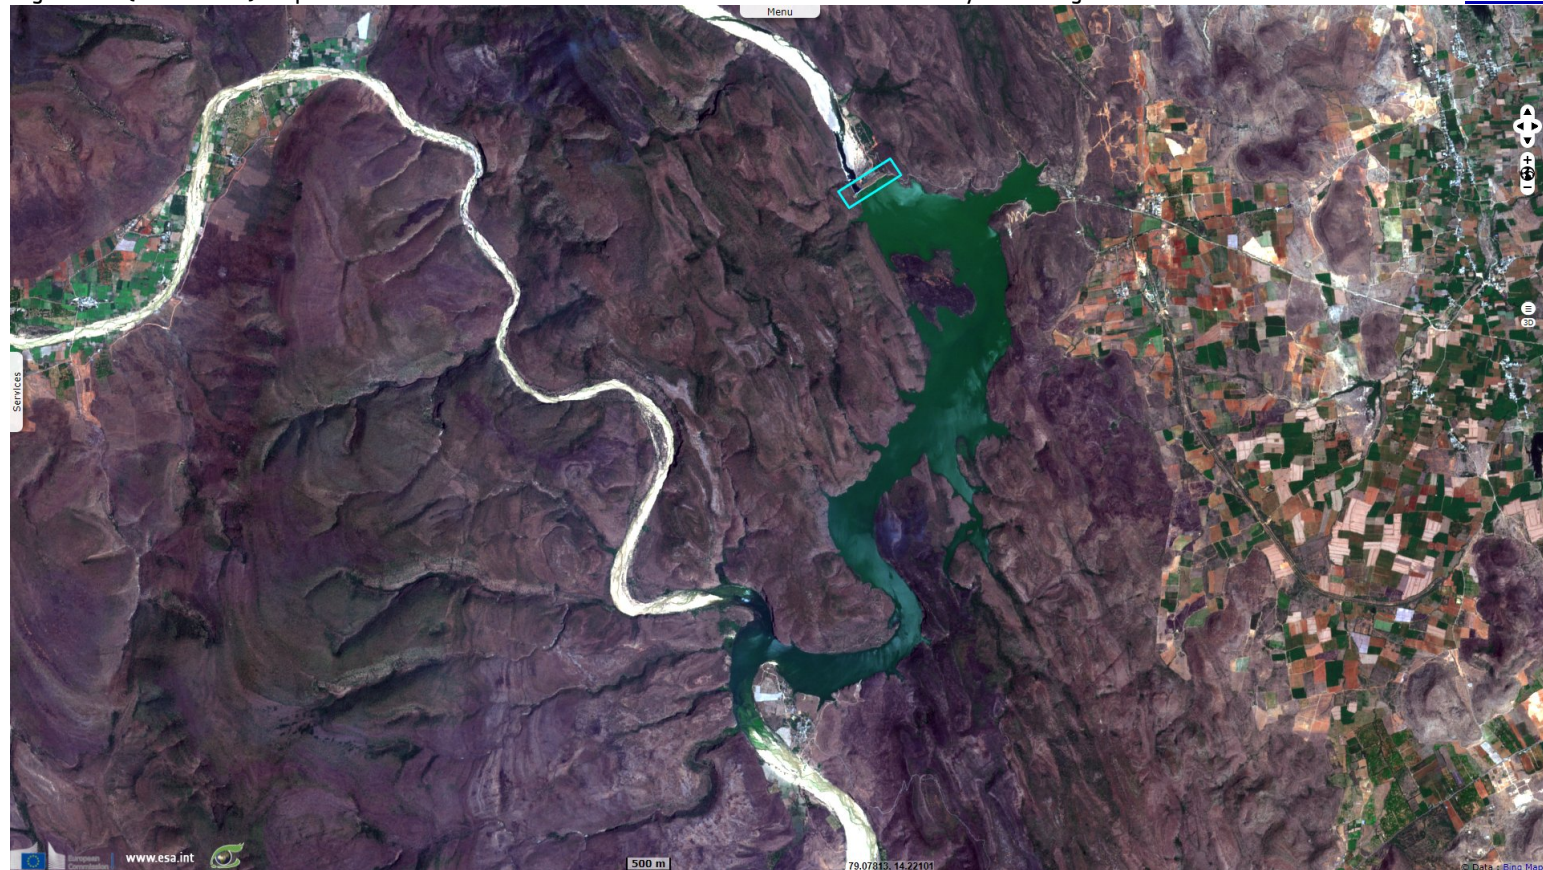
Fig. 3 - S2 (14.03.2021) - Optical view of the lake in March 2021. The dam is located in the cyan rectangle.

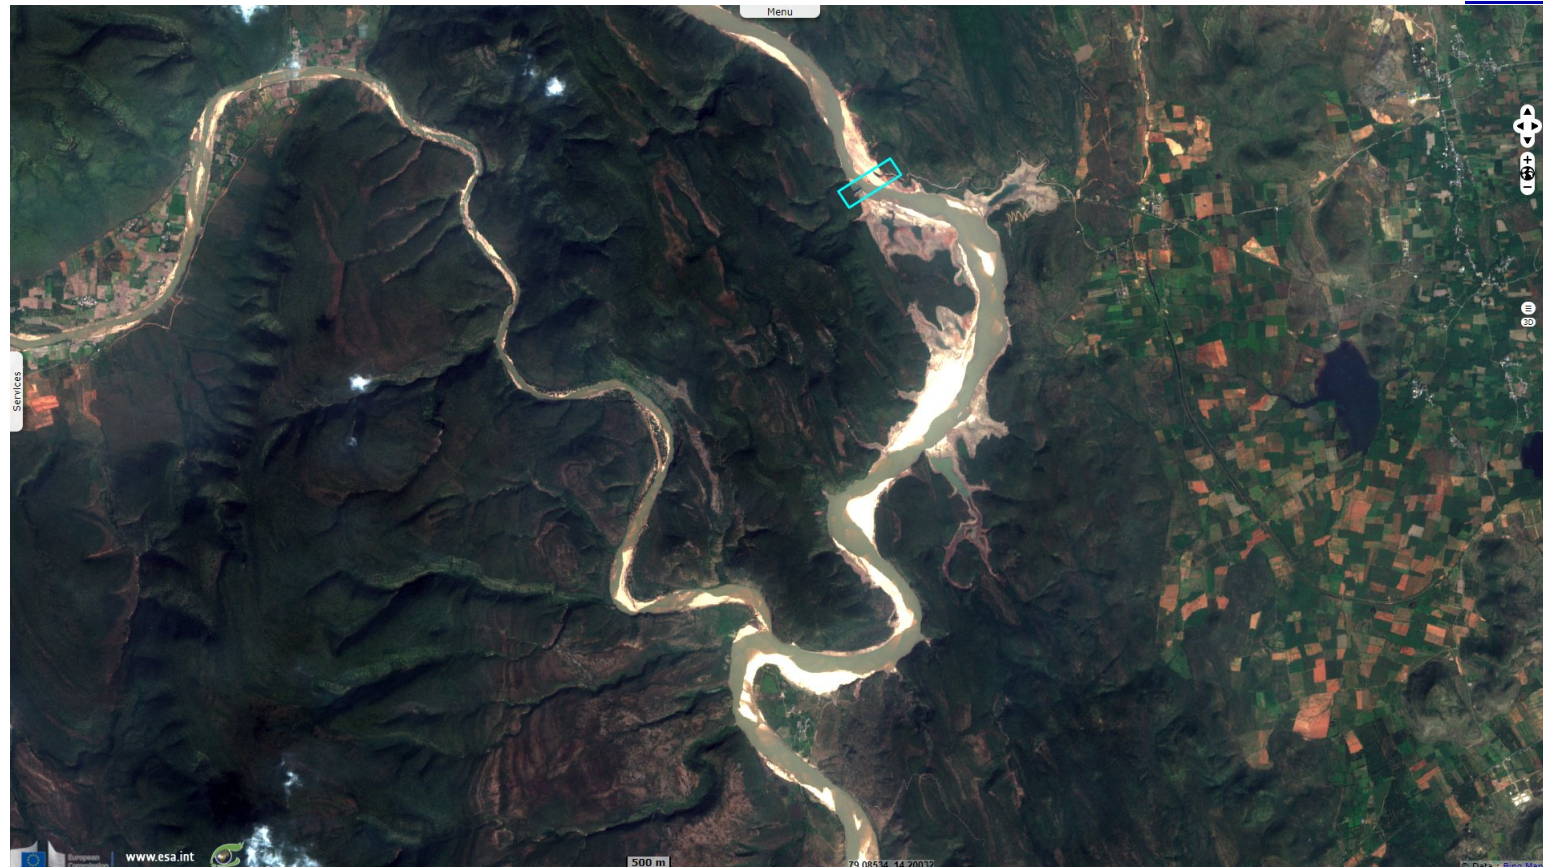
Fig. 4 - S2 (04.12.2021) - Optical view of the lake after the dam failure. The lake has emptied while the upstream waters are stronger than previously.

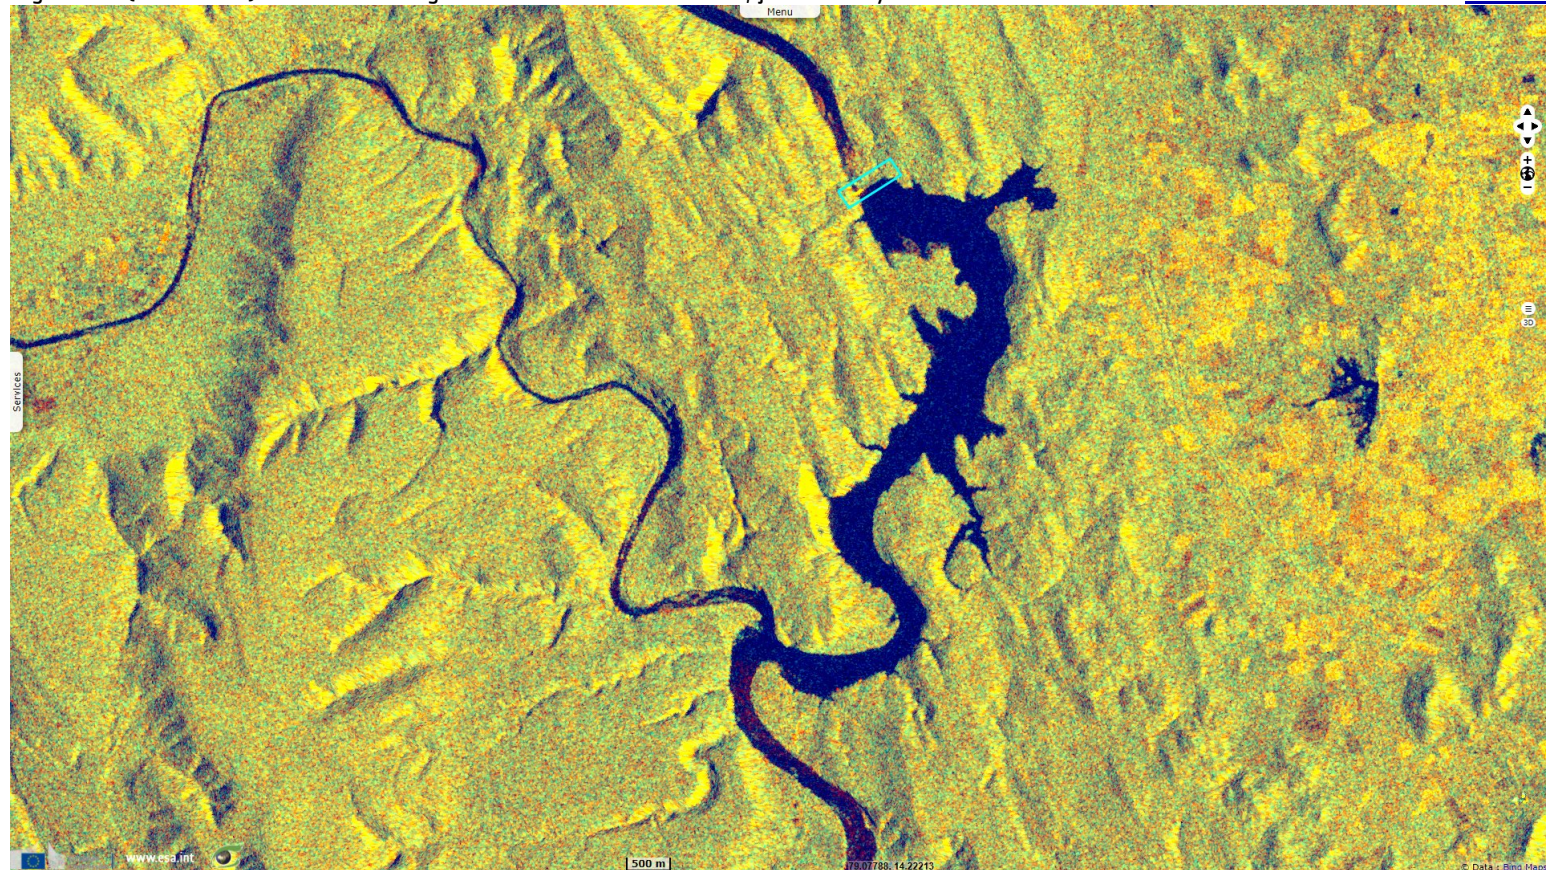
Fig. 5 - S1 (16.11.2021) - Last radar image of the lake before the storm, just two days later.

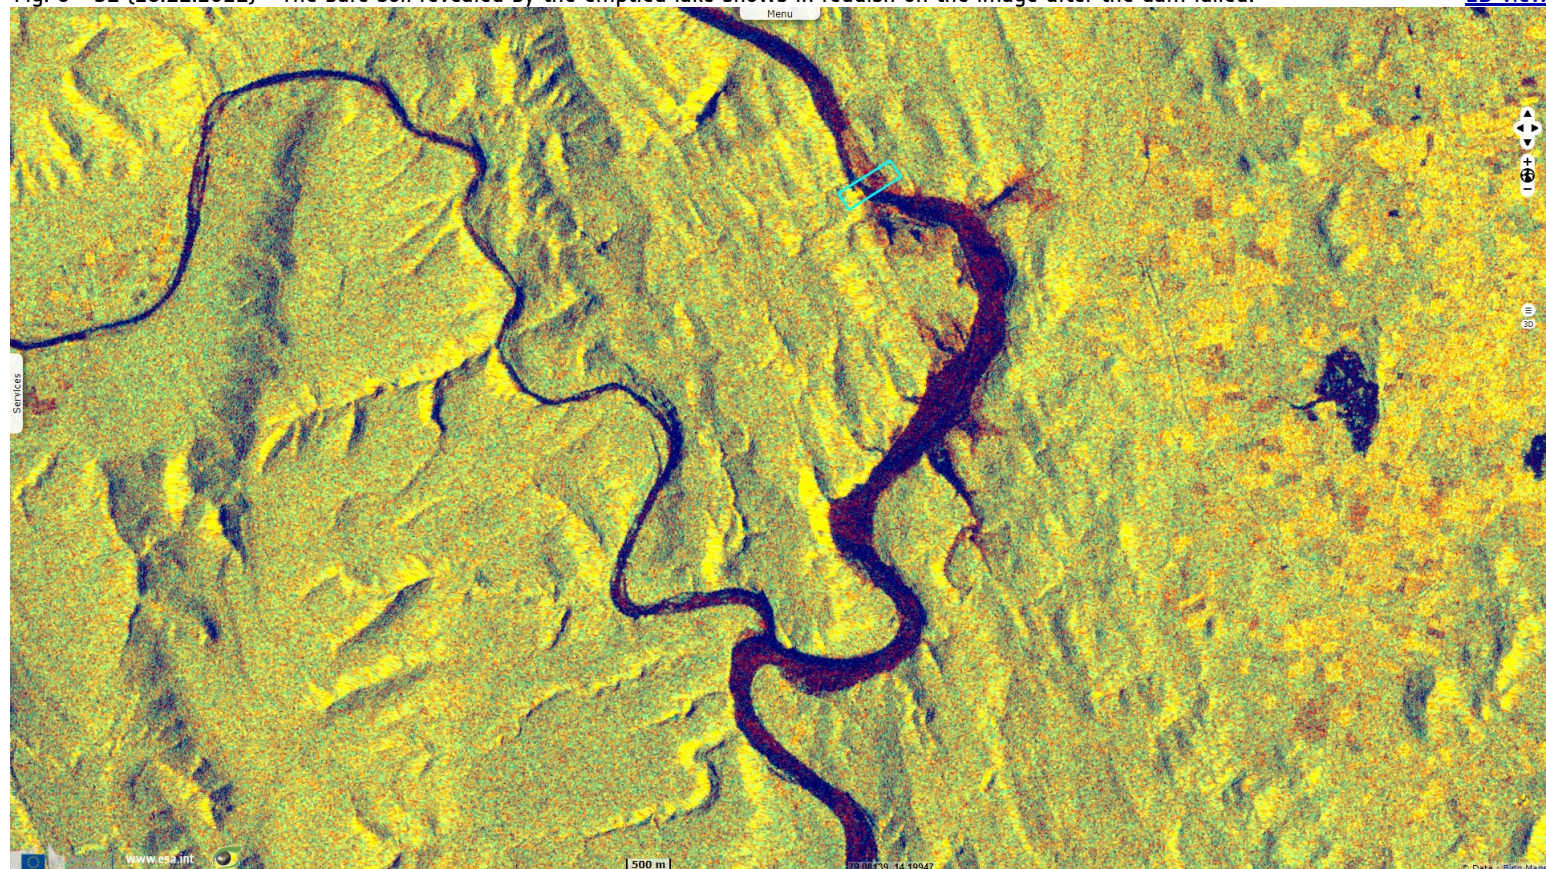
Fig. 6 - S1 (28.11.2021) - The bare soil revealed by the emptied lake shows in reddish on the image after the dam failed.

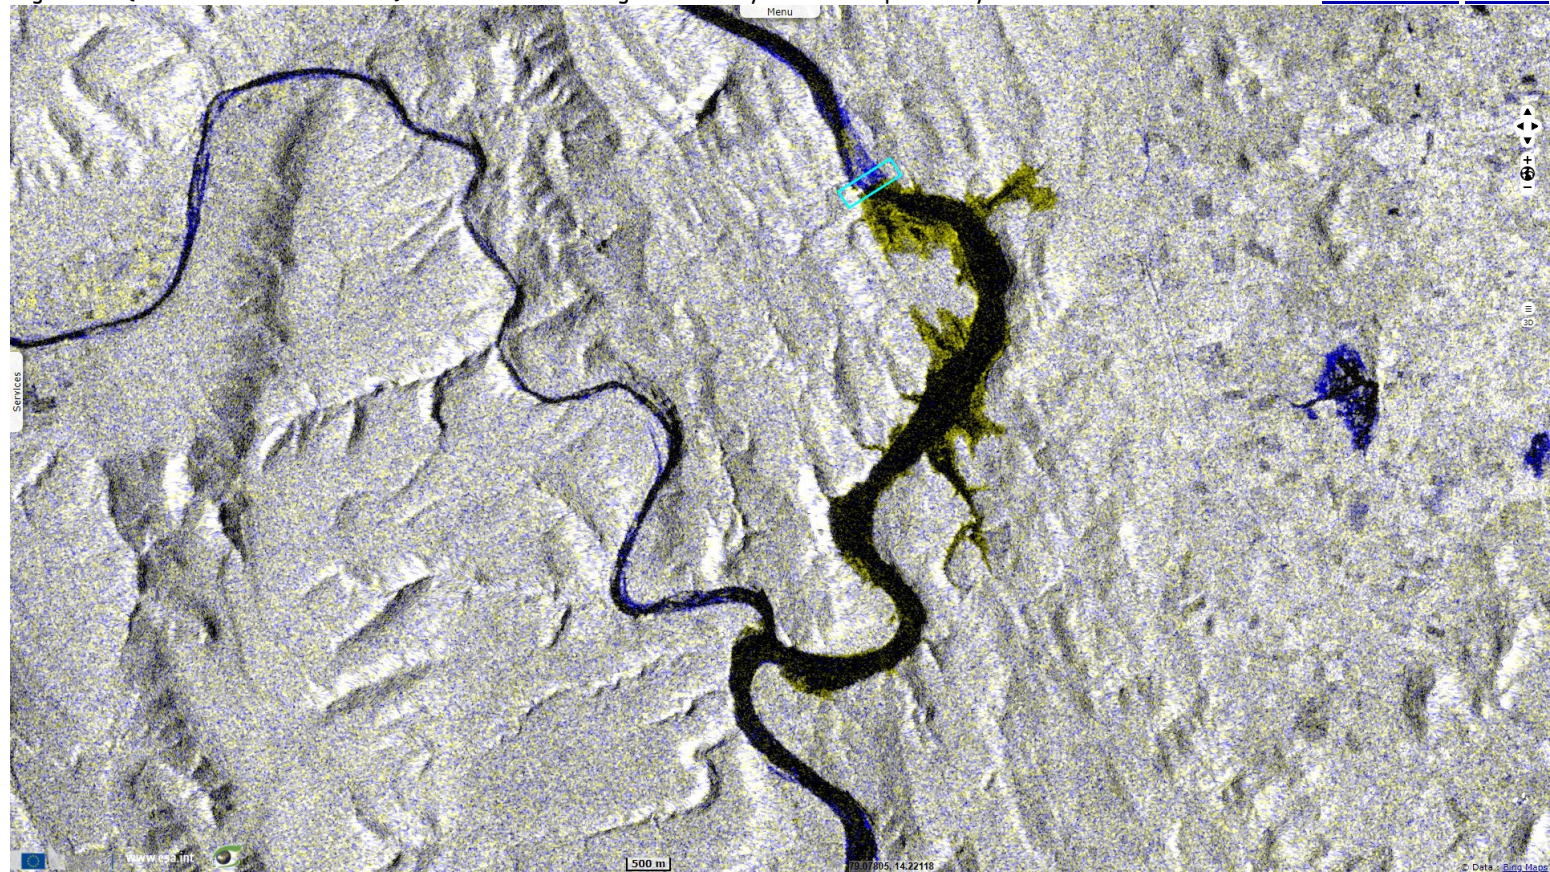
Fig. 7 - S1 (16.11.2021 & 28.11.2021) - This multitime image shows in yellow areas previously underwater.

In blue, one can see areas that were overflowed by excess water, upstream and downstream of the collapsed dam.

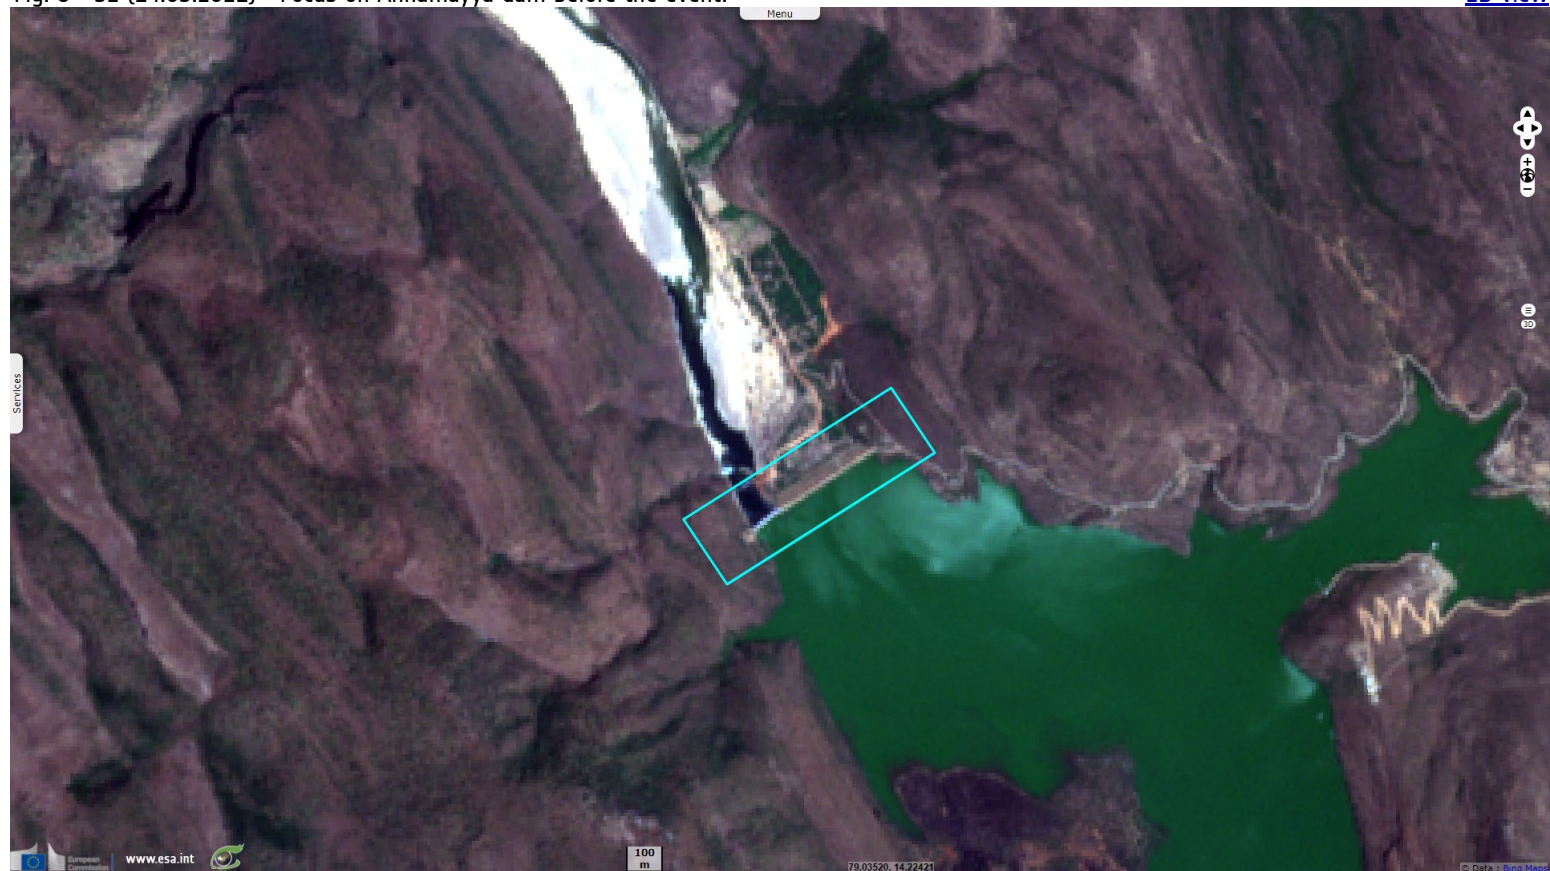
Fig. 8 - S2 (14.03.2021) - Focus on Annamayya dam before the event.

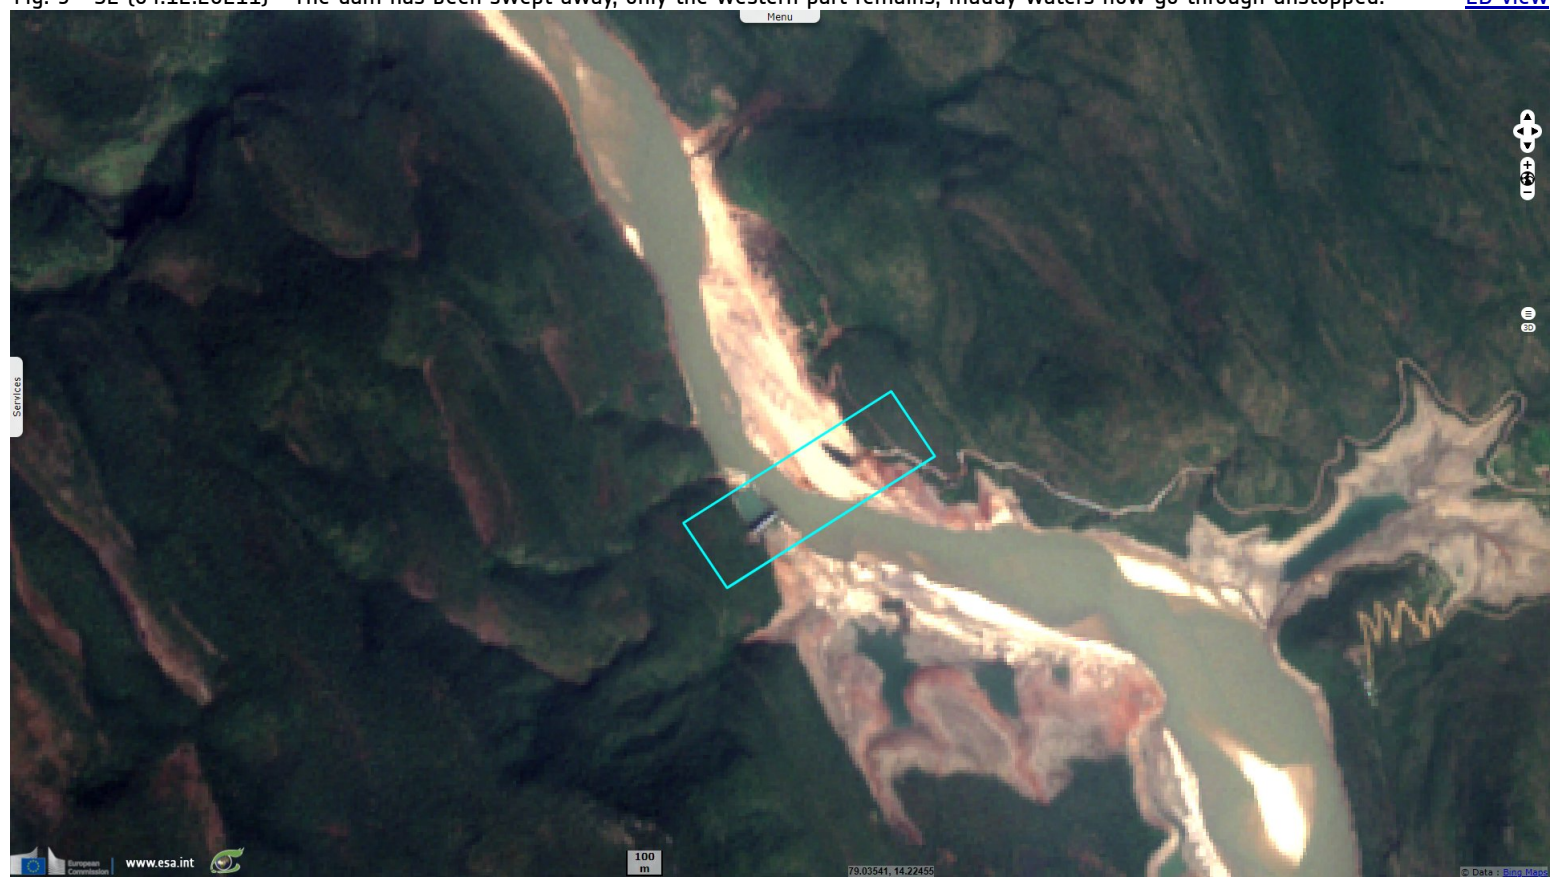
Fig. 9 - S2 (04.12.2021) - The dam has been swept away, only the western part remains, muddy waters now go through unstopped.

A local newspaper [relates](#): "The flash flood caused due to a breach of the project's earthen bund caught at least 18 people in a watery grave and left many others missing in these villages. A sudden gush of about 200 000 cubic meters / sec of floodwater on Friday, with the level reaching up to 3m height, caught the villagers unawares and scampering for their lives.

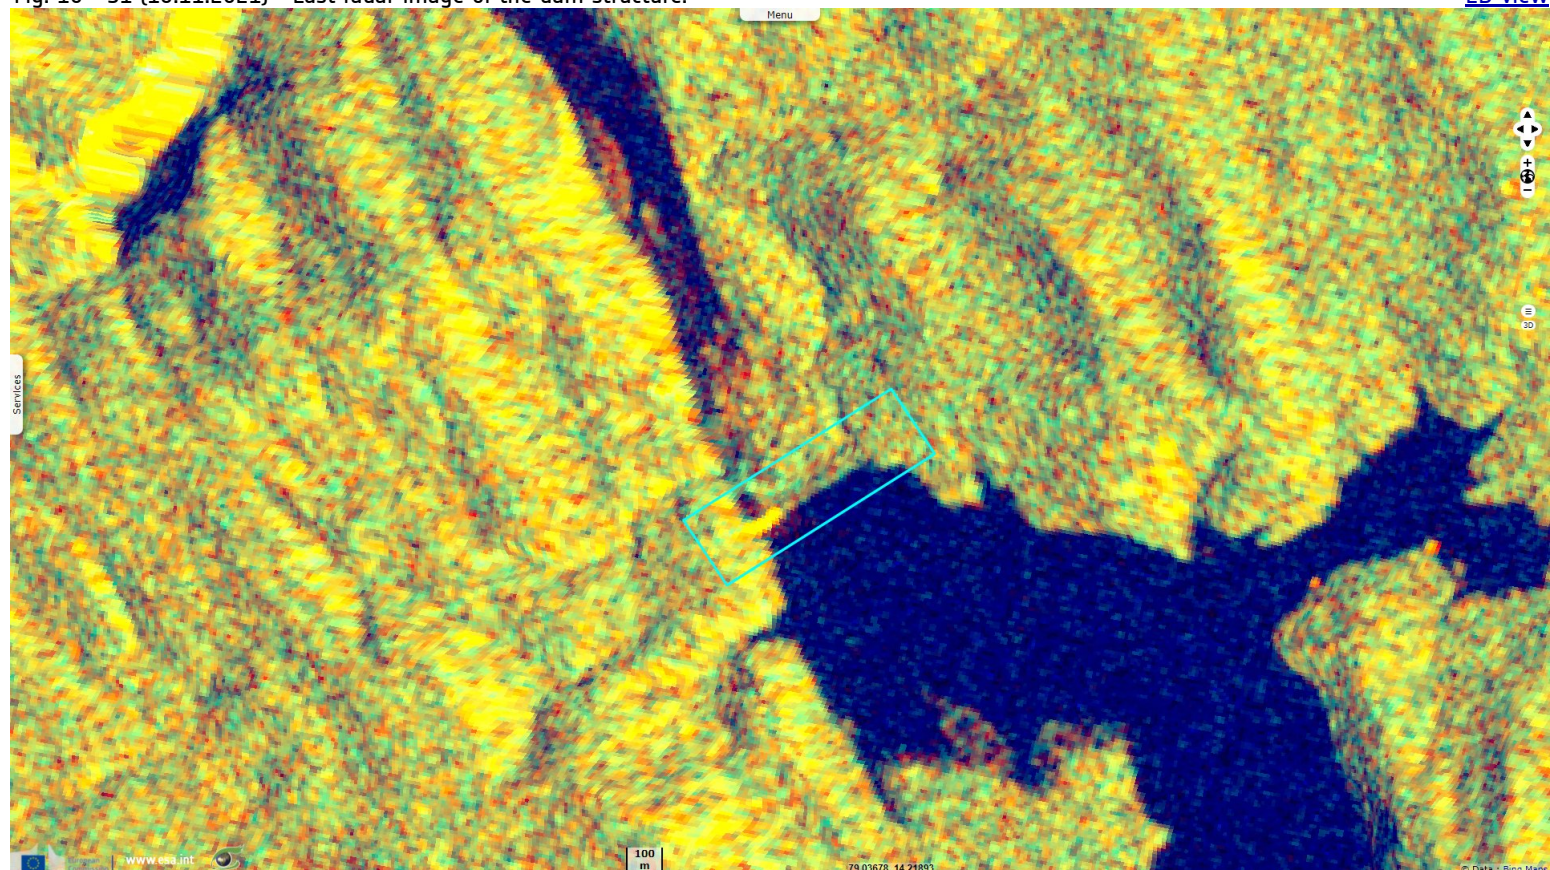
Fig. 10 - S1 (16.11.2021) - Last radar image of the dam structure.

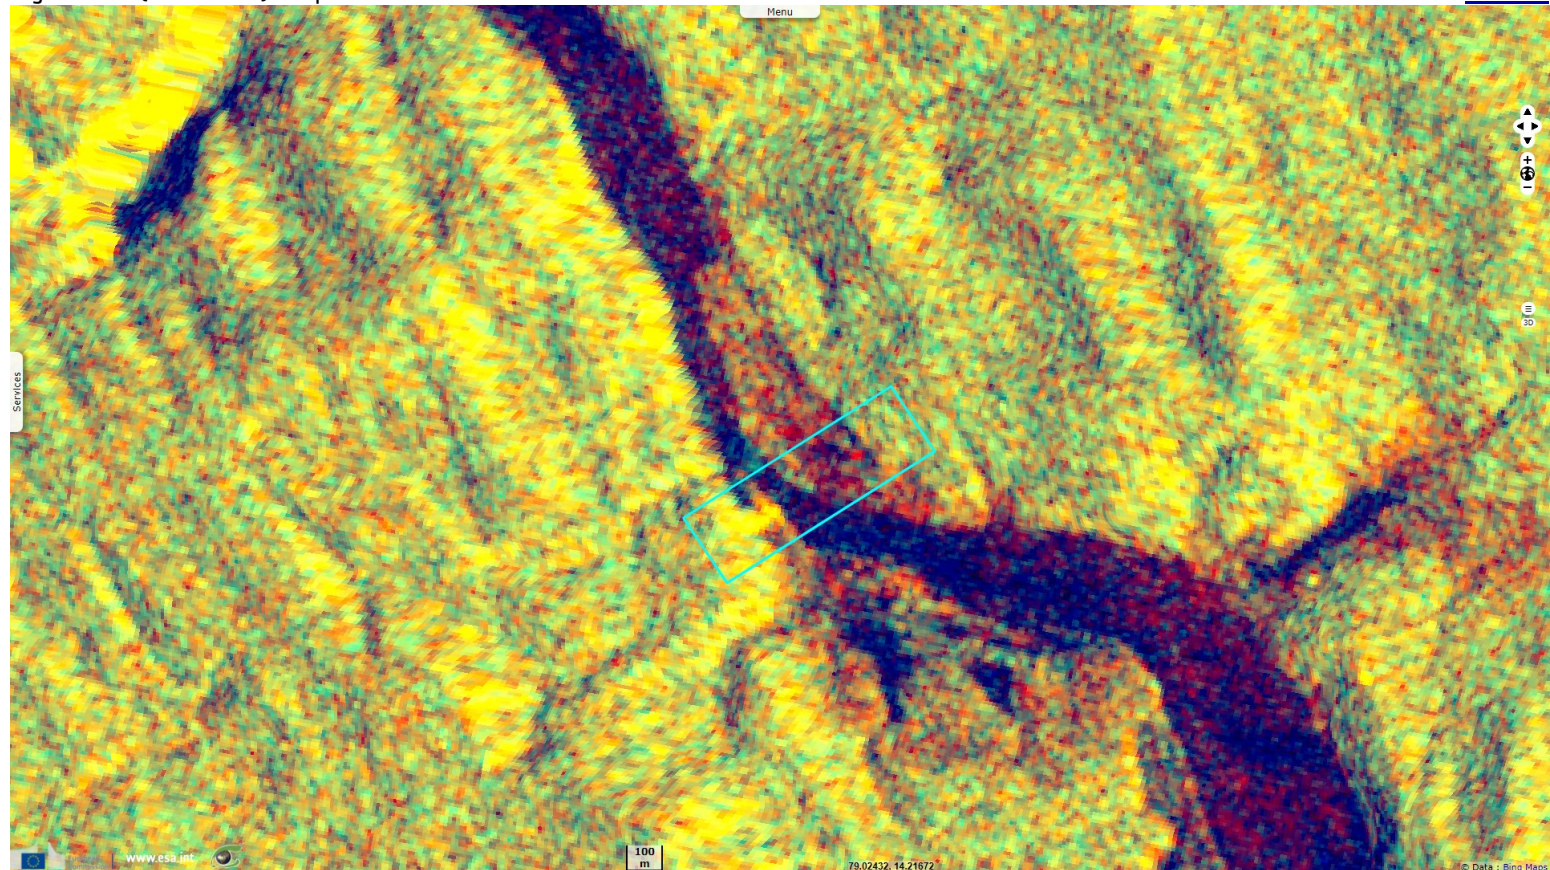
Fig. 11 - S1 (28.11.2021) - A patch of land downstream has also been revealed behind the eastern section of where the dam stood.

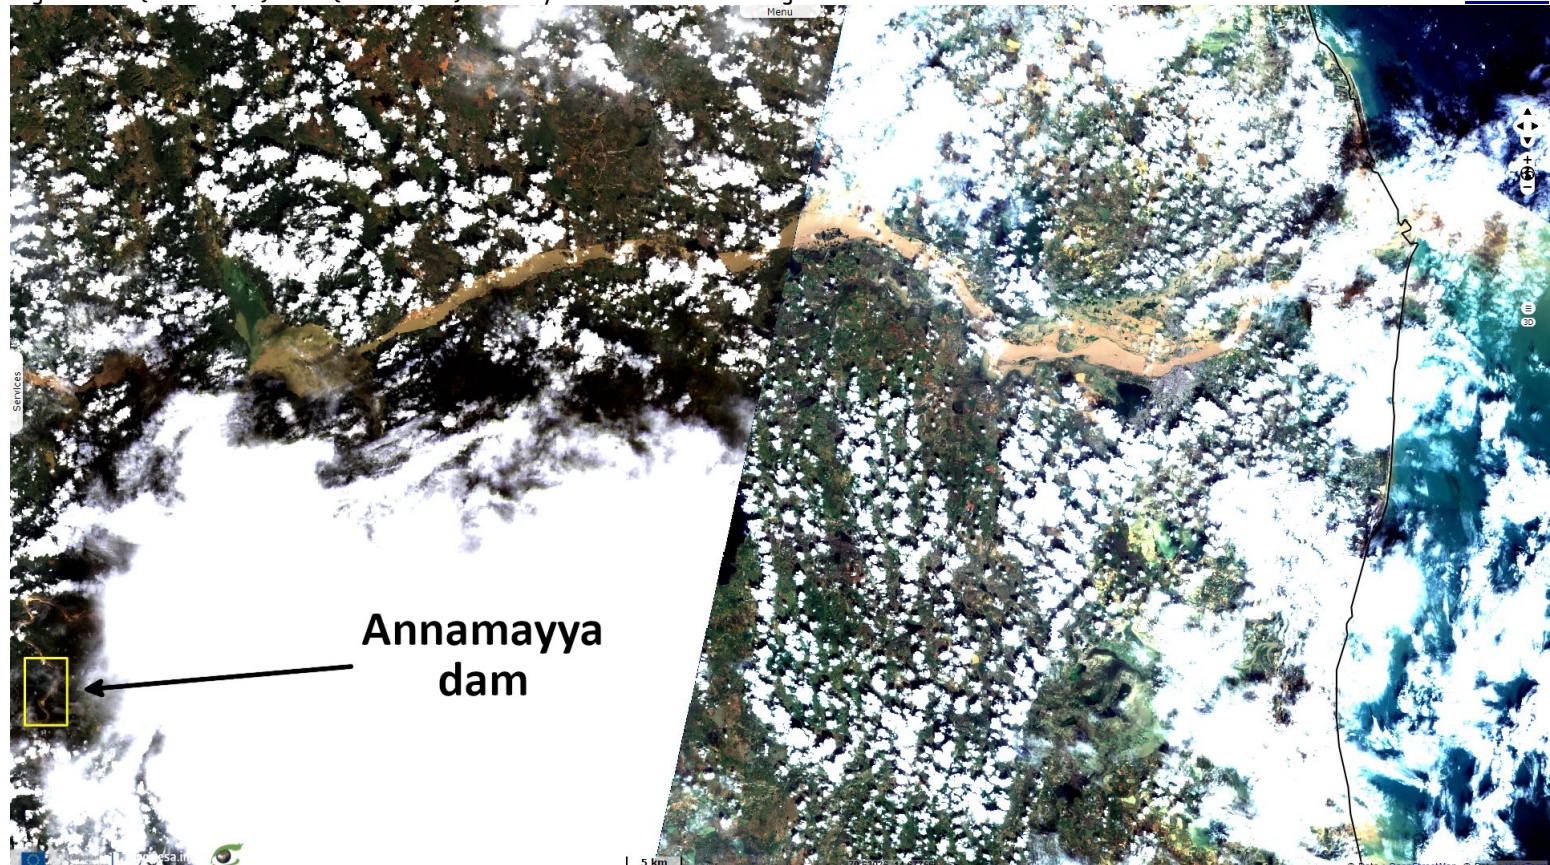
Fig. 12 - S2 (21.11.2021) & L8 (22.11.2021) - Muddy waters flooded the region downstream.

Tens of houses in these villages downstream the project were reduced to rubble. The villagers lost everything, except the clothes on their person. Crops in hundreds of acres stood destroyed. Tens of cattle heads were washed away. Nothing of the household items was left as the deluge gulped them."
