# Two-step large rock avalanche in the Pacific Range

Author(s): Sentinel Vision team, VisioTerra, France - [svp@visioterra.fr](mailto:svp@visioterra.fr)

Keyword(s): Geohazard, geology, mountain, subduction, climate change, landslide, snow, ice melt, glacier, Canada.

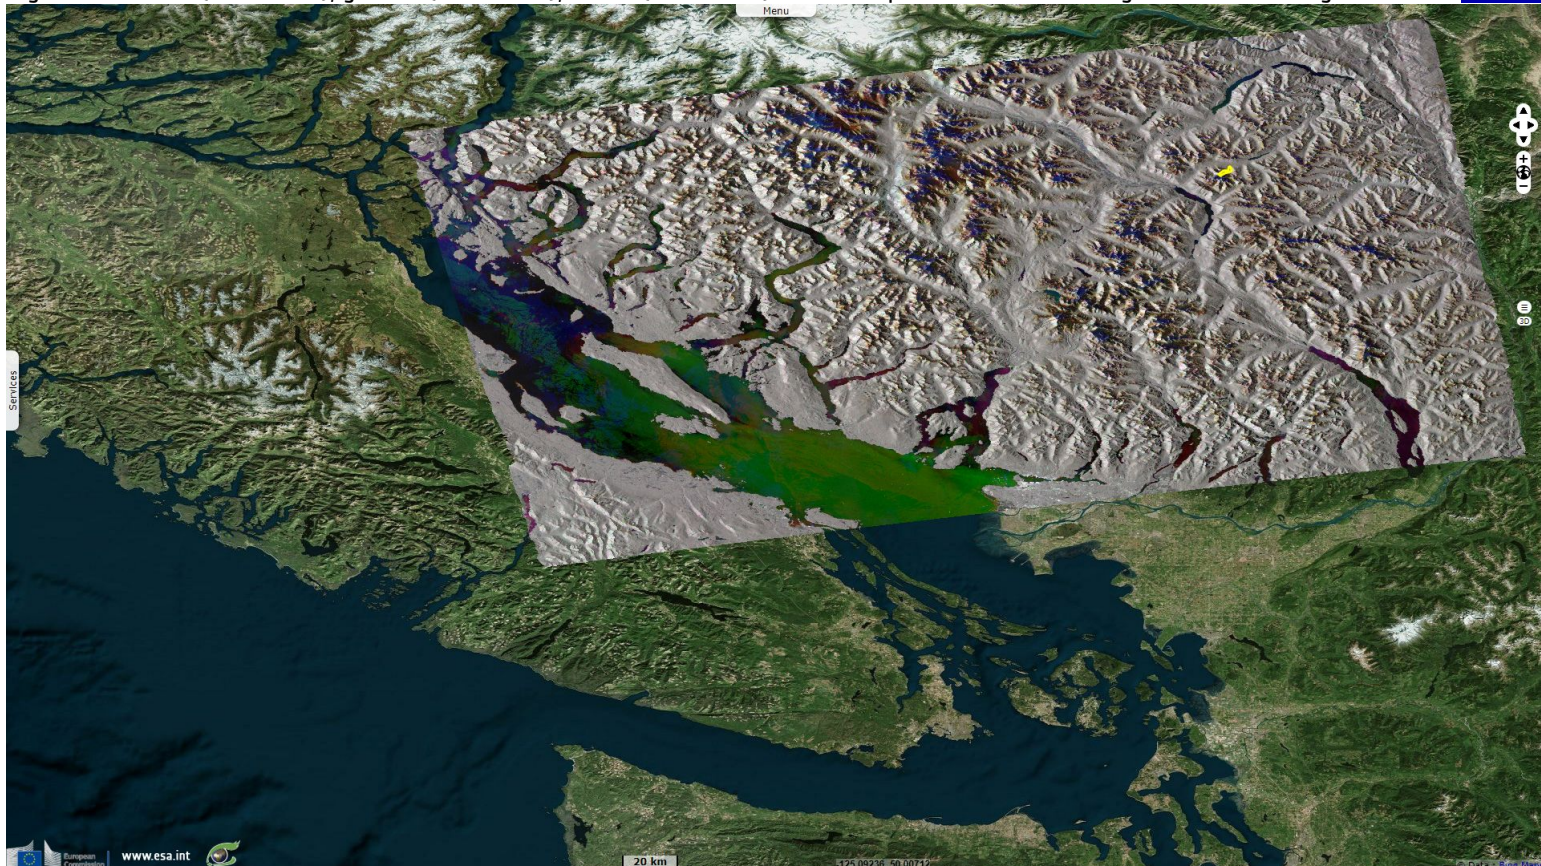
Fig. 1 - S1 - red:vv(28.05.2019), green:vv(16.05.2019), blue:vv(04.05.2019) colour composite - The Pacific range lies east of Georgia Strait. [2D view](#)

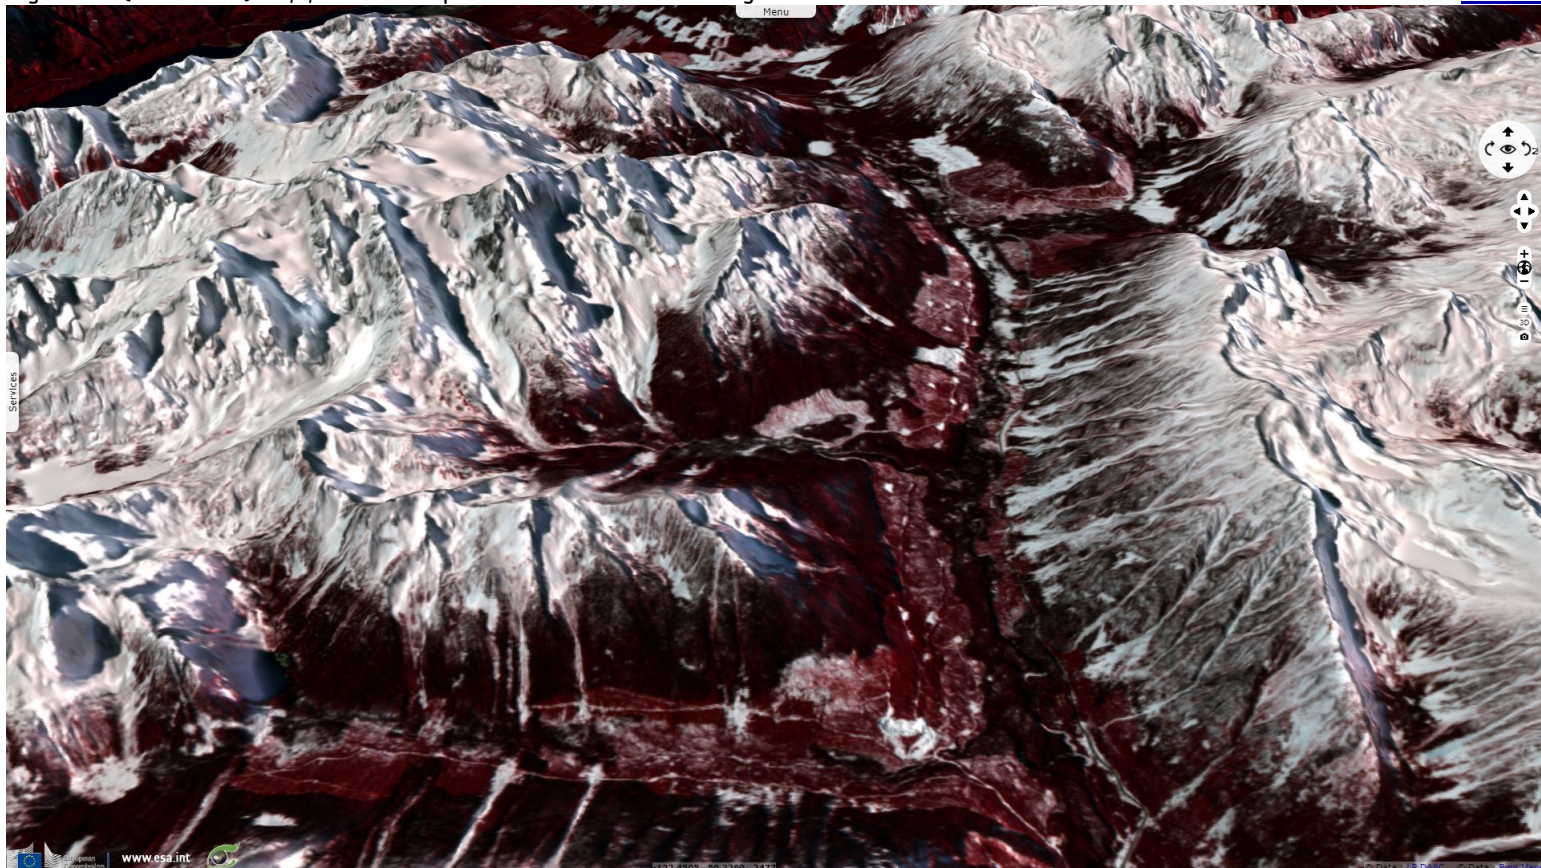
Fig. 2 - S2 (17.03.2019) - 8,4,3 colour composite - Mount Joffre and its glacier in March 2019. [3D view](#)

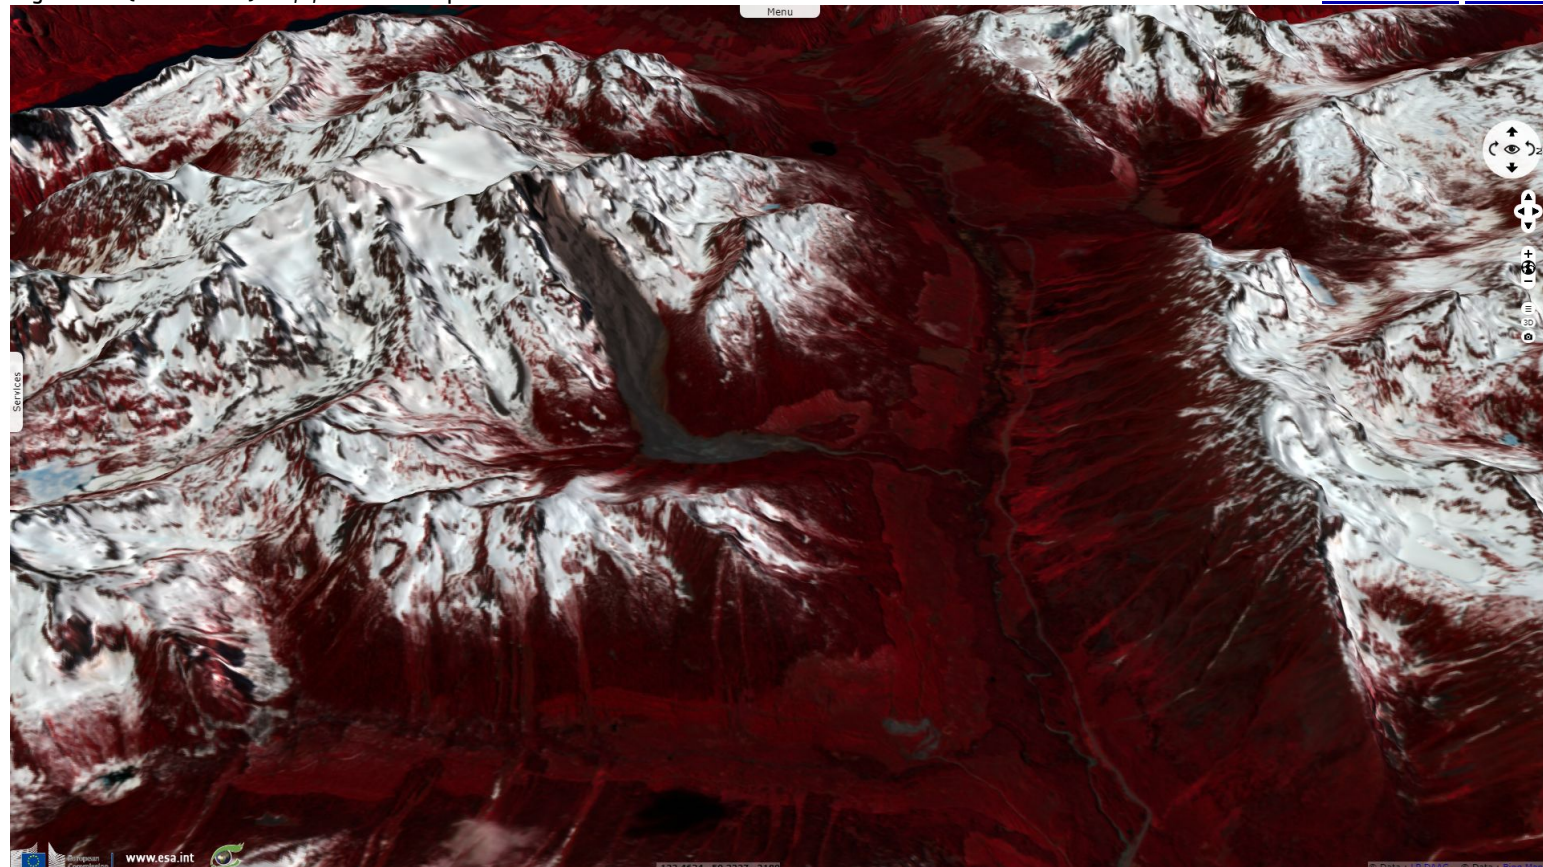
Fig. 3 - S2 (26.05.2019) - 8,4,3 colour composite - View two months later after the avalanche.

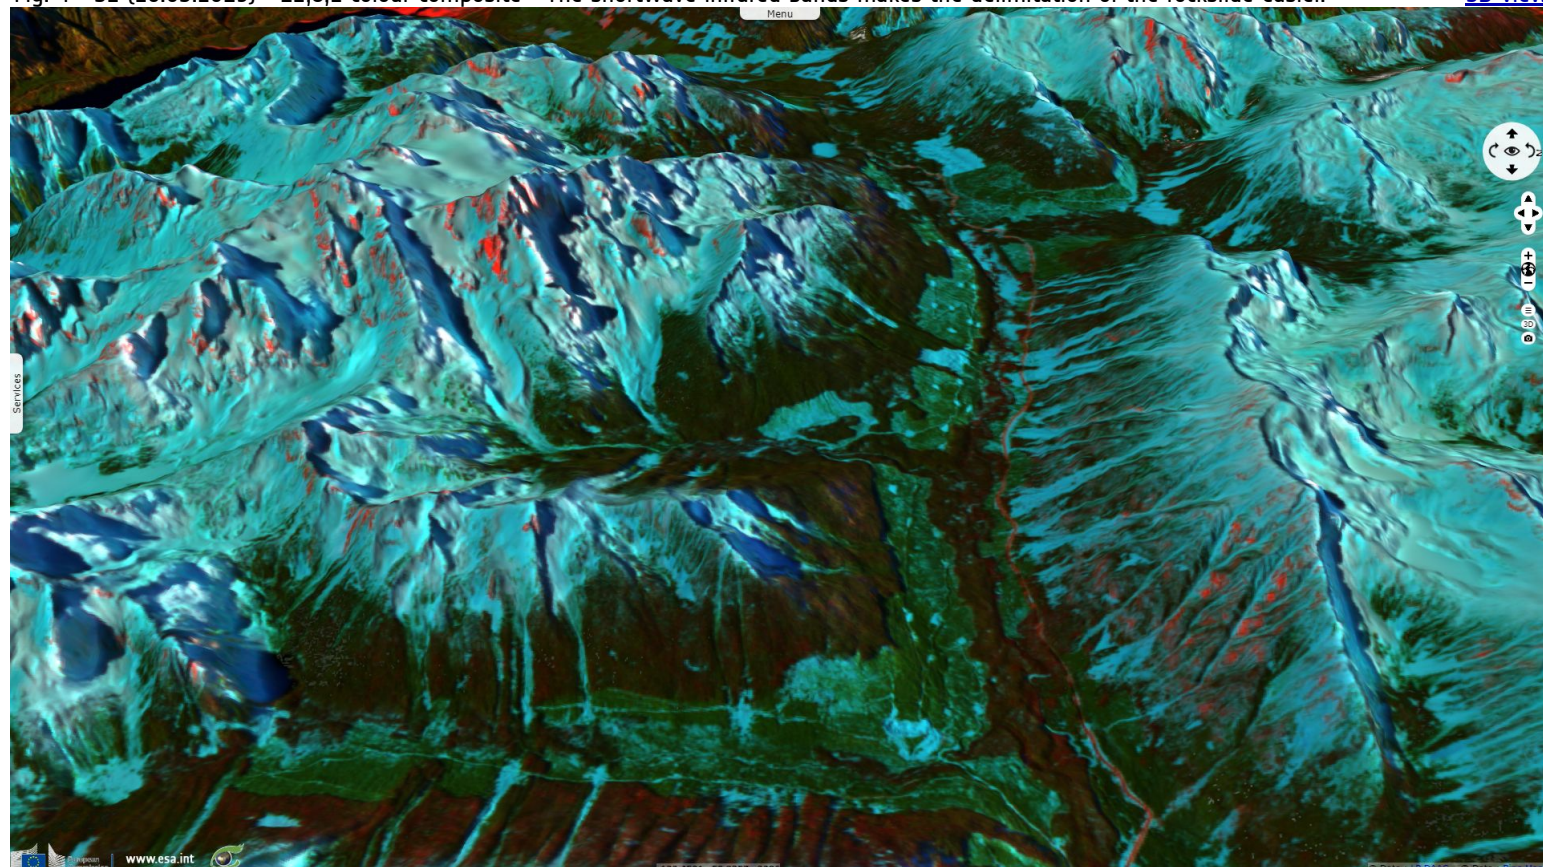
Fig. 4 - S2 (26.05.2019) - 12,8,2 colour composite - The shortwave infrared bands makes the delimitation of the rockslide easier.

On his Twitter account, Dr. Drew Brayshaw [estimated](#) the initial failure area was  $\sim 25\,000\text{ m}^2$  ( $\sim 200\text{ m}$  high,  $\sim 150\text{ m}$  wide) while the avalanche runoff distance is  $\sim 4.2\text{ km}$

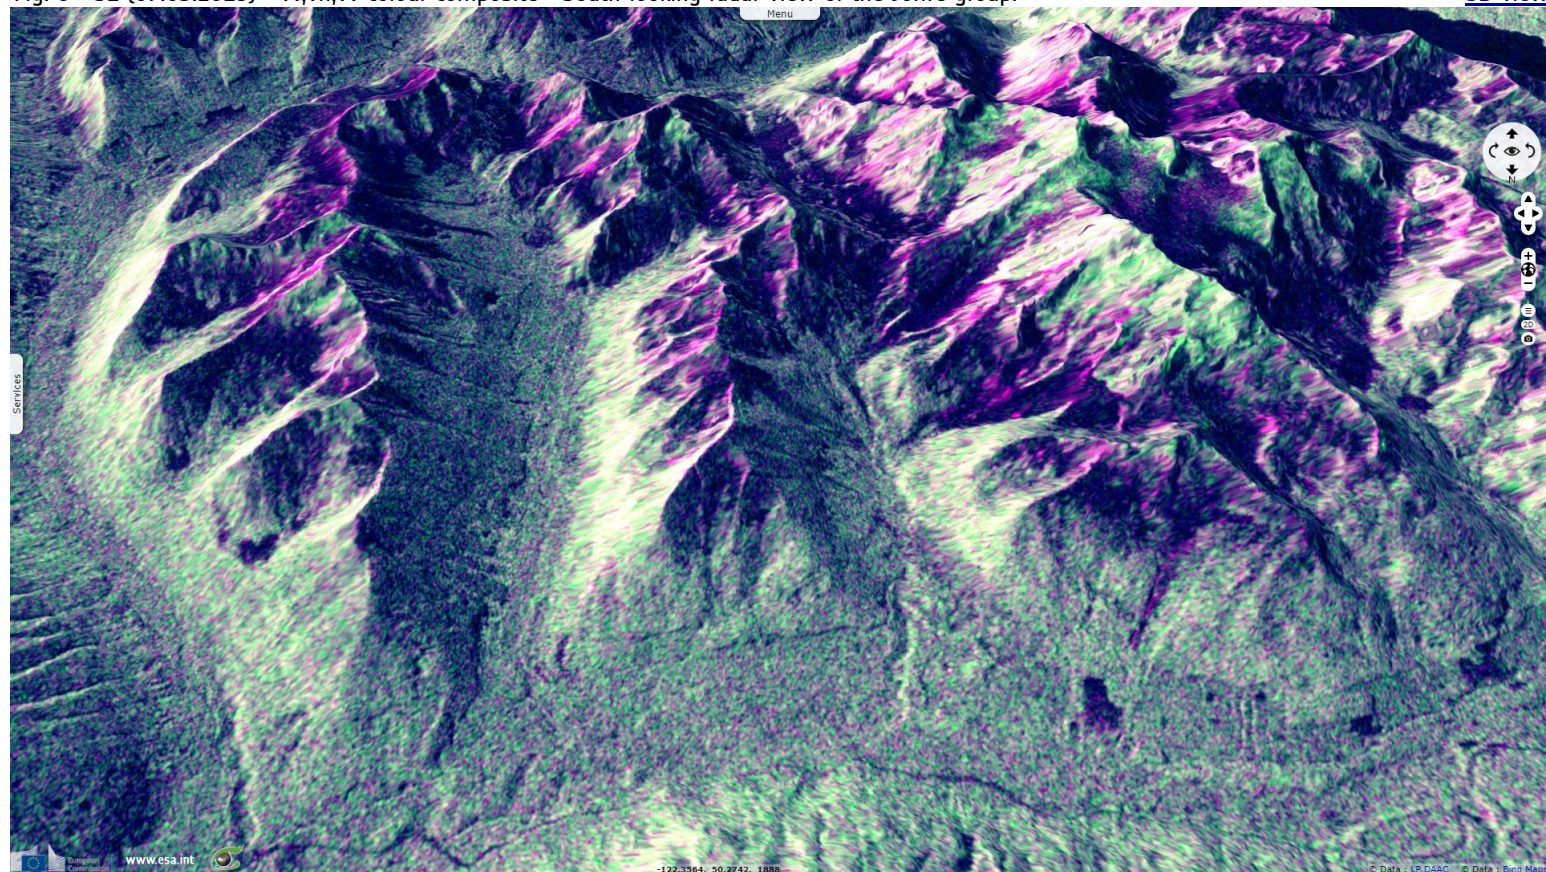
Fig. 6 - S1 (07.05.2019) - vv,vh,vv colour composite - South-looking radar view of the Joffre group.

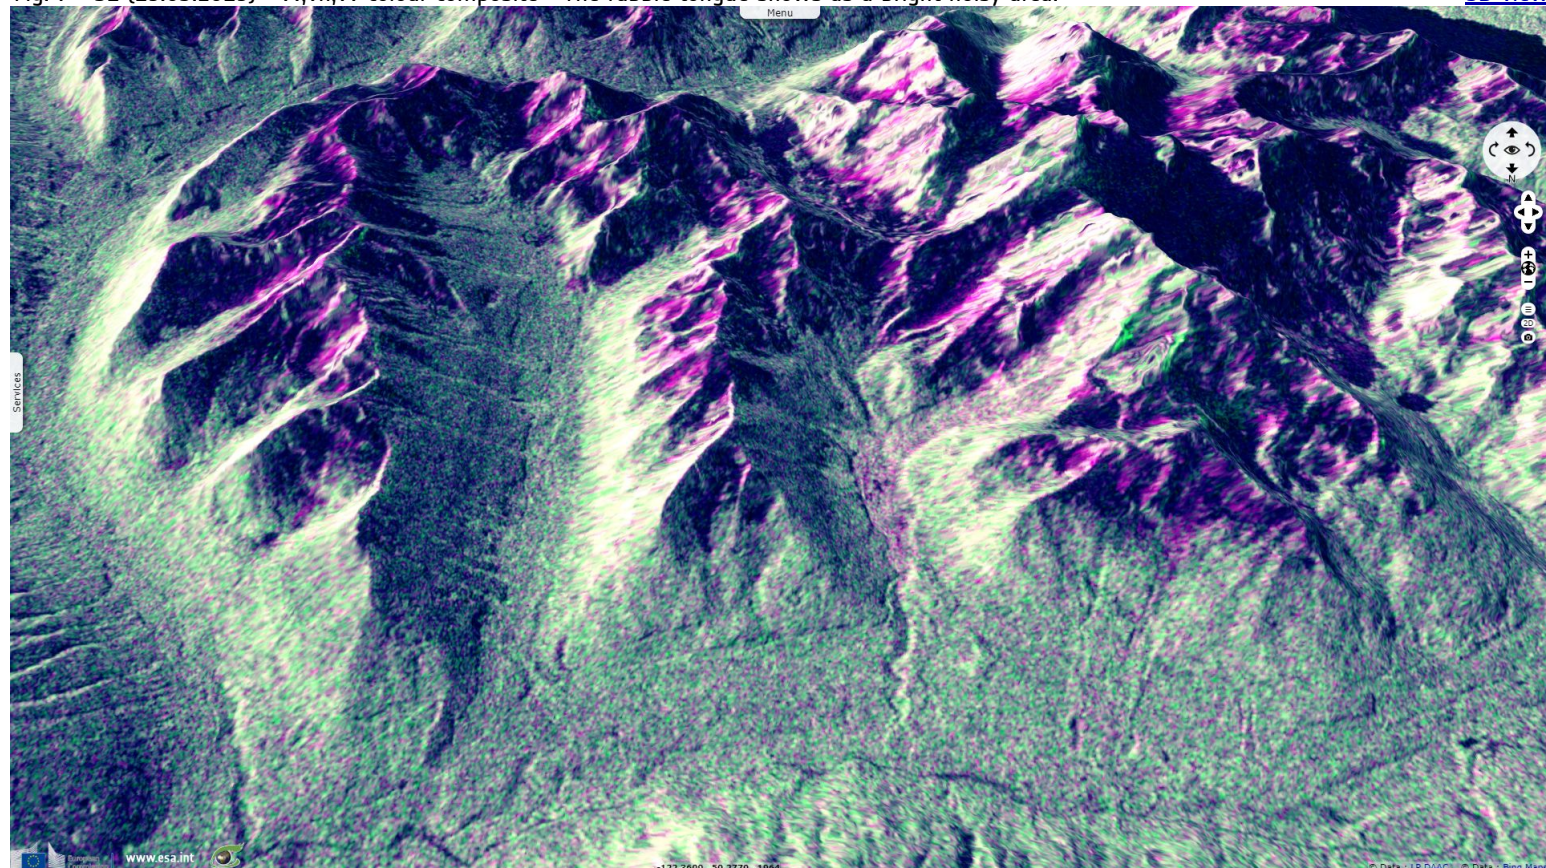
Fig. 7 - S1 (19.05.2019) - vv,vh,vv colour composite - The rubble tongue shows as a bright noisy area.

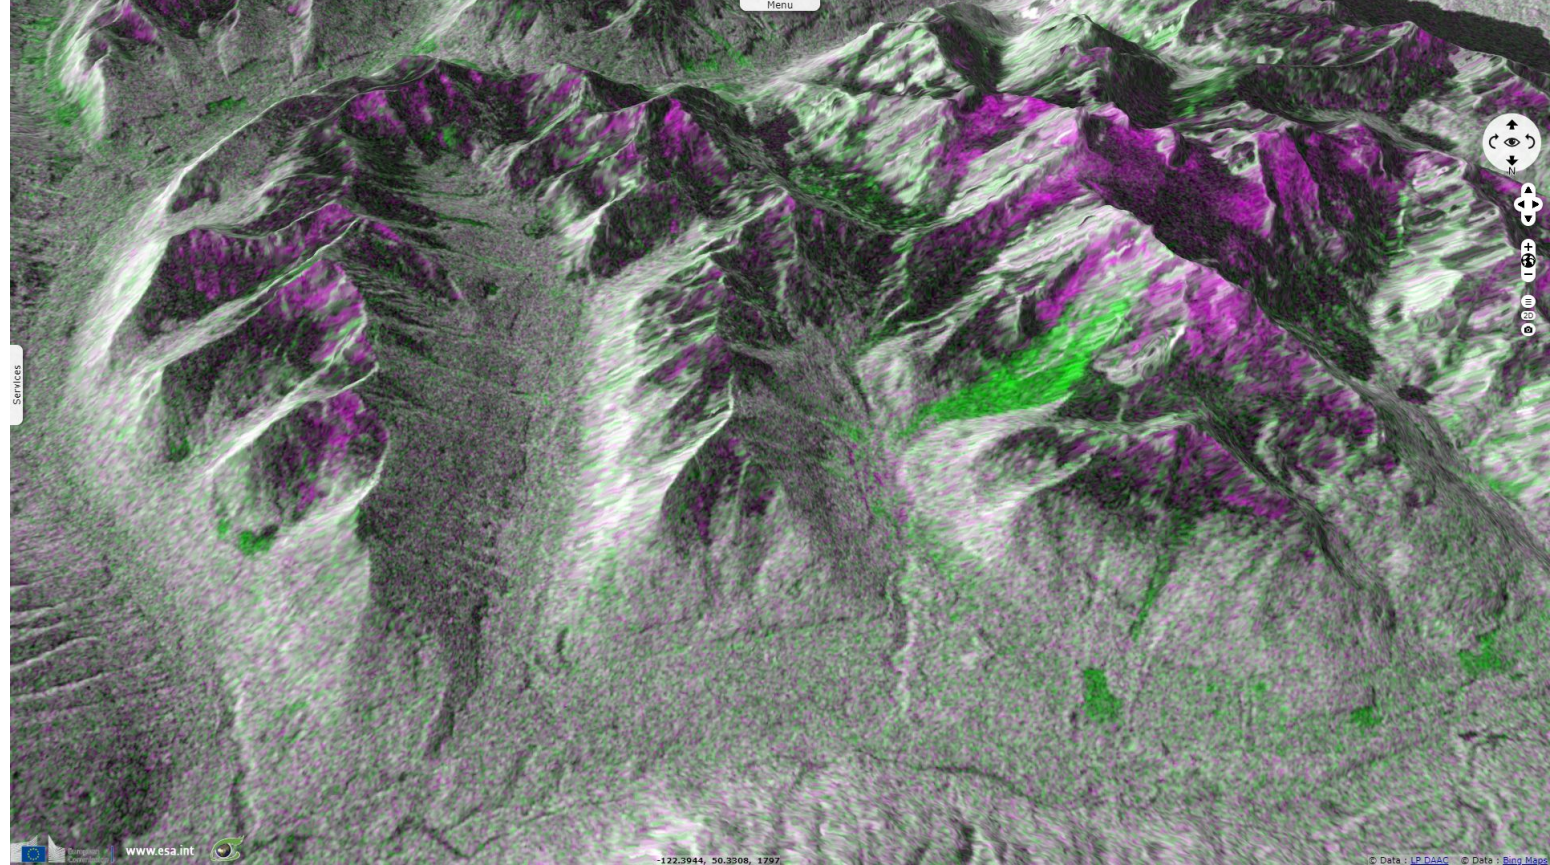
Fig. 8 - S1 - red:vh[07.05.2019], green:vh[19.05.2019], blue:vh[07.05.2019] colour composite - Land cover change shows in purple & green. [3D view](#)

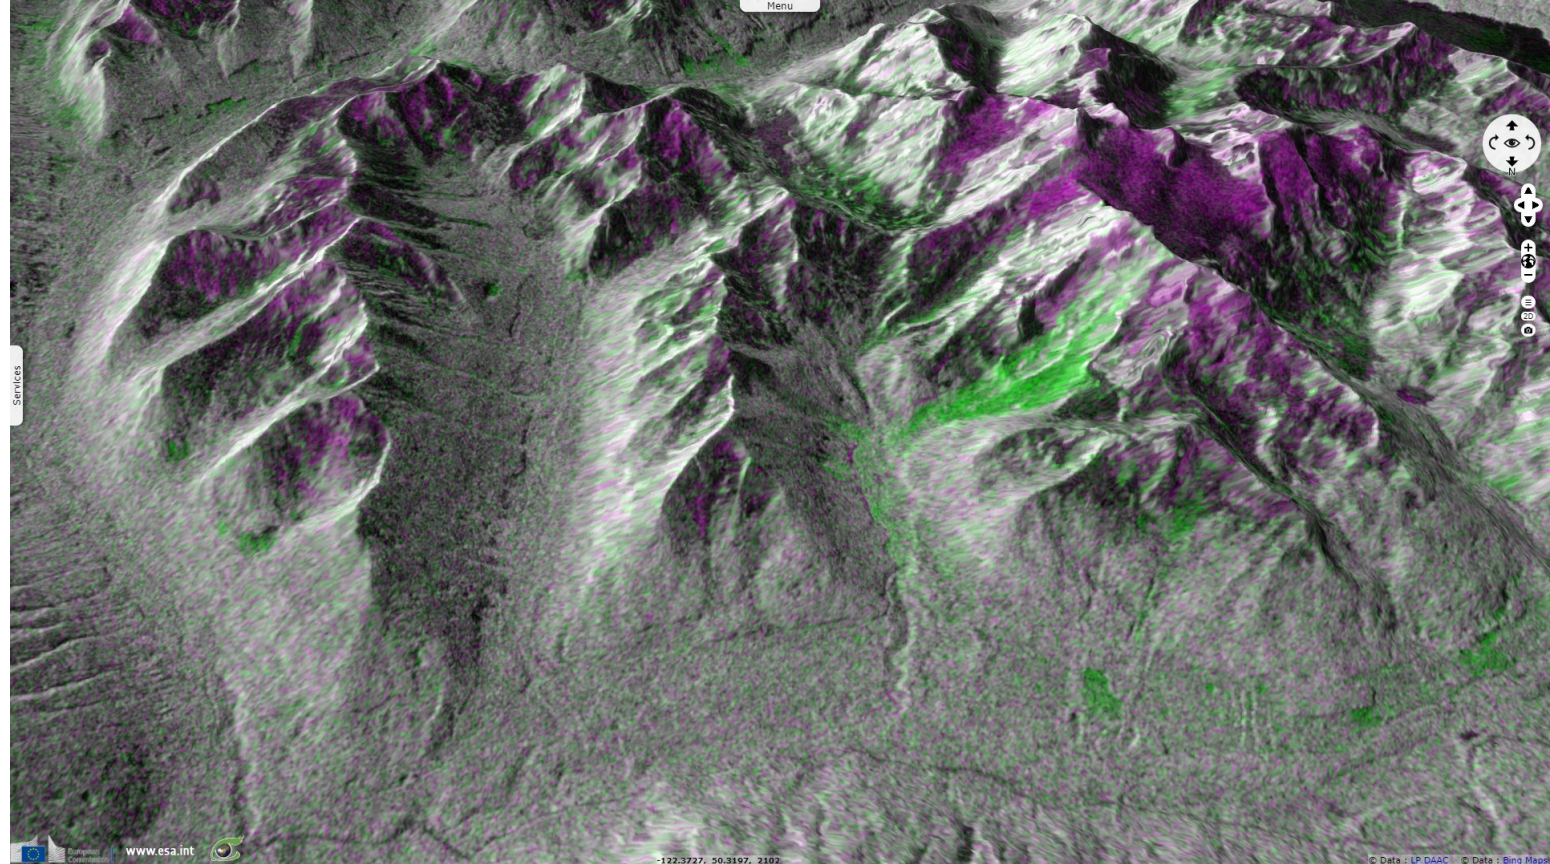
Fig. 9 - S1 - red:vv[07.05.2019], green:vv[19.05.2019], blue:vv[07.05.2019] colour composite - The landslide appears in green. [3D animation](#) [3D view](#)

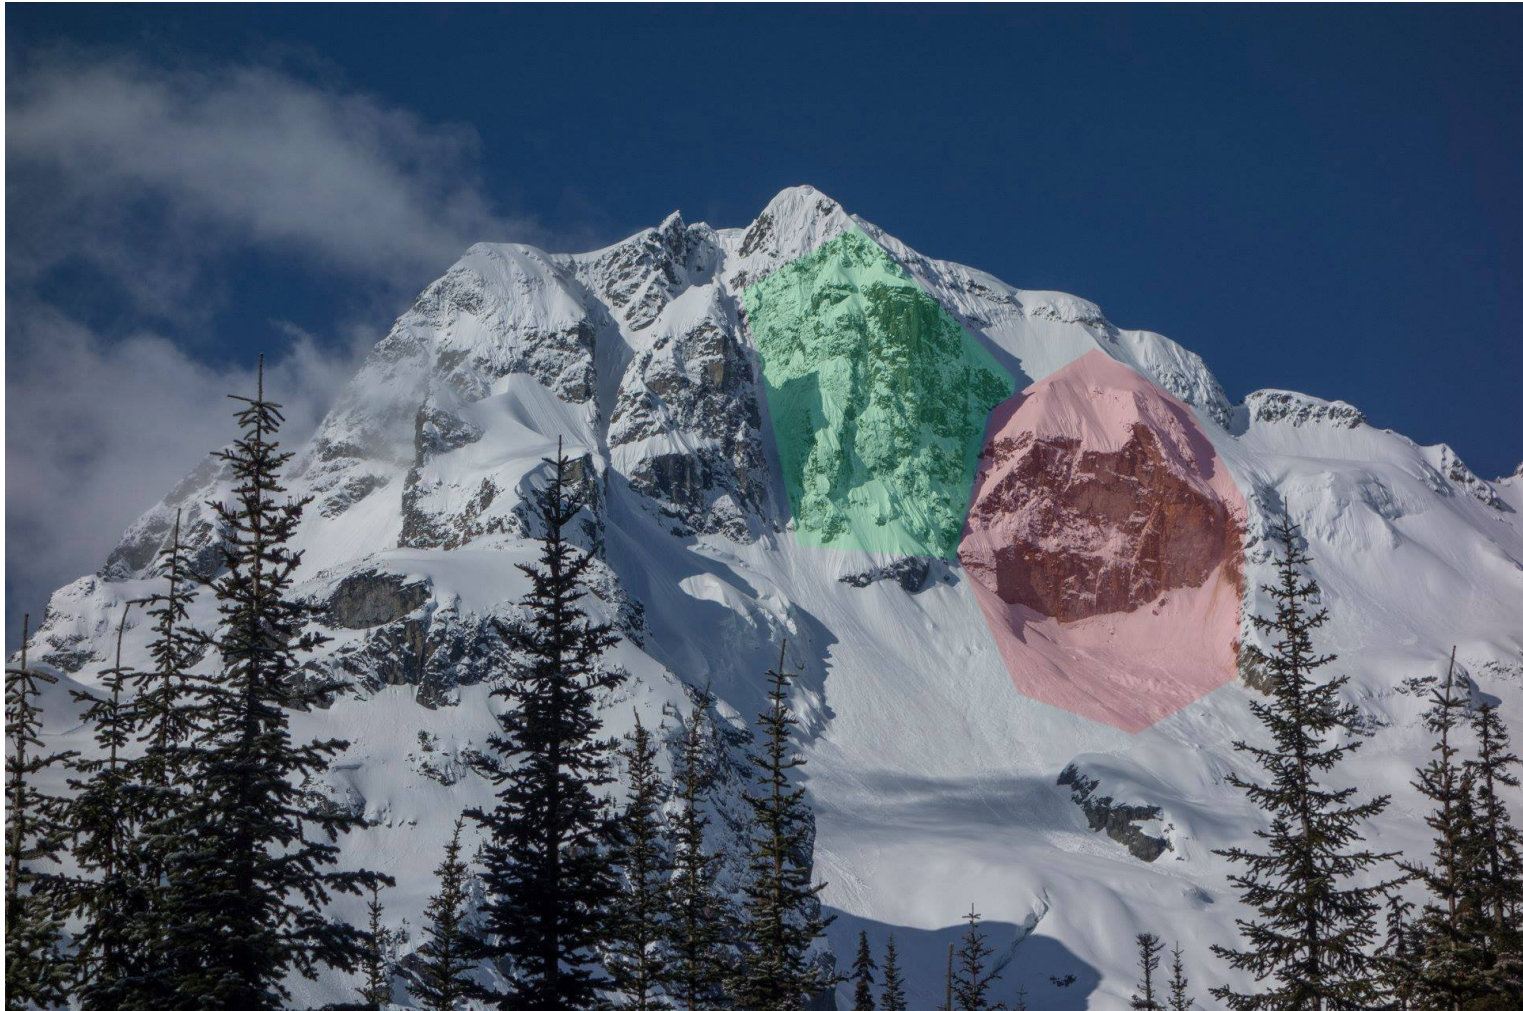
A graphic depicts the two points on Joffre Peak where rockslides occurred this week - Source: [Steve Jones](#).

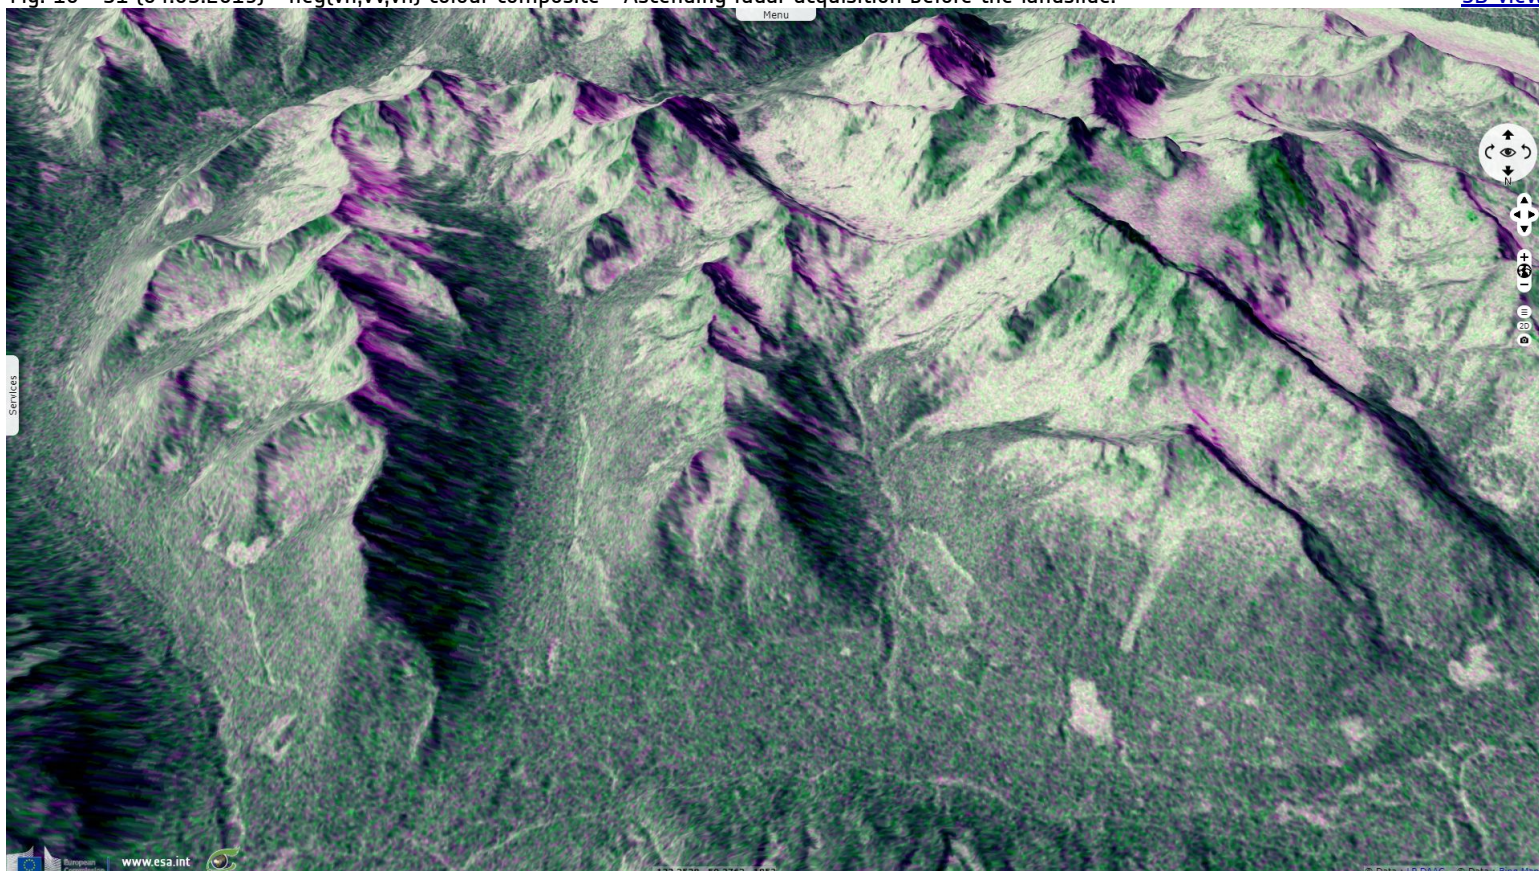
Fig. 10 - S1 (04.05.2019) - neg(vh,vv,vh) colour composite - Ascending radar acquisition before the landslide.

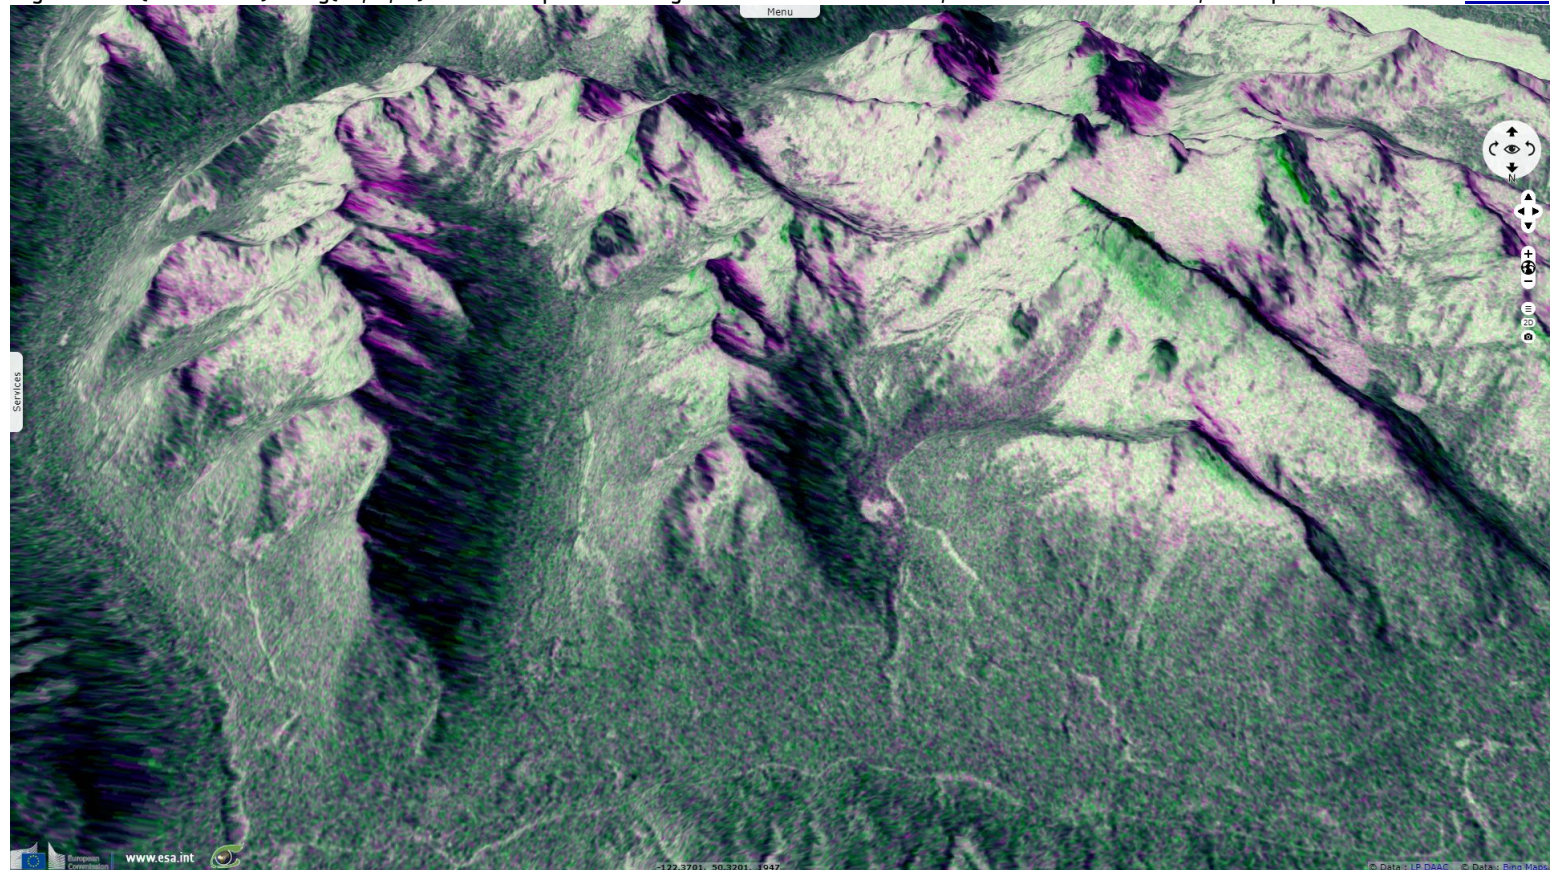
Fig. 11 - S1 (16.05.2019) - neg(vh,vv,vh) colour composite - Image between the landslides, the rubble show in dark, a temp lake in white. [3D view](#)

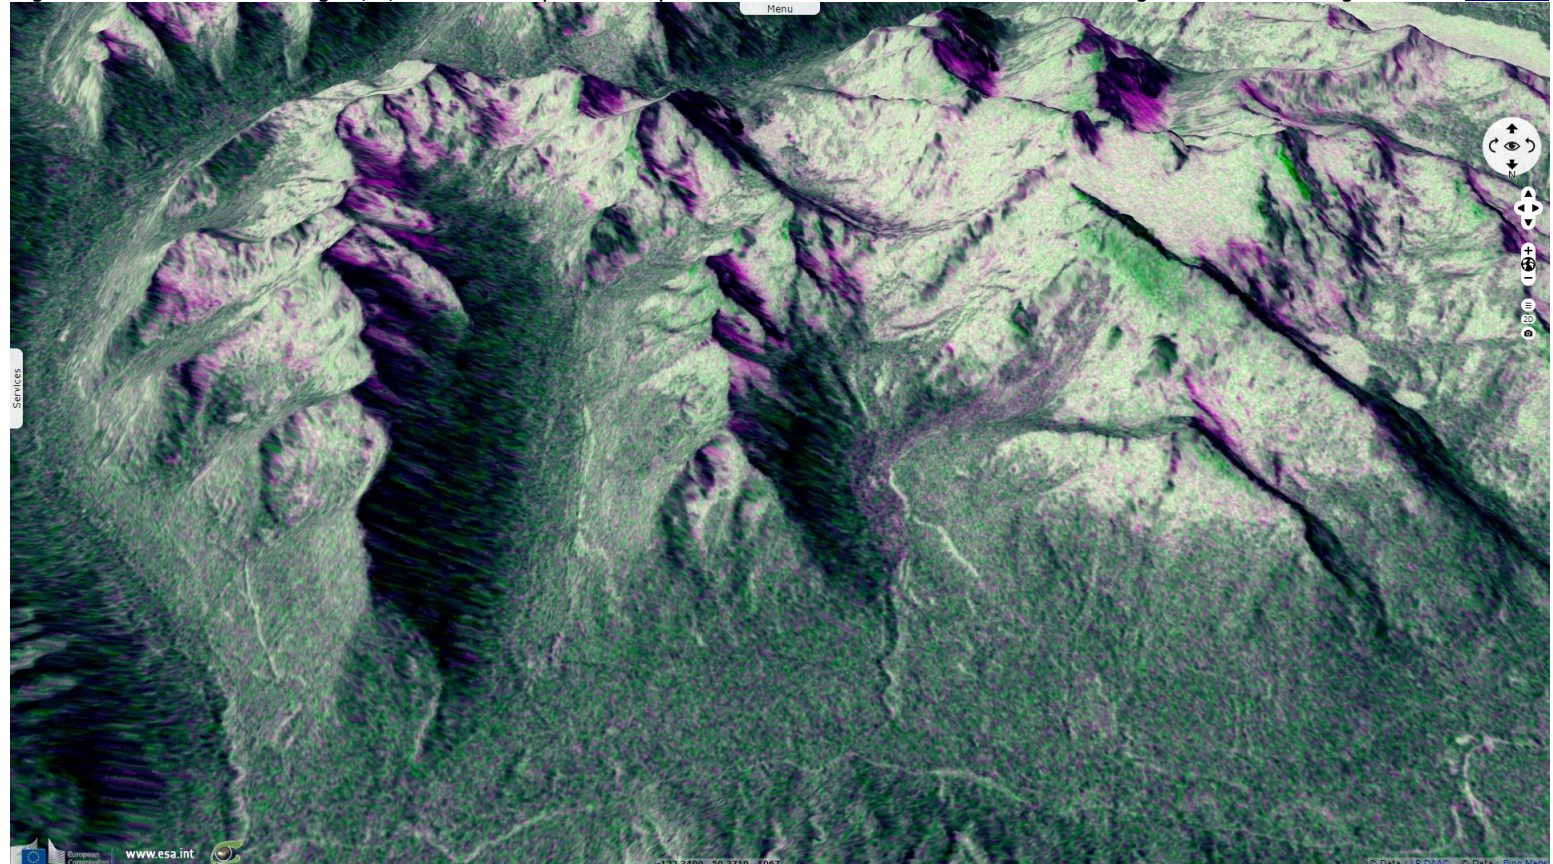
Fig. 12 - S1 (28.05.2019) - neg(vh,vv,vh) colour composite - Acquisition after the second landslide shows a large avalanche starting zone. [3D view](#)

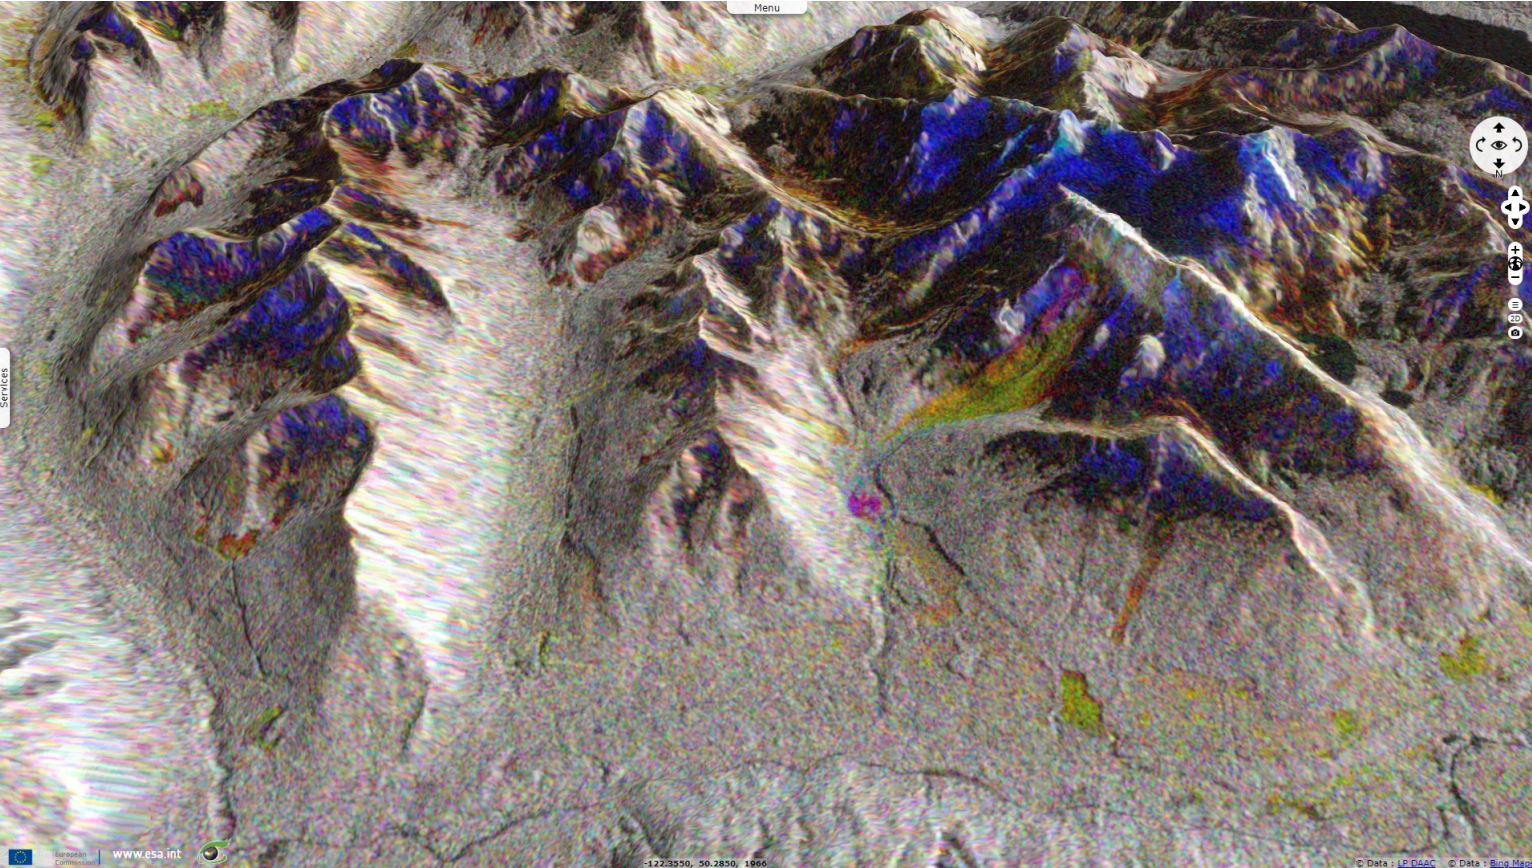
Fig. 13 - S1 - red:vv(28.05.2019), green:vv(16.05.2019), blue:vv(04.05.2019) colour composite - Multidate composite before / between / after. [3D view](#)

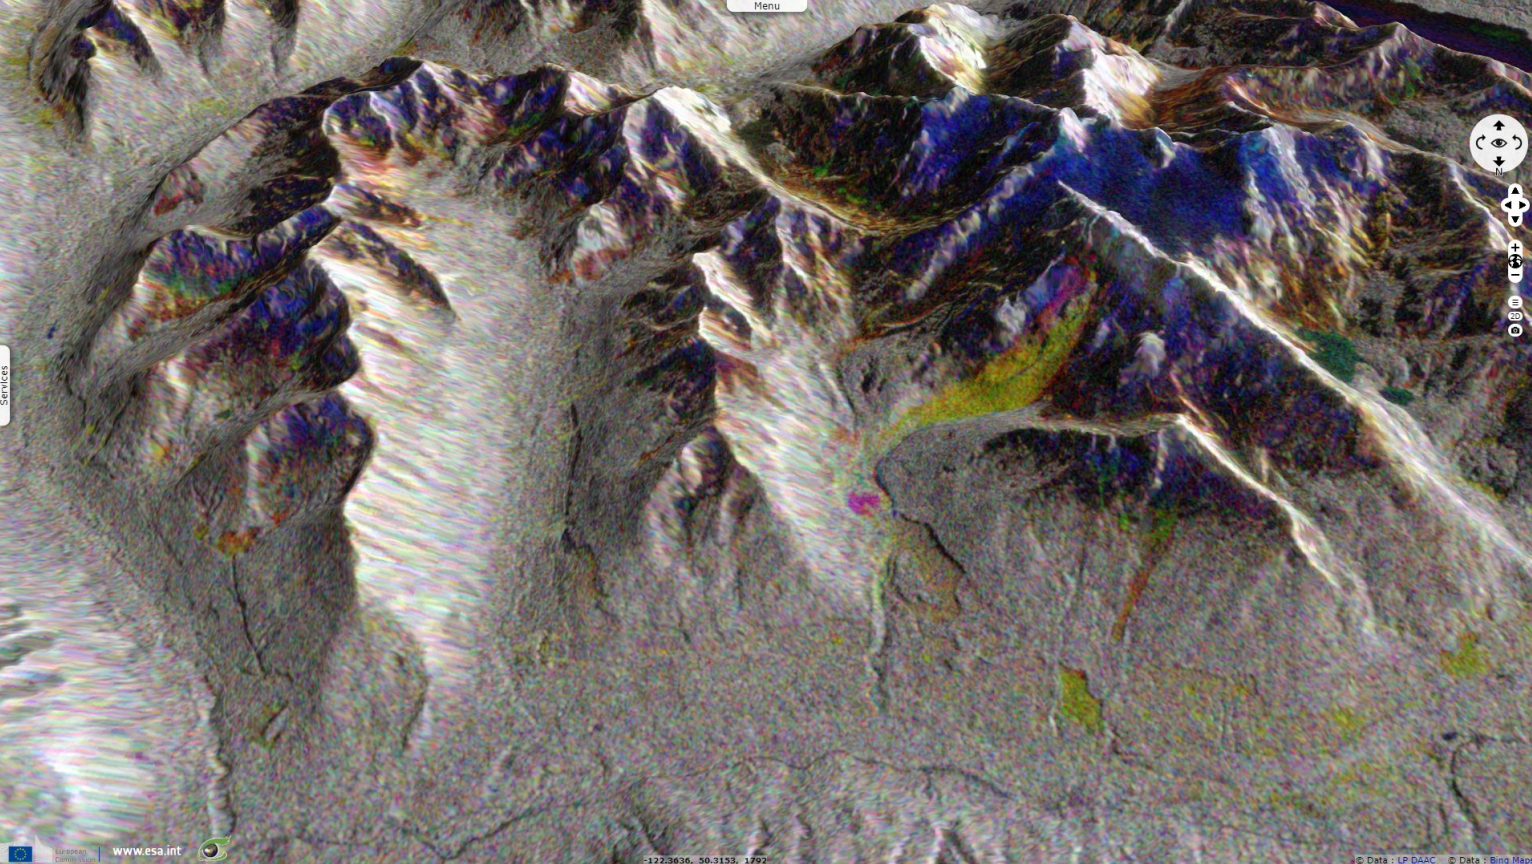
Fig. 14 - S1 - red:vh(28.05.2019), green:vh(16.05.2019), blue:vh(04.05.2019) colour composite - Same using the VH polarisation [3D animation](#) [3D view](#)
