A landslide in Elliot Creek causes a tsunami-like wave, Canada

Author(s): Sentinel Vision team, VisioTerra, France - syp@visioterra.fr

Keyword(s): Geohazard, landslide, river, lake, glacier, icefield, cryosphere, global warming, climate change, fjord, Canada

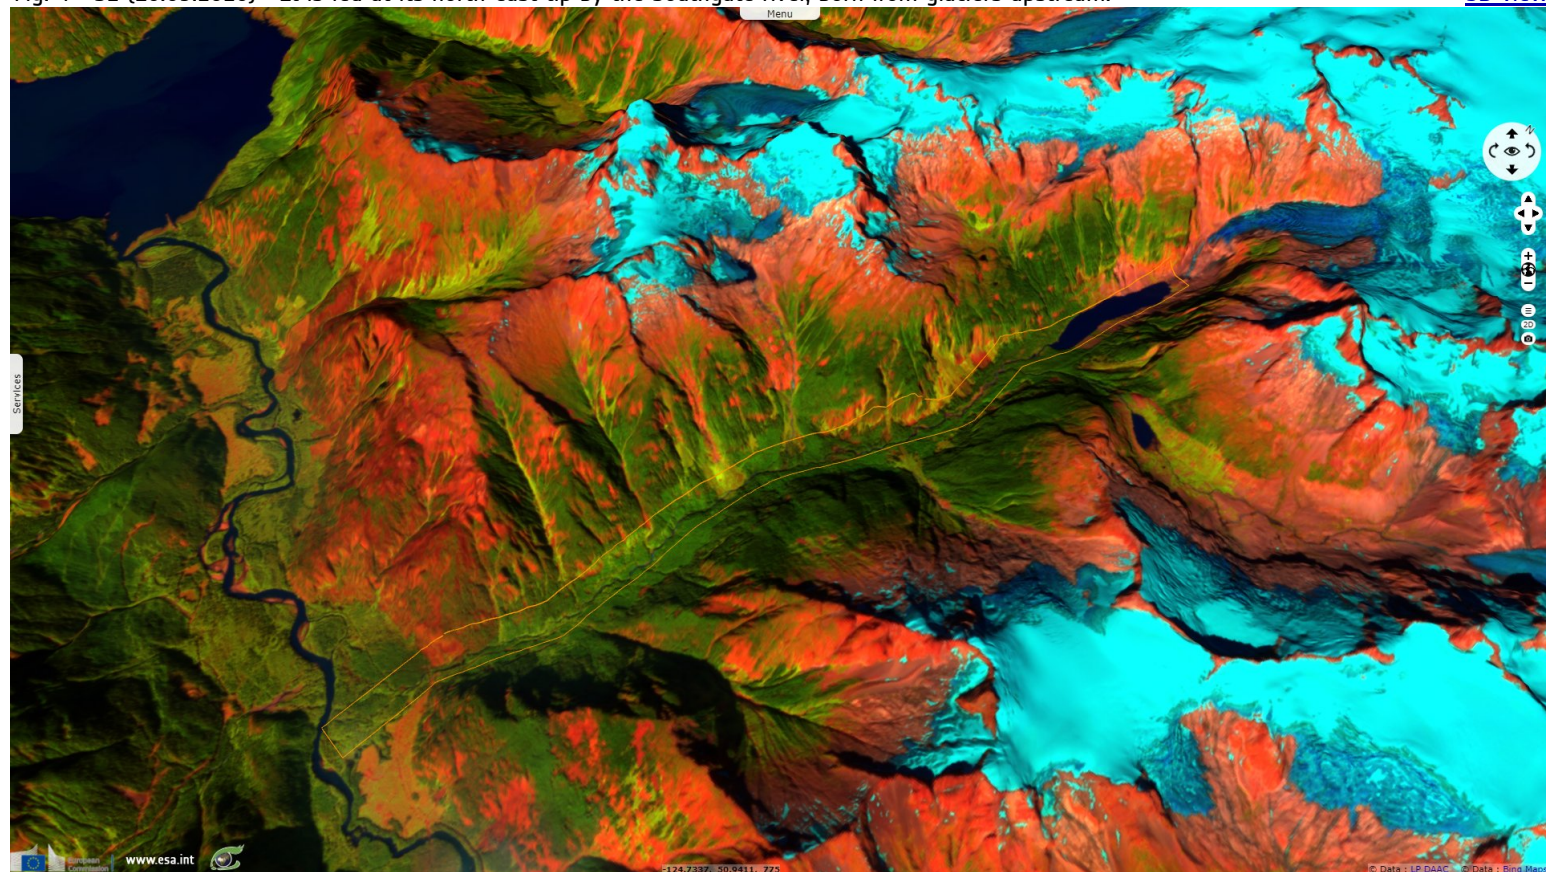
Fig. 4 - S2 (10.09.2020) - It is fed at its north-east tip by the Southgate river, born from glaciers upstream.

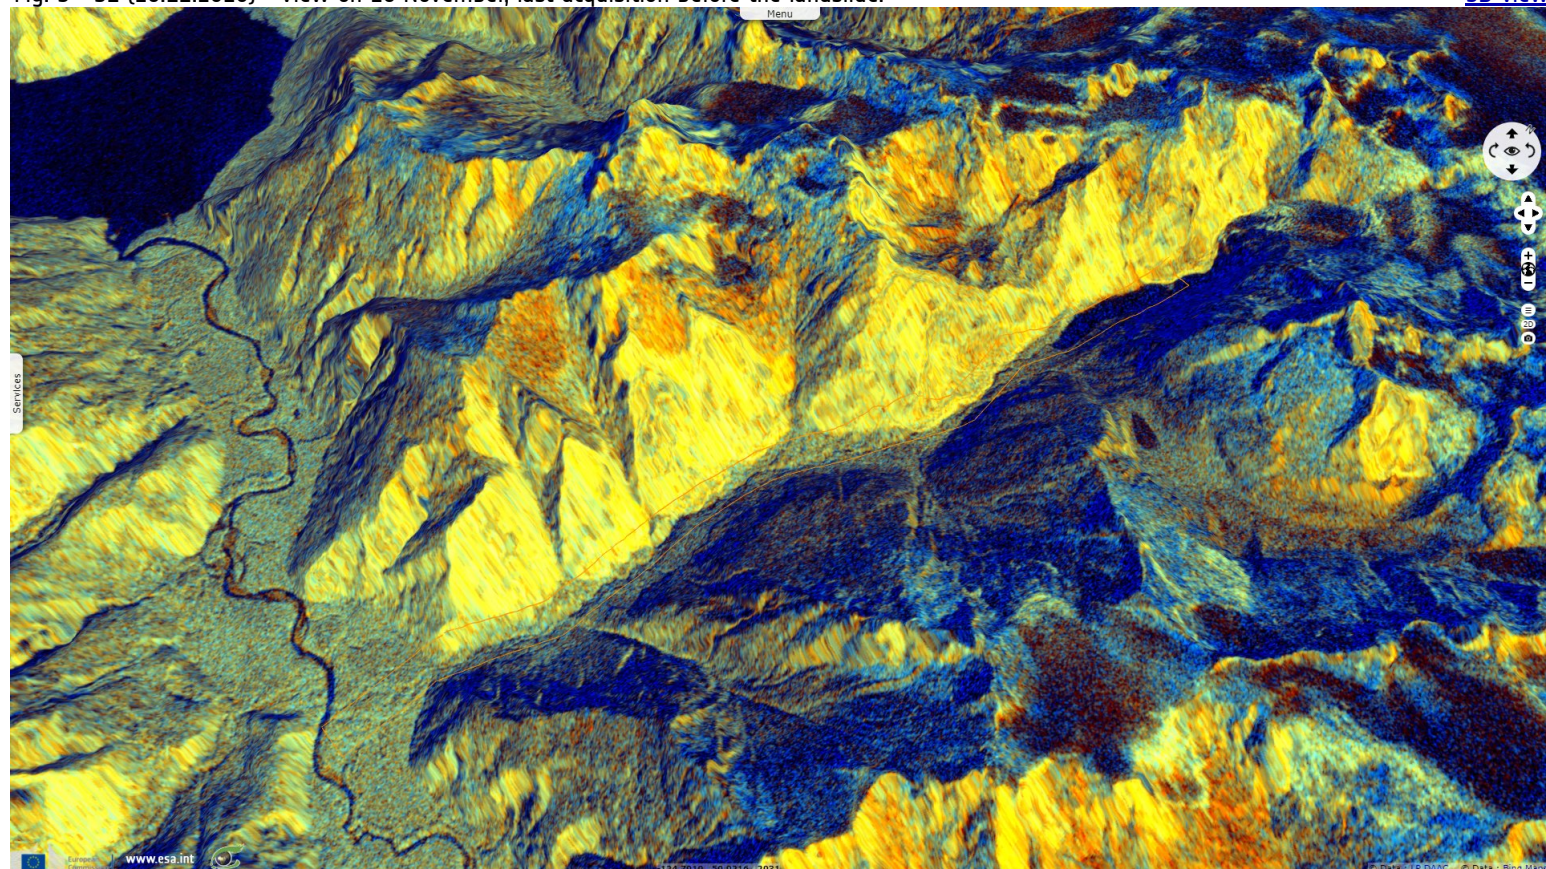
Fig. 5 - S1 (26.11.2020) - View on 26 November, last acquisition before the landslide.

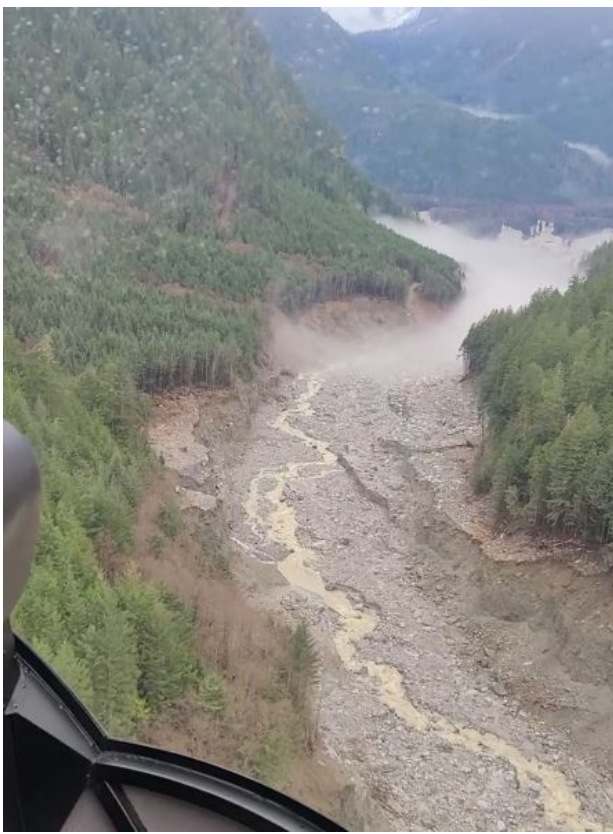
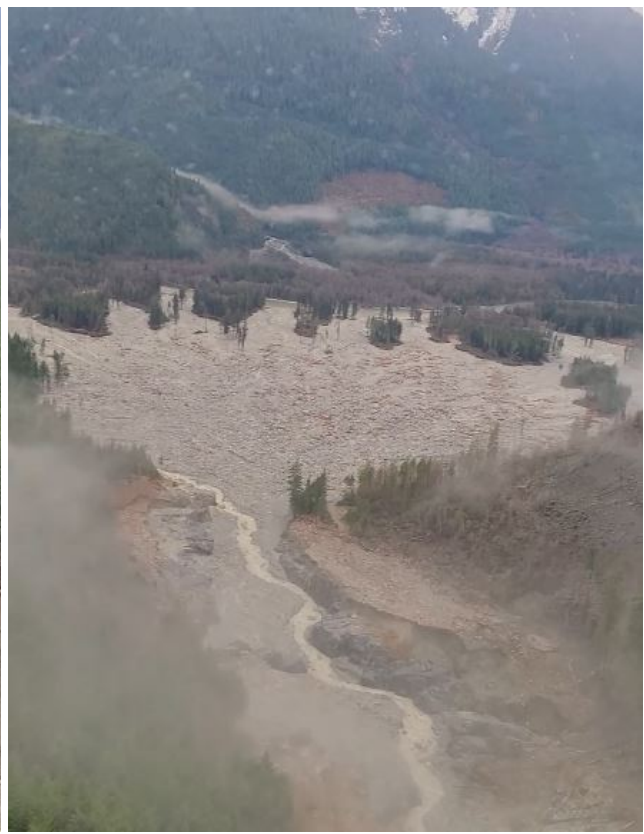
Still from one of the 49 North Helicopters videos. Left: track of the Bute Inlet landslide. Right: lower part of the Bute Inlet landslide, at the mouth of the valley there is extensive deposition of sediment. Source: Pilot [Bastian Fleury](#).

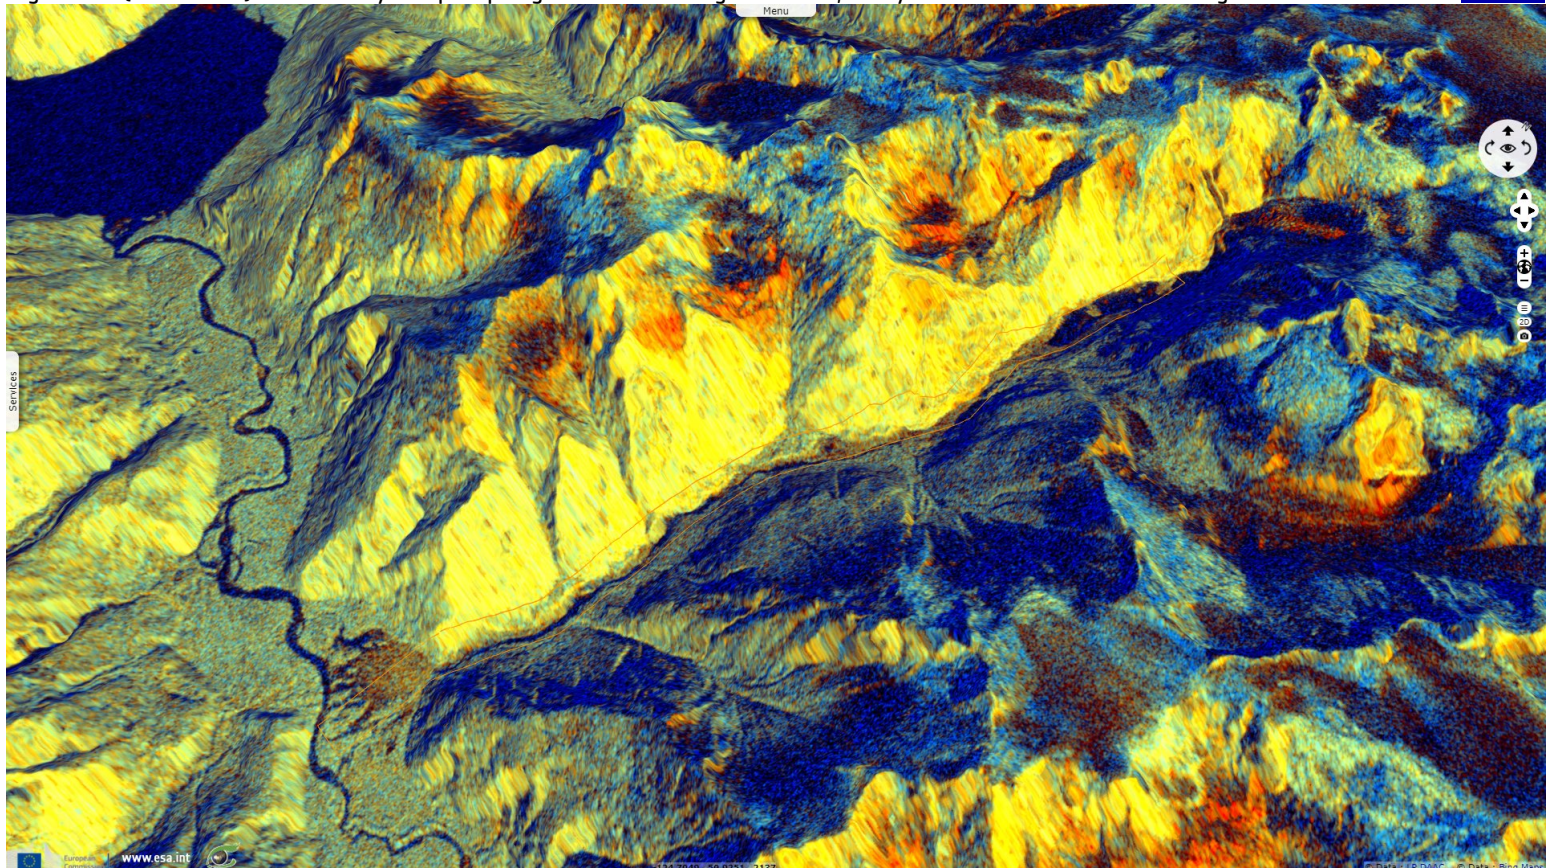
Fig. 6 - S1 (08.12.2020) - These very steep slopes gave birth to a large landslide, easily visible when it reached Southgate river.

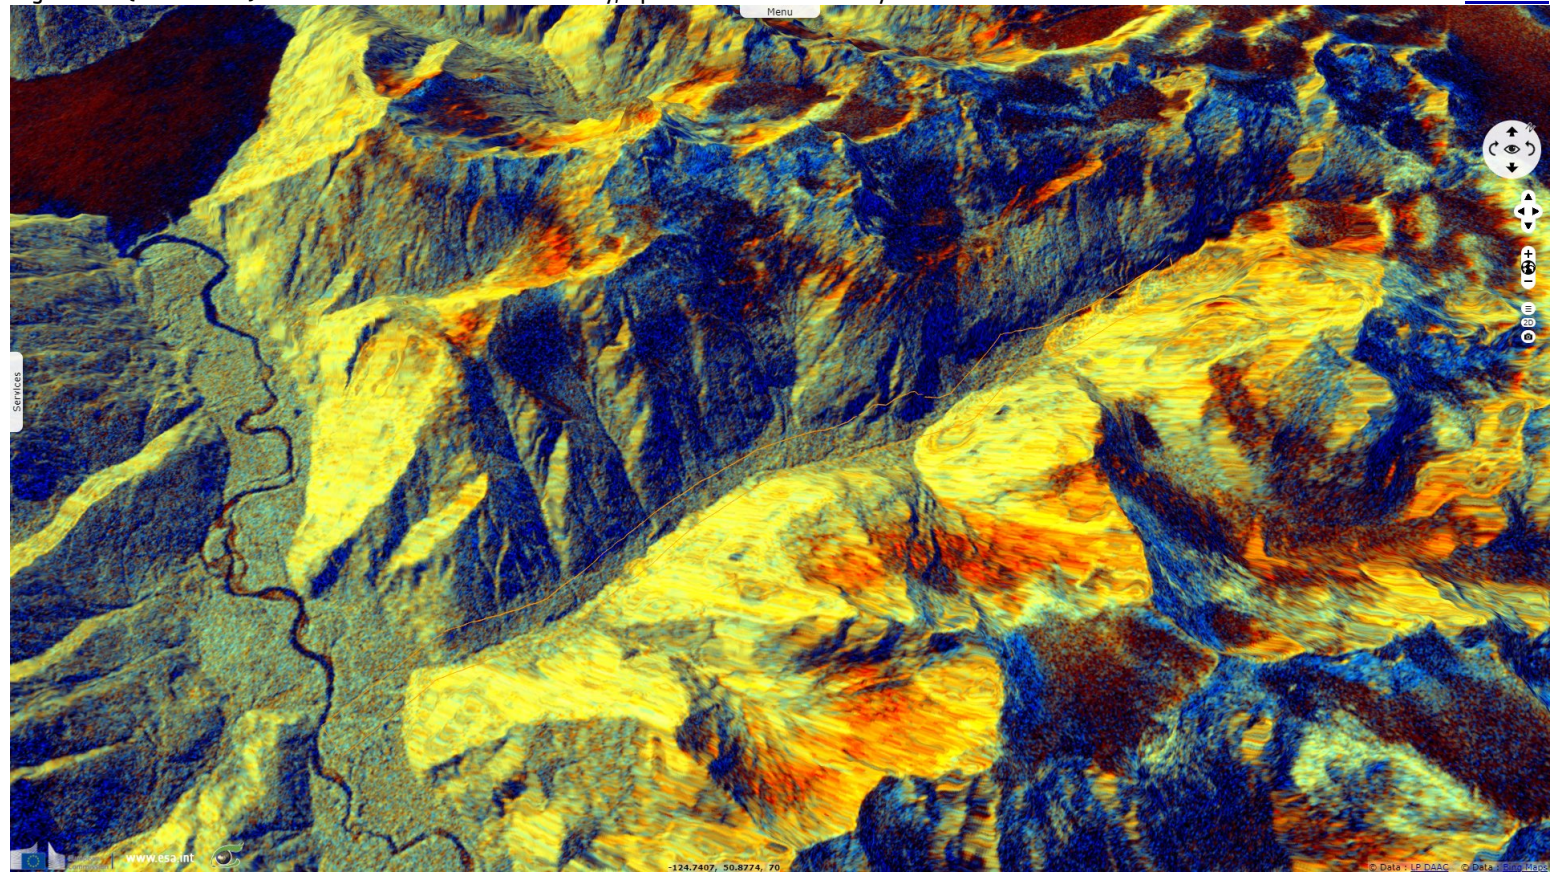
Fig. 7 - S1 (18.11.2020) - The rocks slid down in the valley, up to 13 kilometres away from the source.

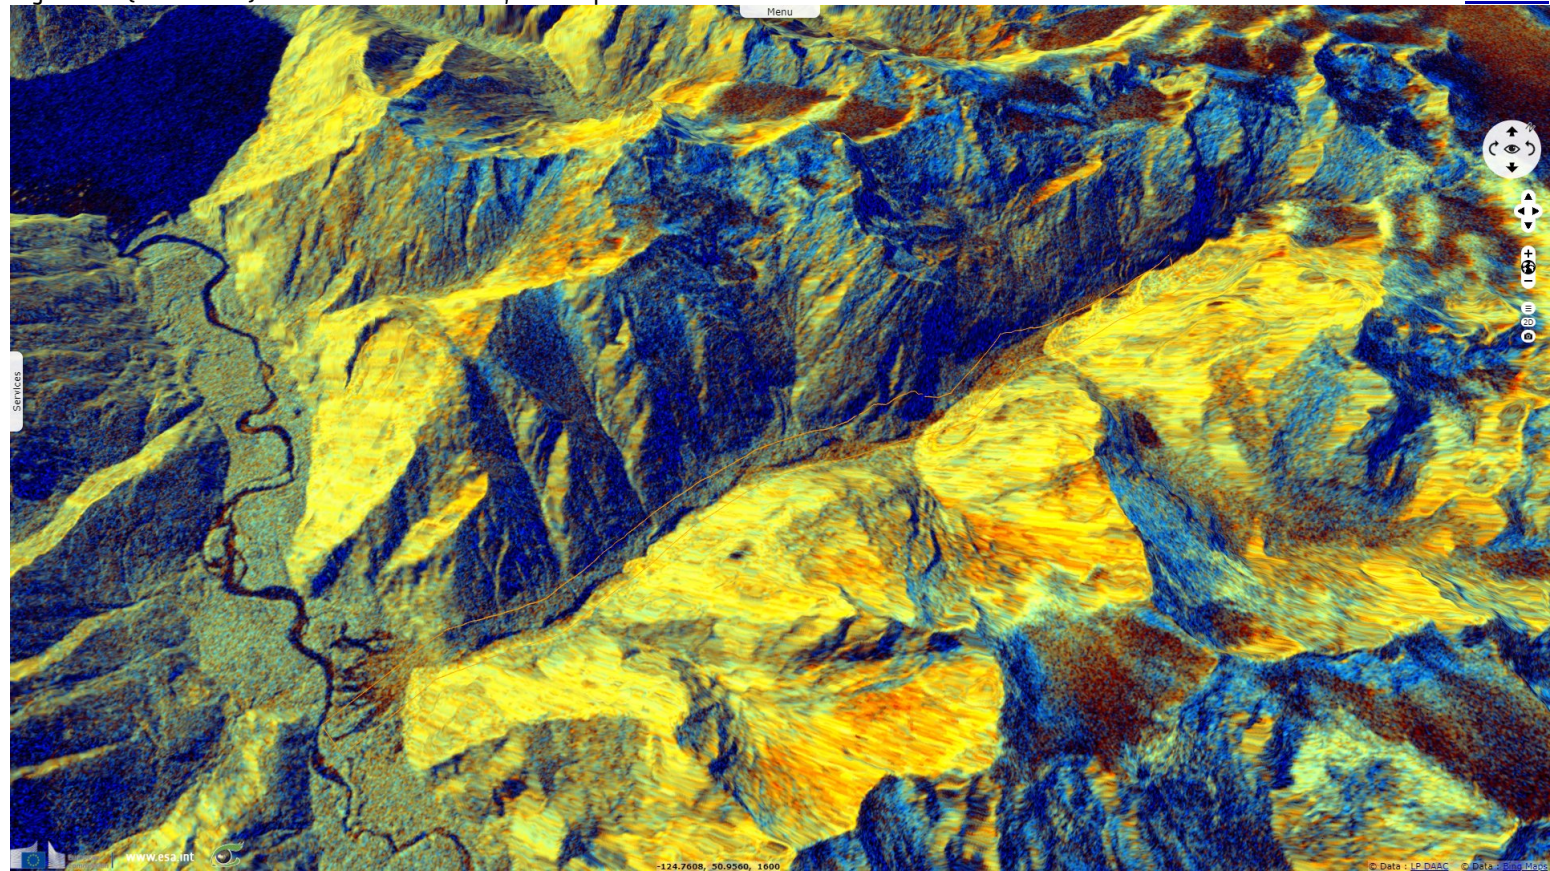
Fig. 8 - S1 (30.11.2020) - View on 30 November, first acquisition after the landslide.

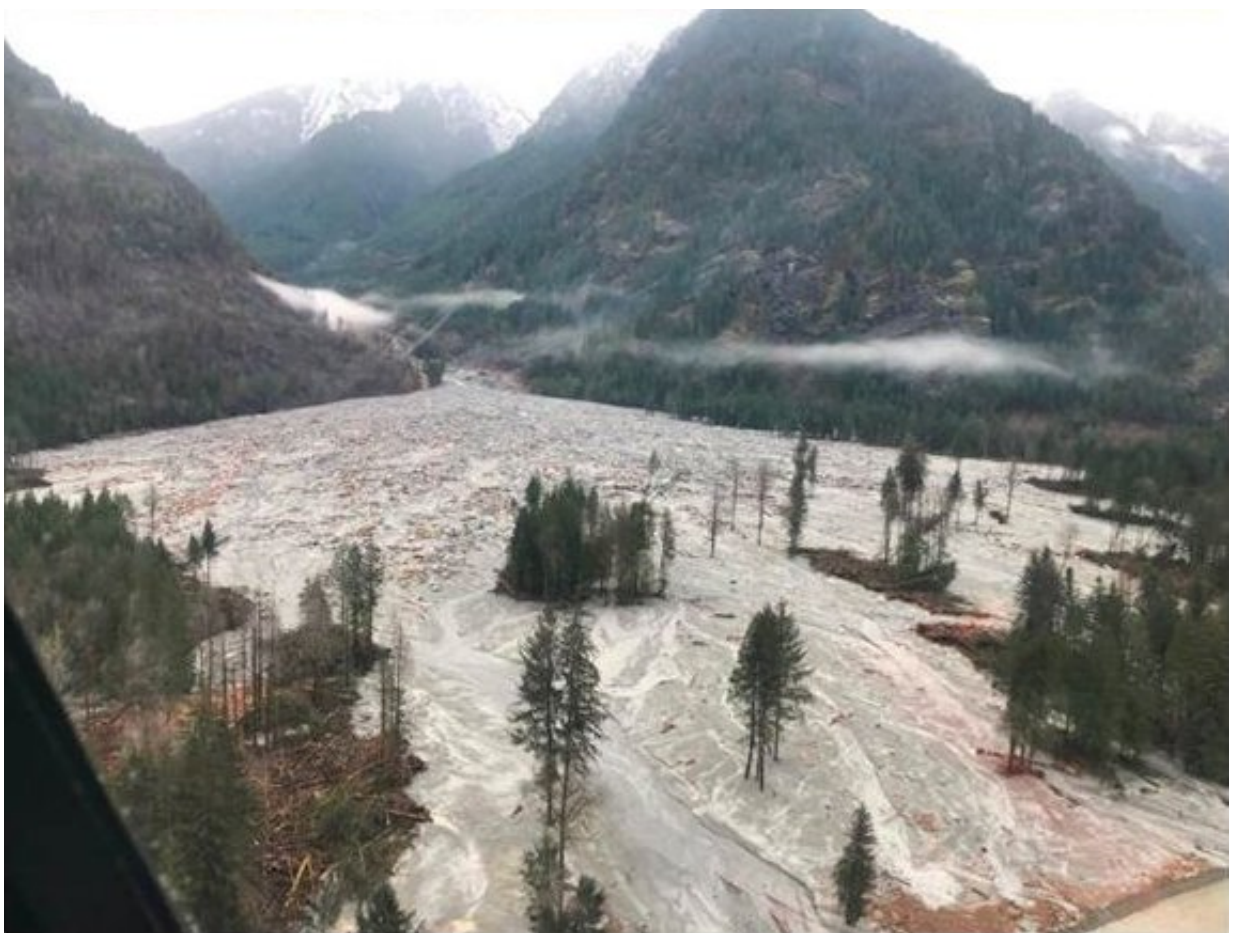
Still from one of the 49 North Helicopters videos. Glacial lake outburst flood, at Elliot Creek just east of the head of Bute Inlet, part of glacier failed and hit lake. Source: Pilot [Bastian Fleury](#).

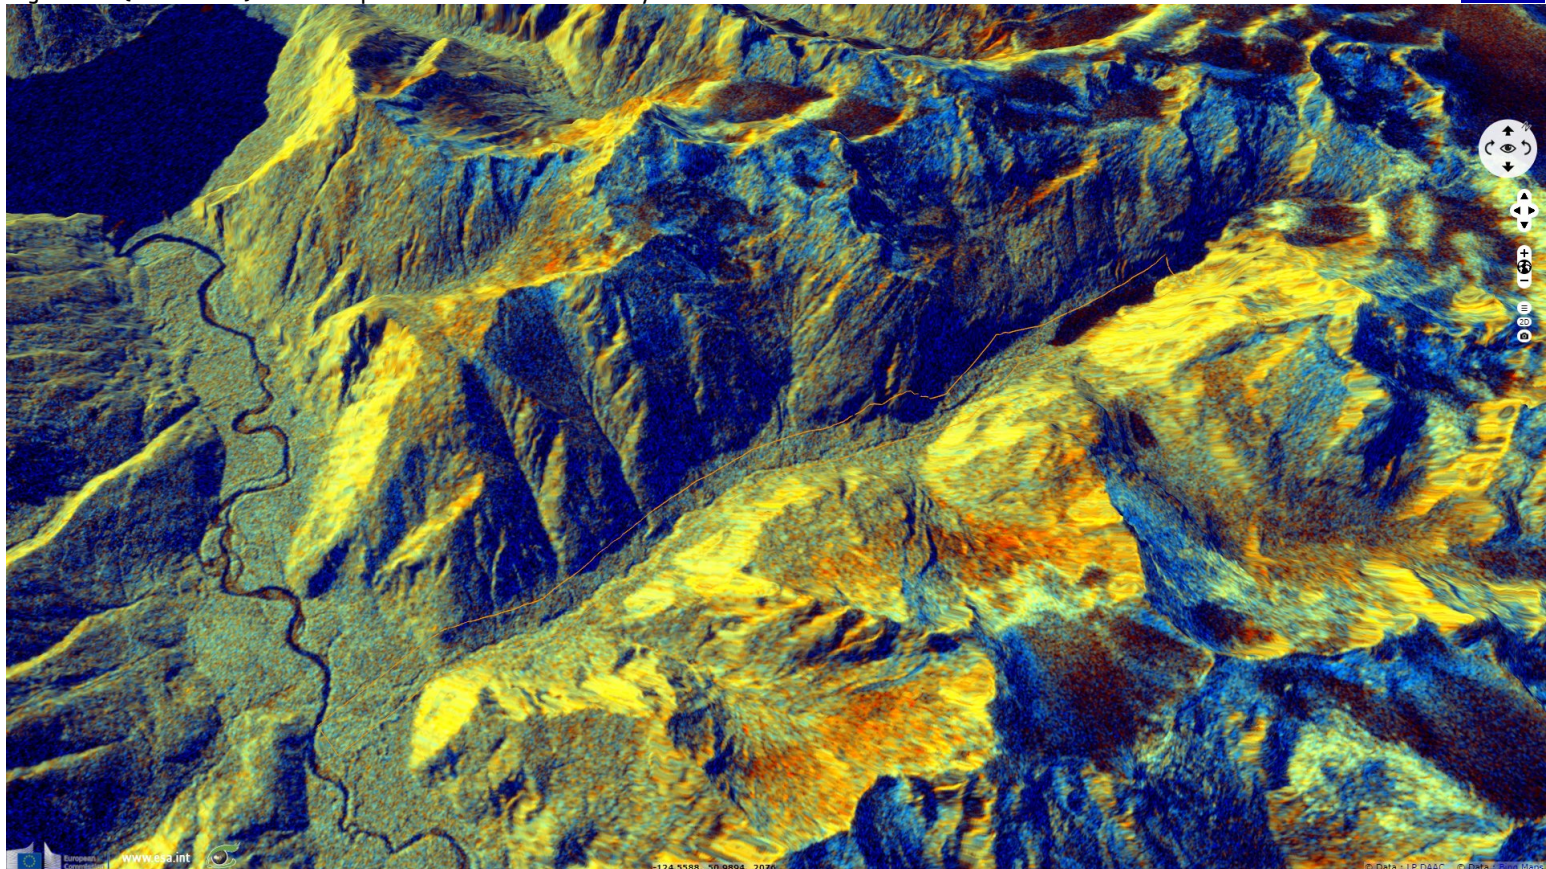
Fig. 9 - S1 (23.11.2020) - This couple best shows the tributary born from Elliot Lake before the landslide.

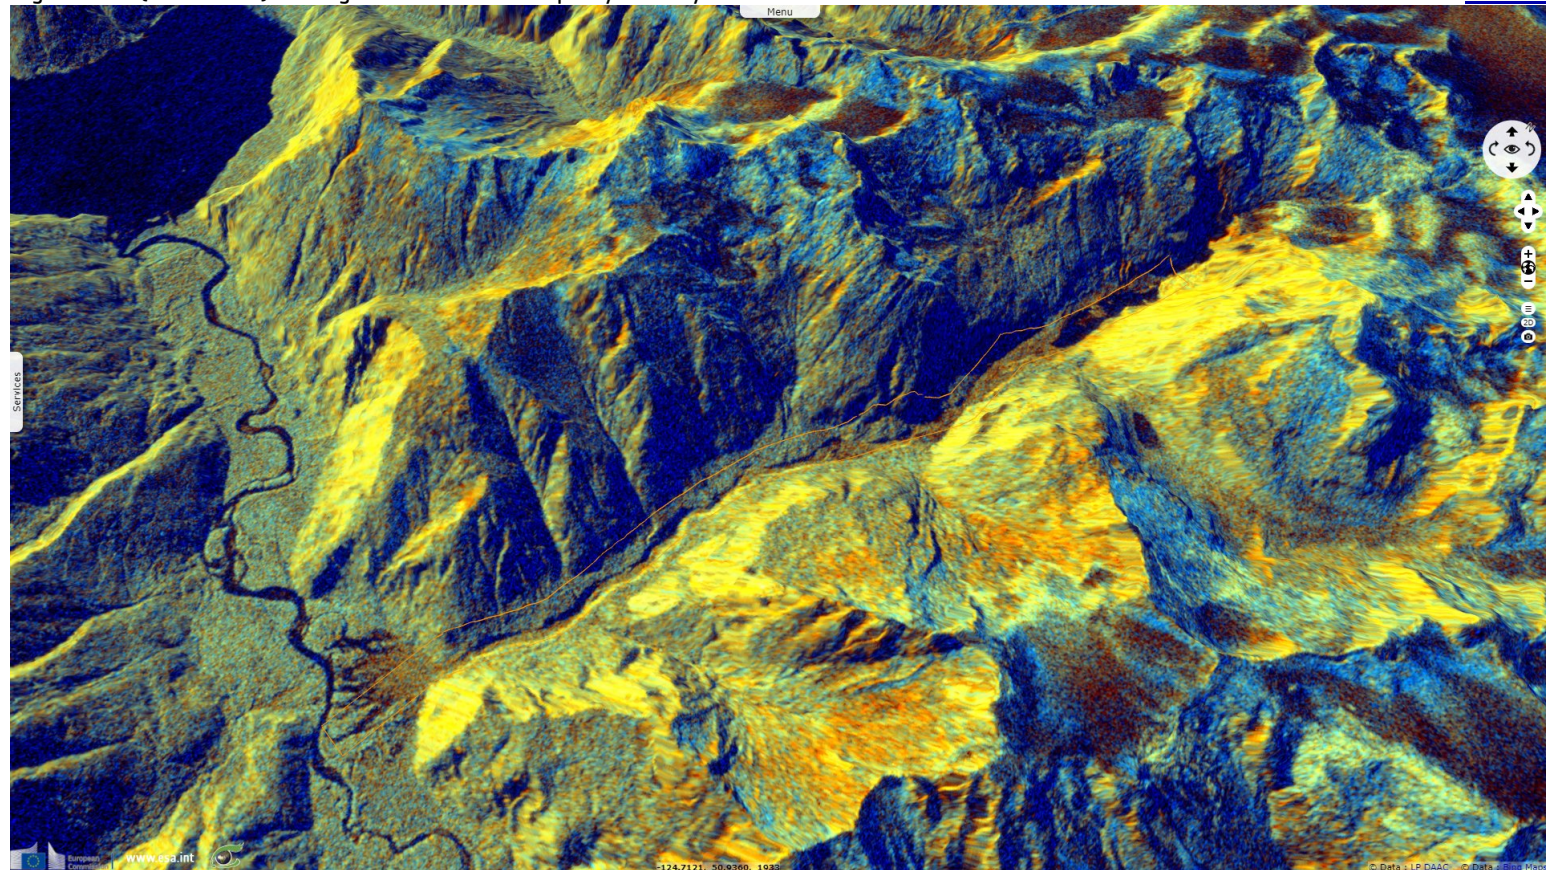
Fig. 10 - S1 (05.12.2020) - The glacial lake has been partly filled by the landslide.
