A landslide causes a glacier failure at the top of India

Author(s): Sentinel Vision team, VisioTerra, France - svp@visioterra.fr

Keyword(s): Natural disaster, landslide, flood, dam, climate change, erosion, glacier, water colour, India, Himalaya

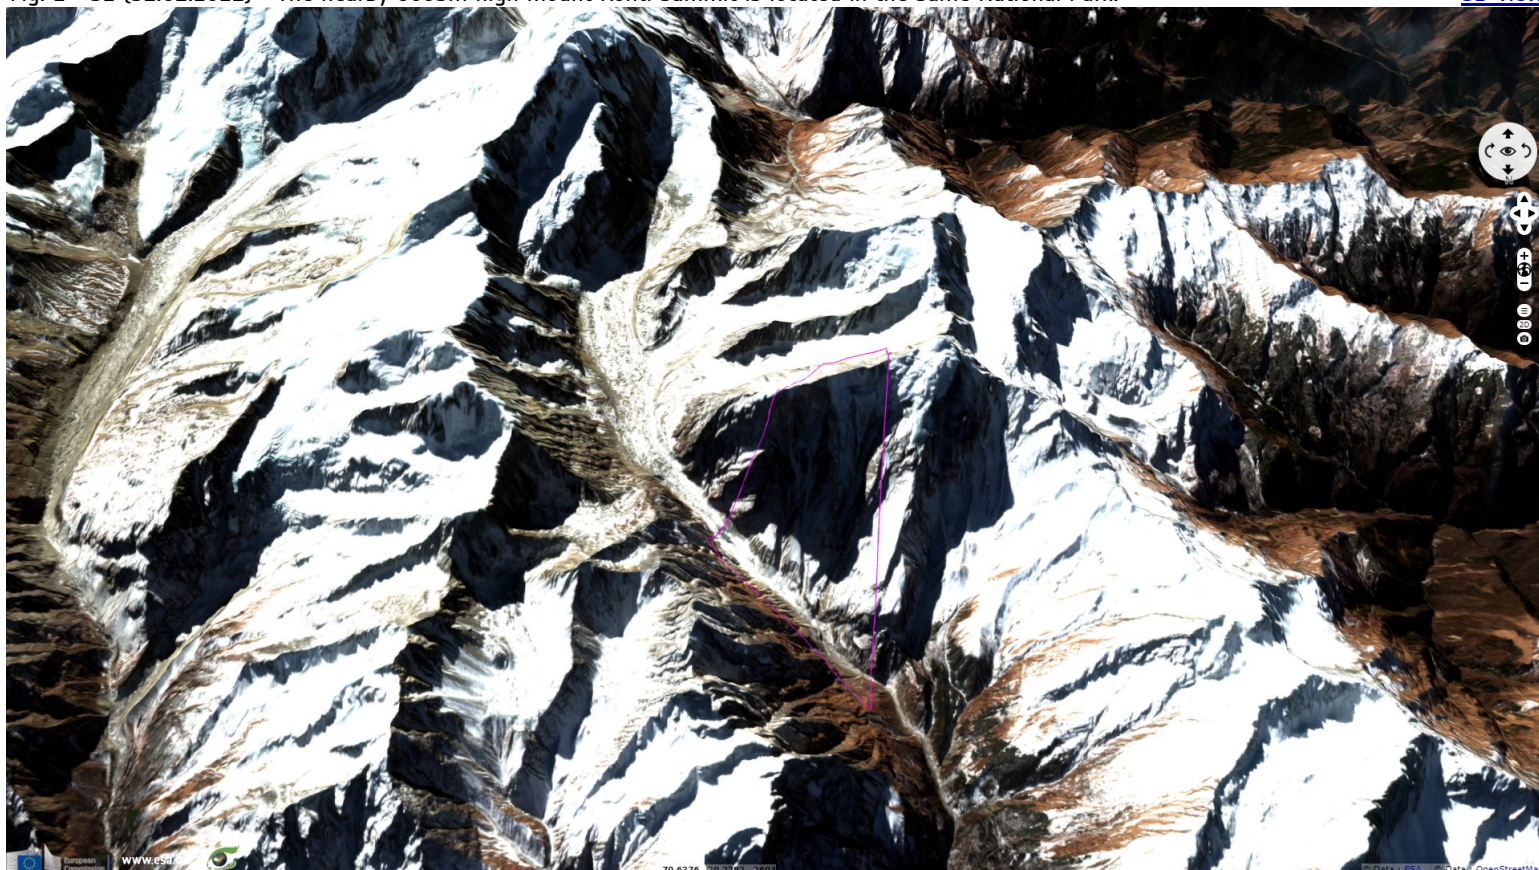
Fig. 2 - S2 (31.01.2021) - The nearby 6063m high mount Ronti summit is located in the same National Park.

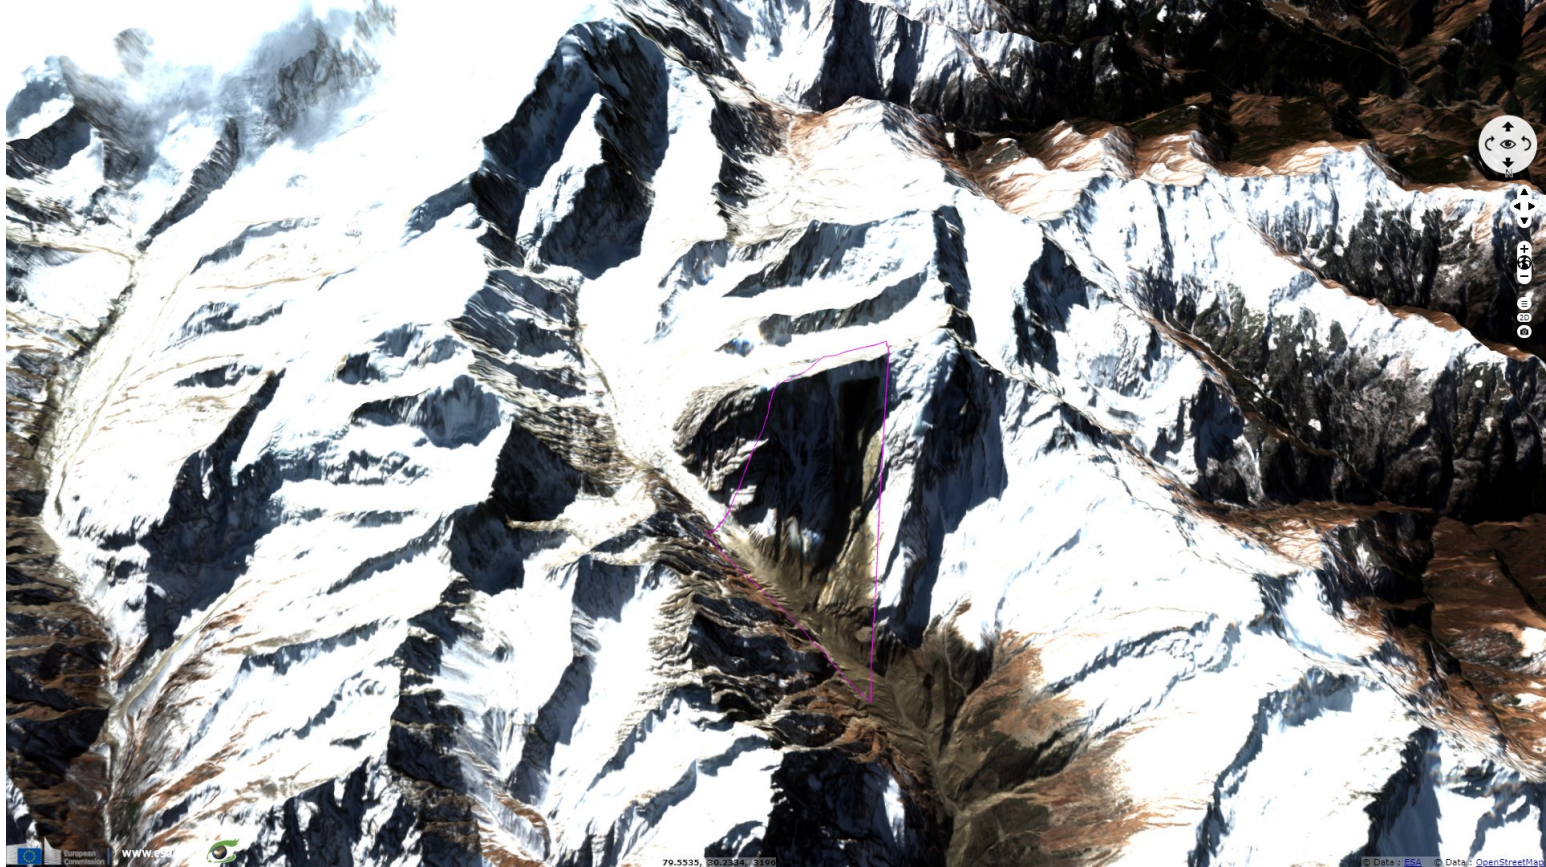
Fig. 3 - S2 (10.02.2021) - A large landslide happened there on 07.02.2021, causing the glacier underneath to fail.

Dave Petley, Pro-Vice-Chancellor at the University of Sheffield [wrote](#) for the Landslide blog: "For orientation, the valley floor is to the north, and the block that has dropped off is about 550 m wide. This is a very steep slope, so the block is very large indeed. My interpretation is that this is a wedge failure – note the inclined surfaces on the east and west side, although the basal shear plane may be another, slope parallel, joint. The block has dropped out of this wedge-shaped source, and fallen almost vertically about 1800 metres."

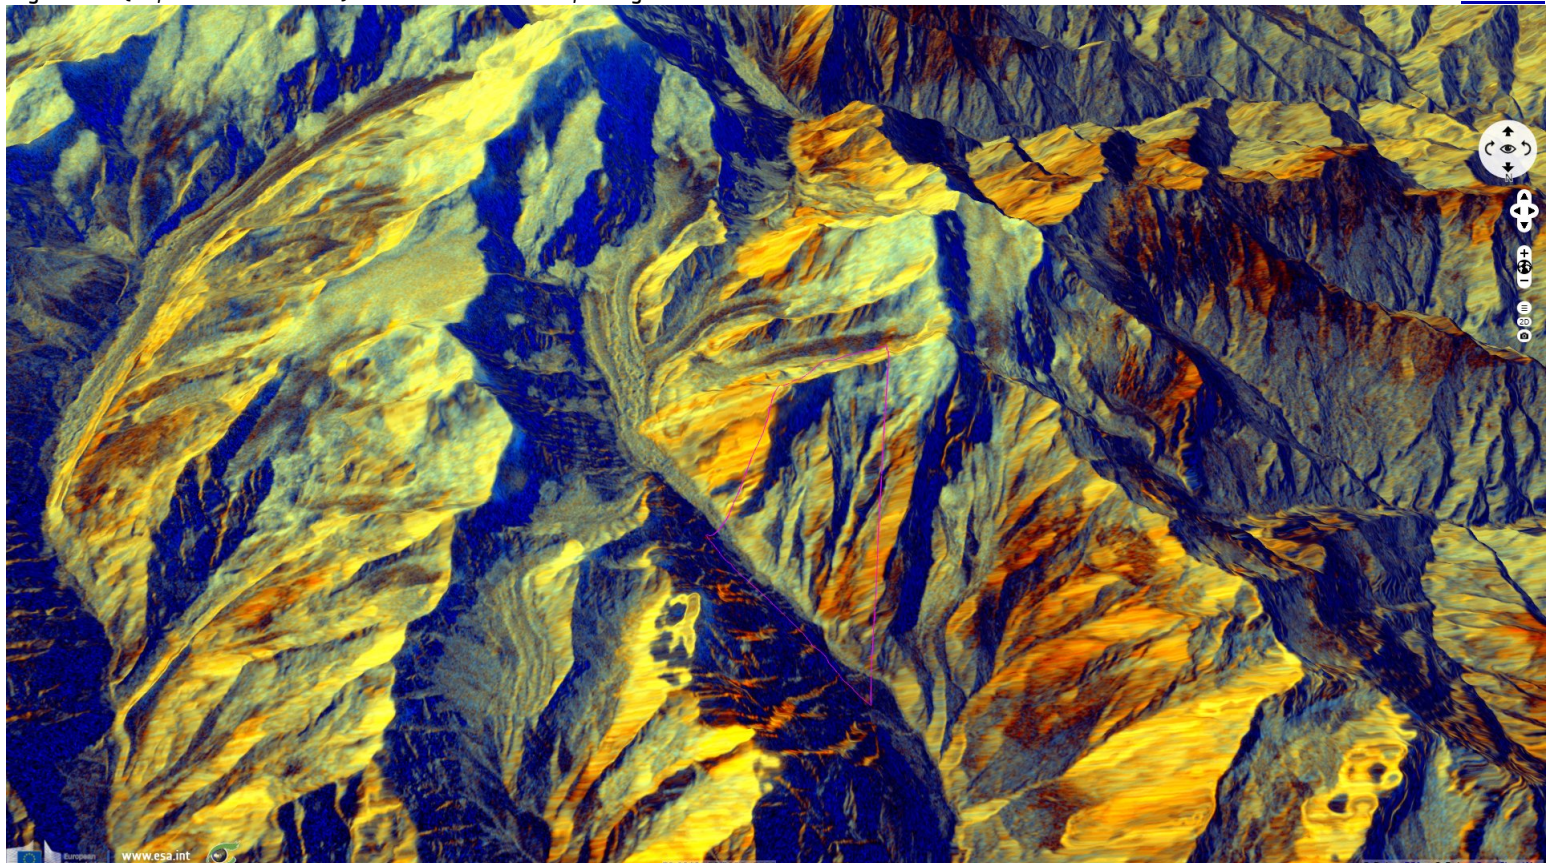
Fig. 4 - S1 (06, 18 & 30.01.2021) - Parallel to the crest, a large "fissure" can be seen on this facet.

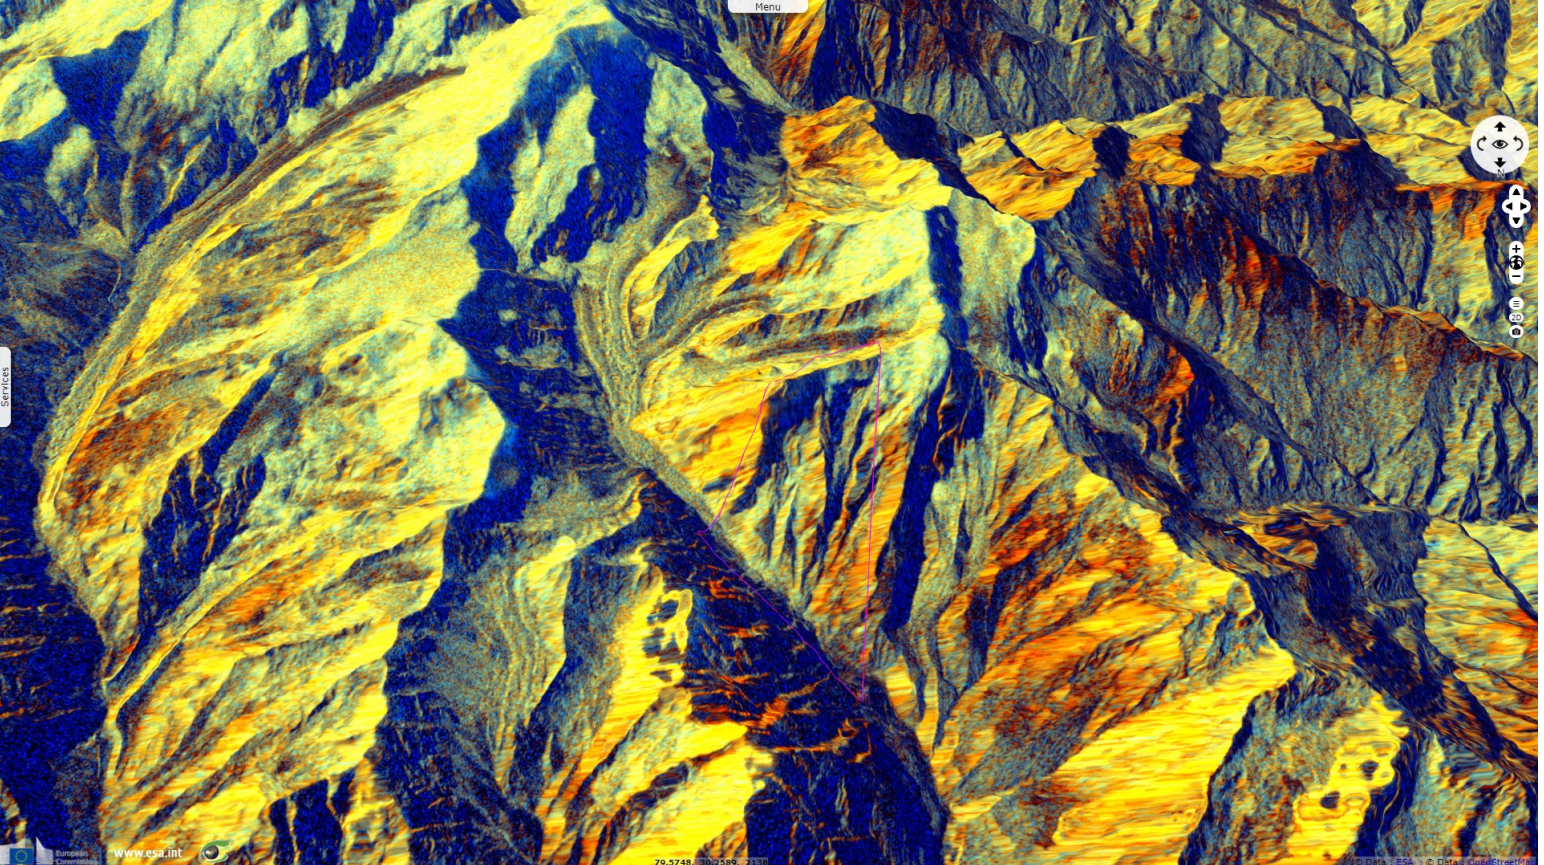
Fig. 5 - S1 (11.02.2021) - It is there that the landslide caused a large part of the glacier tongue to disappear.

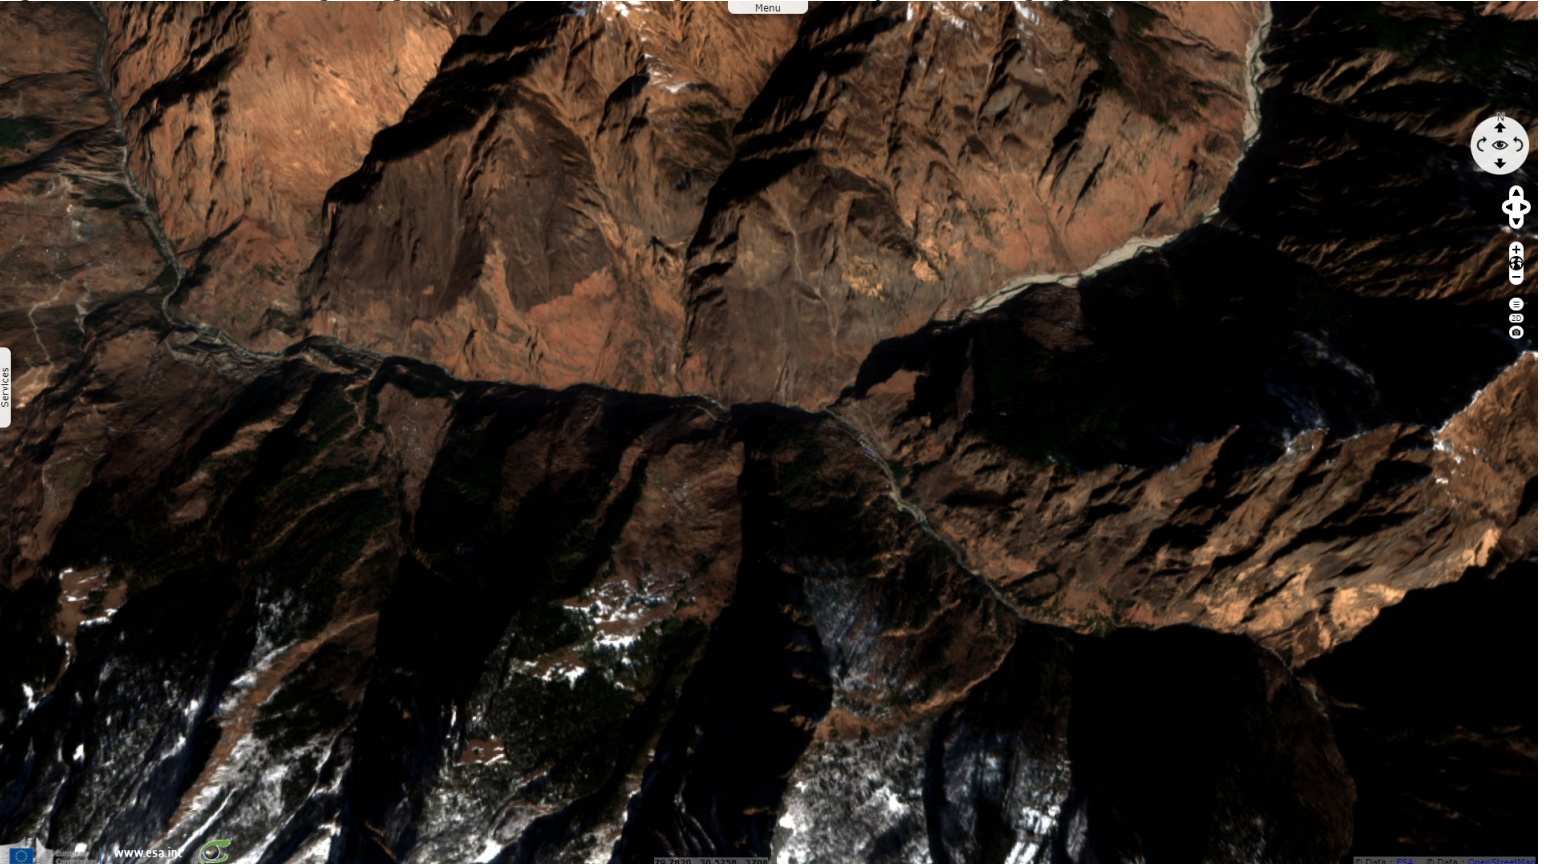
Fig. 6 - S2 (31.01.2021) - This glacier gives birth to the Rishi Ganga river which then joins the Dauliganga.

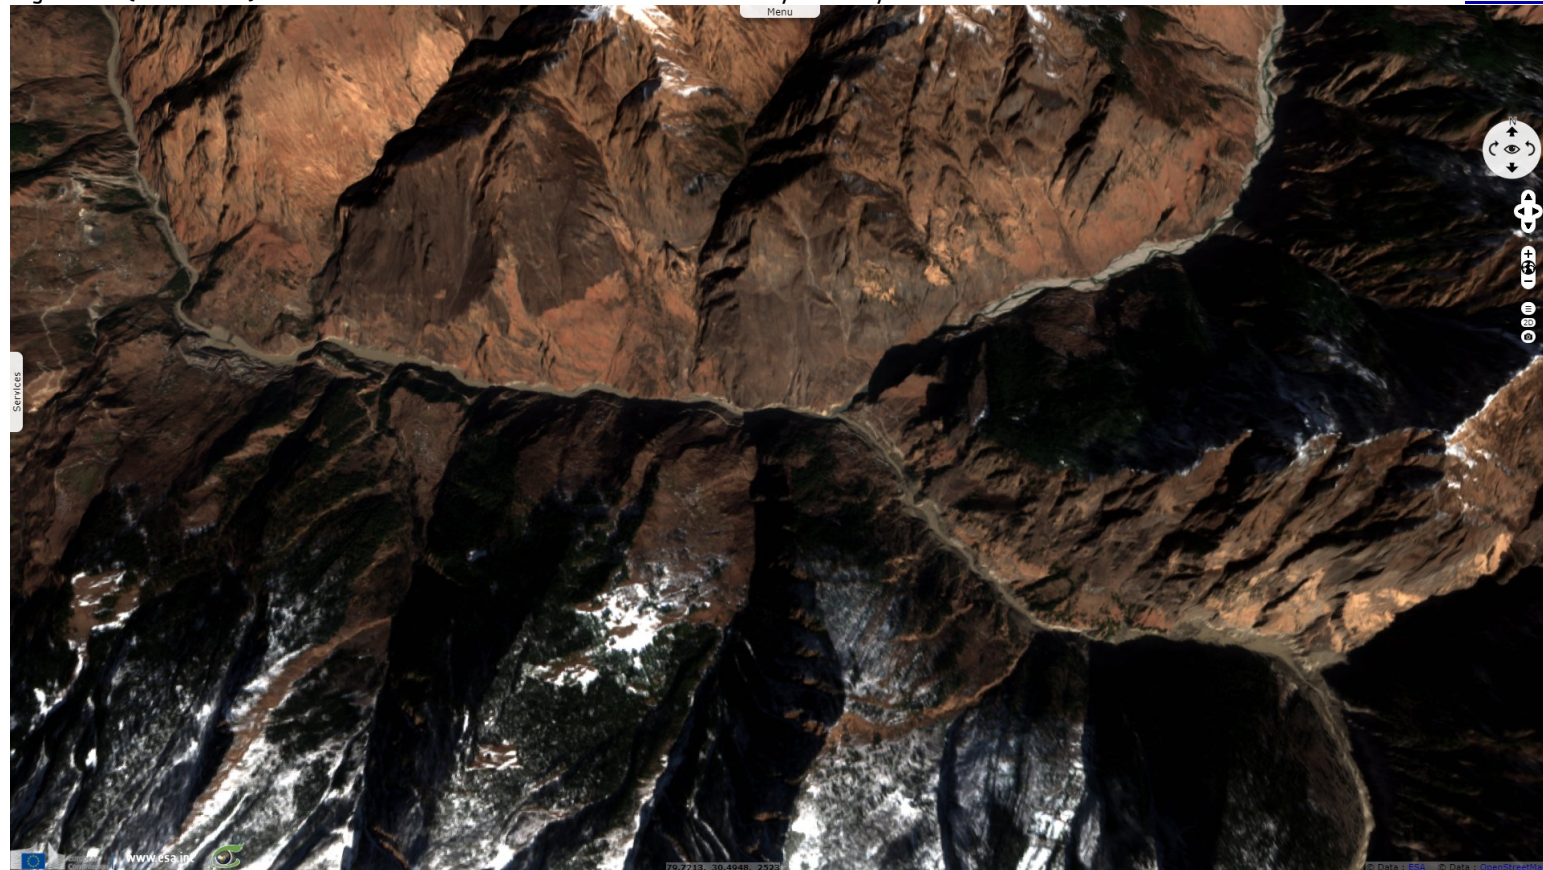
Fig. 7 - S2 (10.02.2021) - The blue main stem takes the colour of its muddy tributary.

According to [Professor Petley](#), the block of rock with some ice: "will have instantly fragmented to generate a huge rock and ice avalanche, which travelled down the glacier. This would have been extremely fast and very energetic. On the way it generated a vast quantity of dust, which is smeared on the valley side to the west of the valley. Down valley (to the north) the rock avalanche was able to entrain a vast amount of water and sediment."

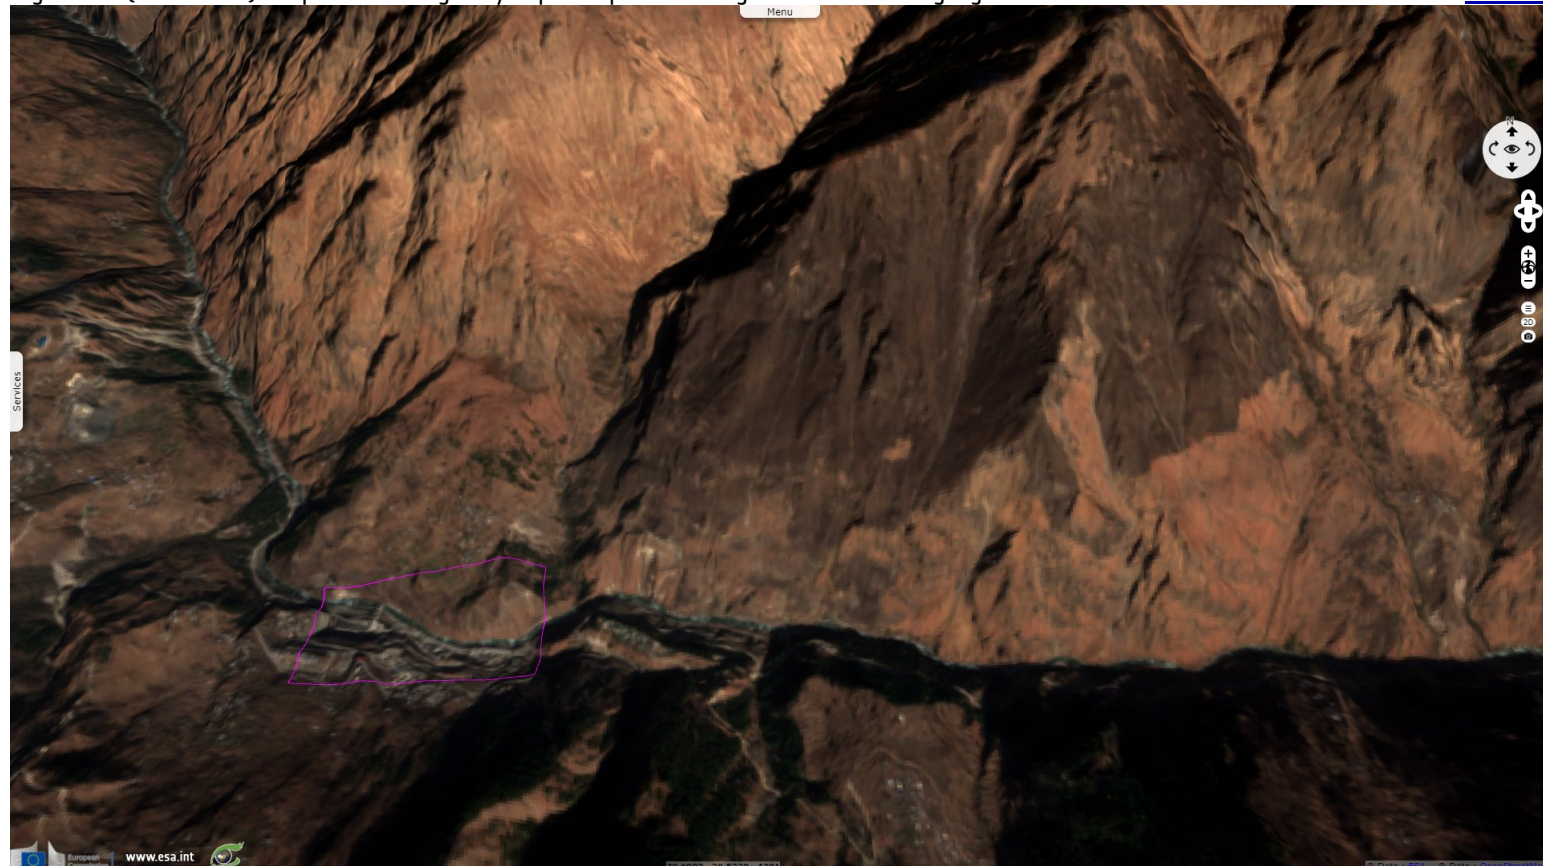
Fig. 8 - S2 (31.01.2021) - Tapovan Vishnugad hydropower plant is being built on the Dauliganga before it reaches the Alaknanda river.

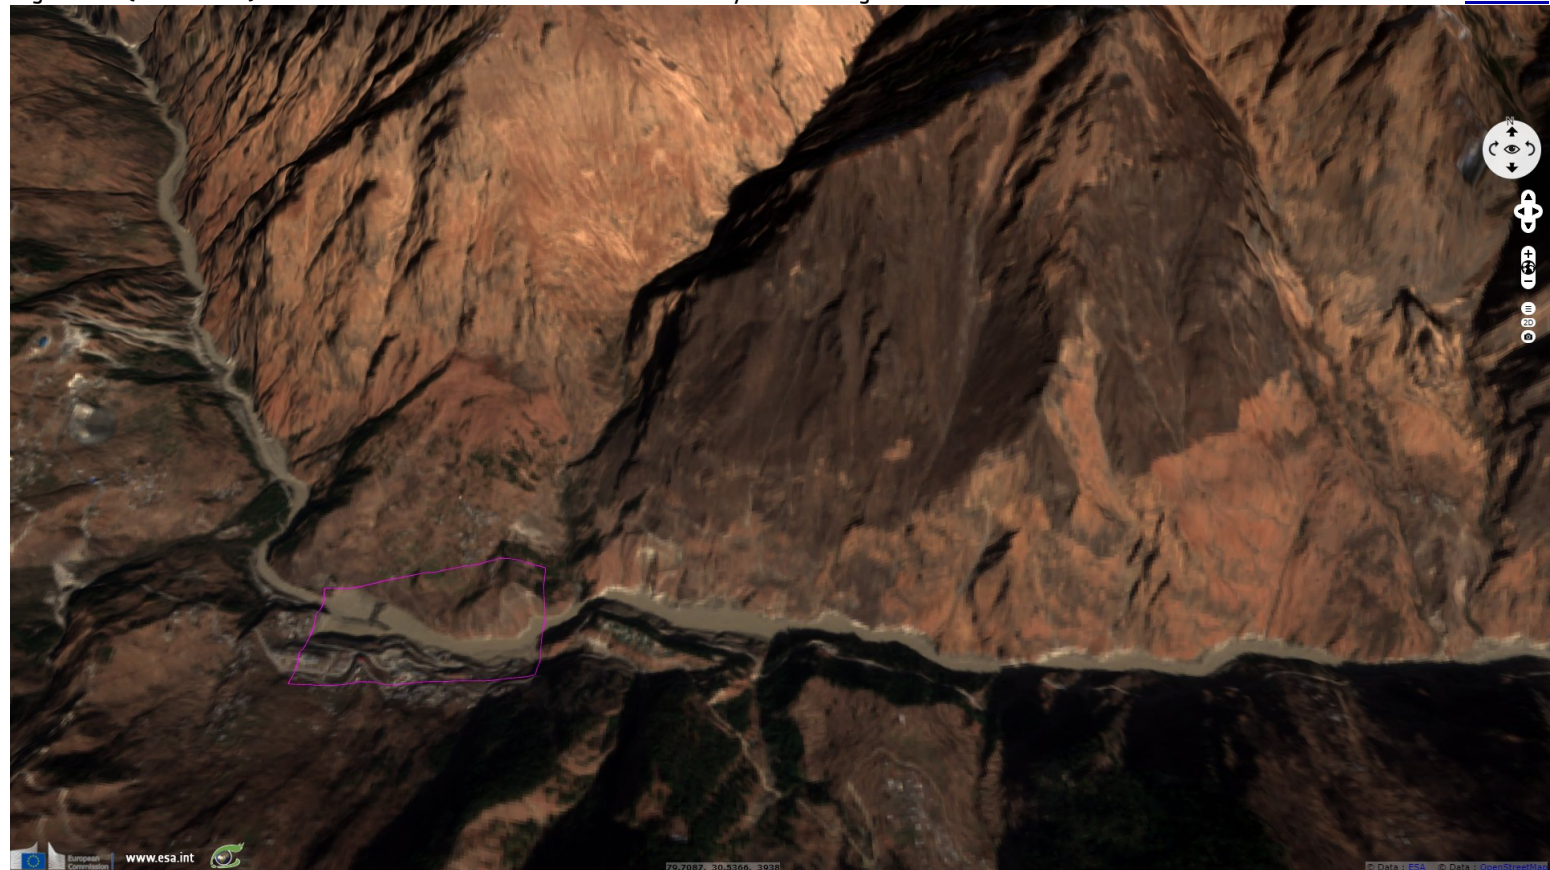
Fig. 9 - S2 (10.02.2021) - The construction site has been devastated by the ensuing flood.

India Today [published](#) the following toll: "Twenty-six bodies have been recovered and 171 are still missing after the glacier burst in Uttarakhand's Chamoli district, as per DGP Ashok Kumar. This comes even as multiple agencies joined hands to rescue at least 30 workers trapped in a 250-metre tunnel at Tapovan. Rescue efforts in the affected areas near Joshimath, gained momentum with teams of the Army, Indo-Tibetan Border Police (ITBP), National Disaster Response Force (NDRF) and State Disaster Response Force (SDRF) coordinating to rescue 30-35 people feared trapped in a tunnel at the Tapovan-Vishnugad project. Officials said 27 people were rescued alive. Of these, 12 were saved from the smaller of the two tunnels at the Tapovan-Vishnugad project site and 15 from the Rishiganga site."

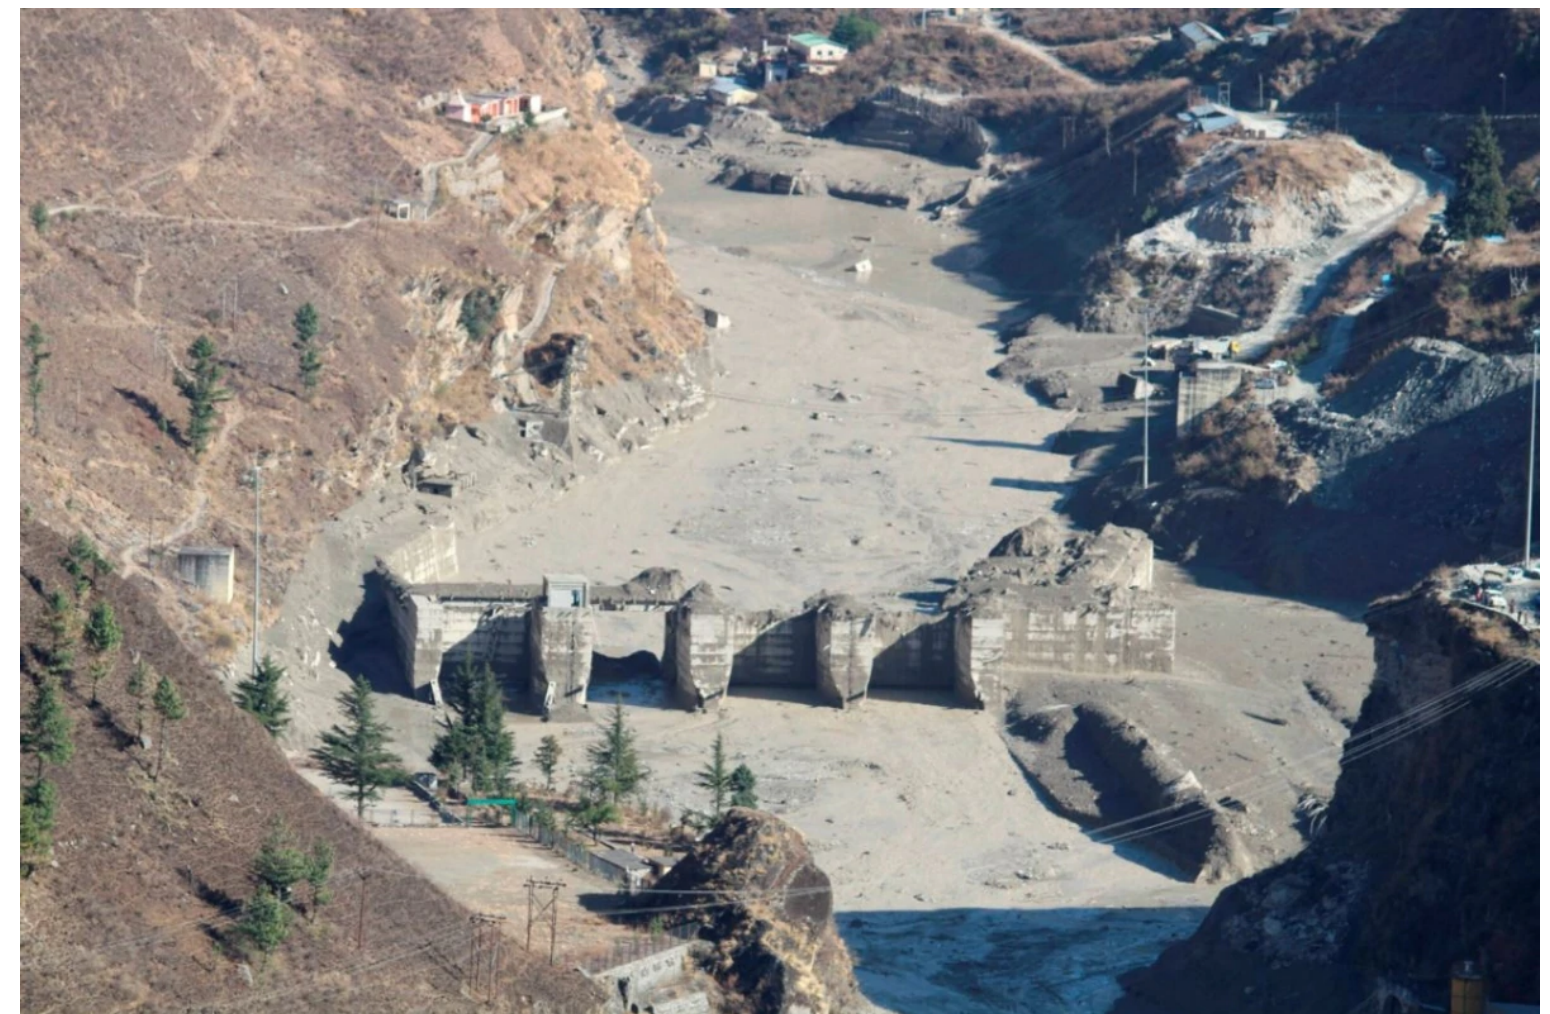
Damaged Dhauli Ganga hydel power project - Source: [PTI](#).

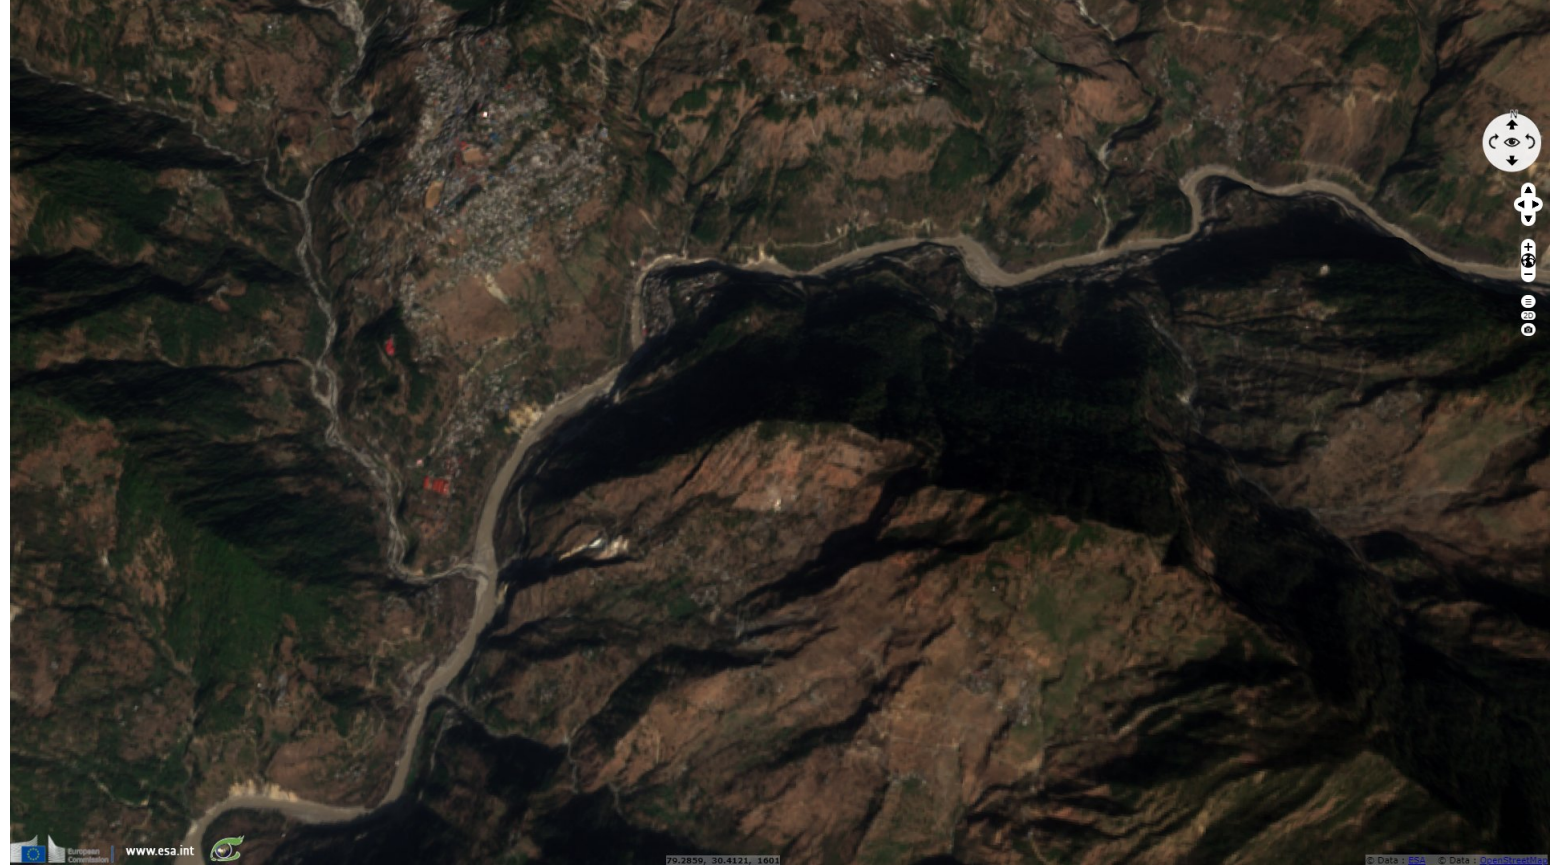
Fig. 11 - S2 (31.01.2021) - Srinagar hydropower plant is located further downstream on the Alaknanda river. [3D view](#)

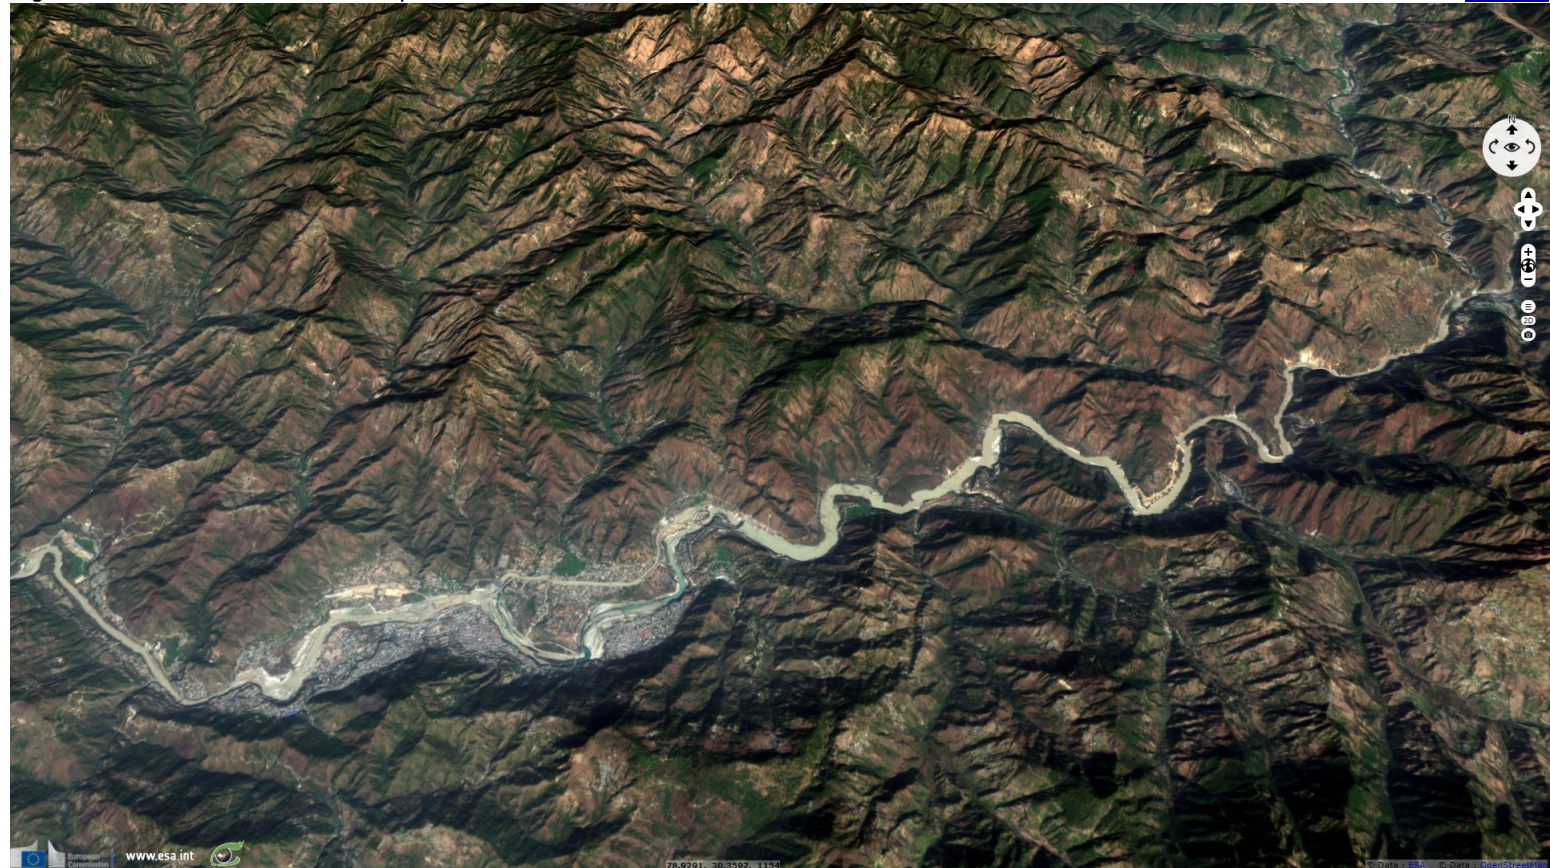
Fig. 12 - S2 (10.02.2021) - It did not prevent the eroded material to flow below the dam.

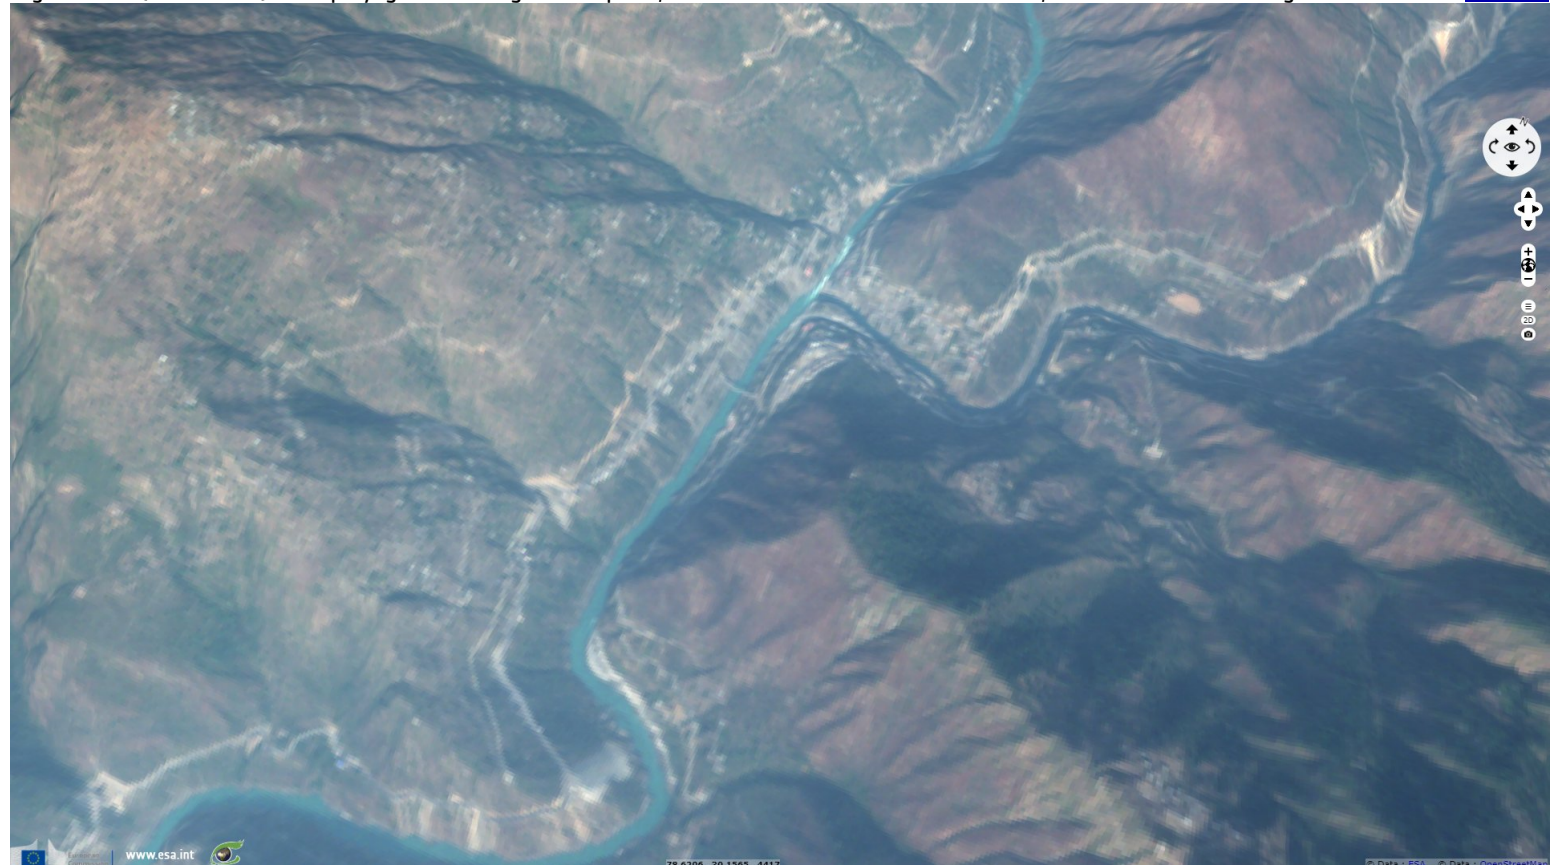
Fig. 14 - S2 [10.02.2021] - The material coming from the glacier and the landslide reached the beginning of the Ganges. [3D view](#)
