# Large mine landslide harms none in Spain

Keyword(s): Geohazard, landslide, natural resources, geology, Spain

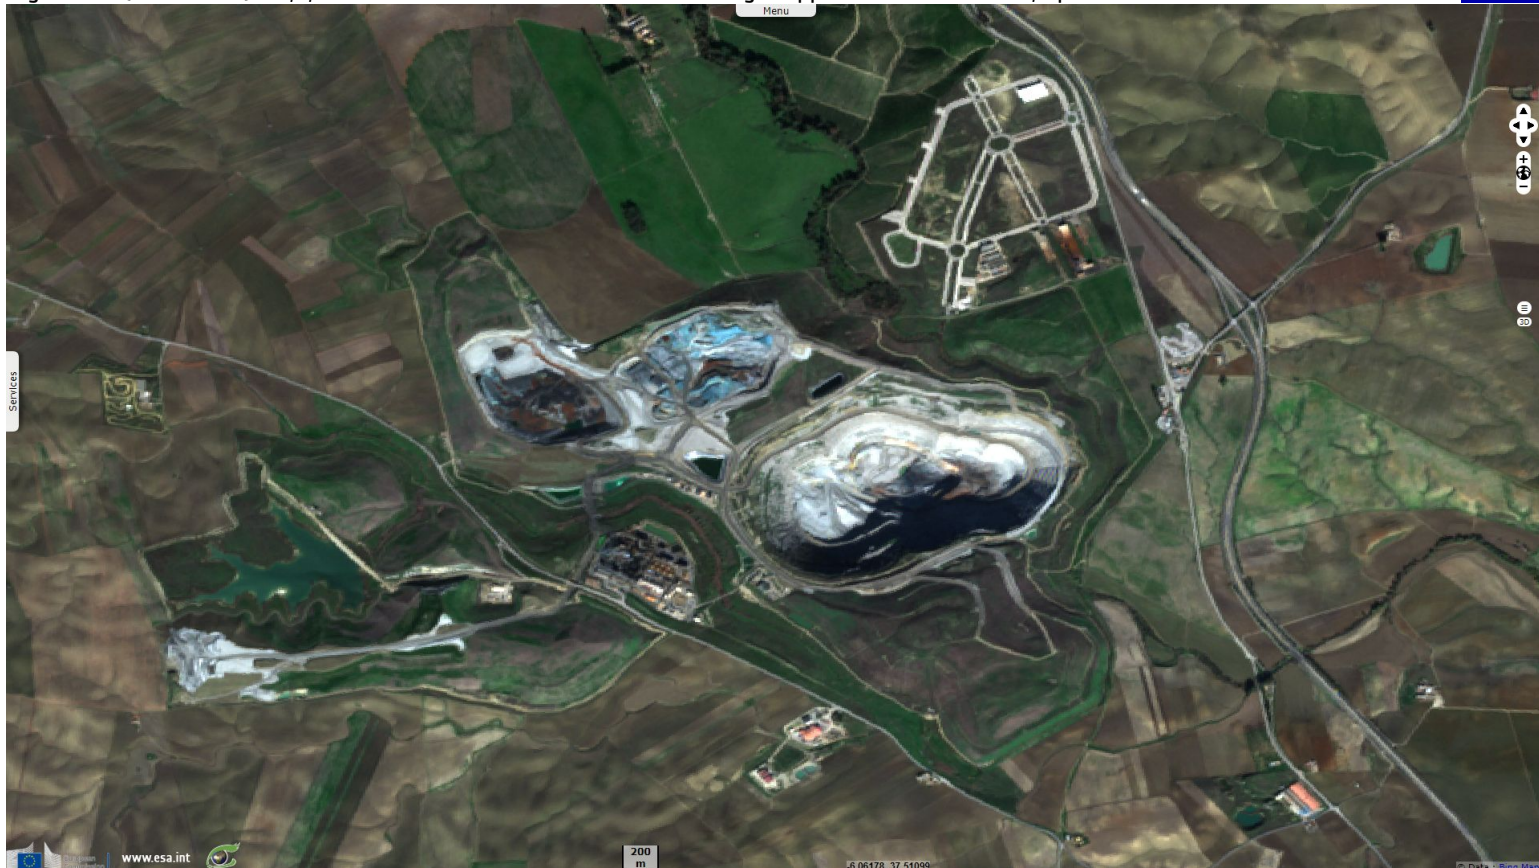
Fig. 1 - S2 (07.01.2019) - 4,3,2 natural colour - Cobre Las Cruces is a large copper mine in Andalucia, Spain.

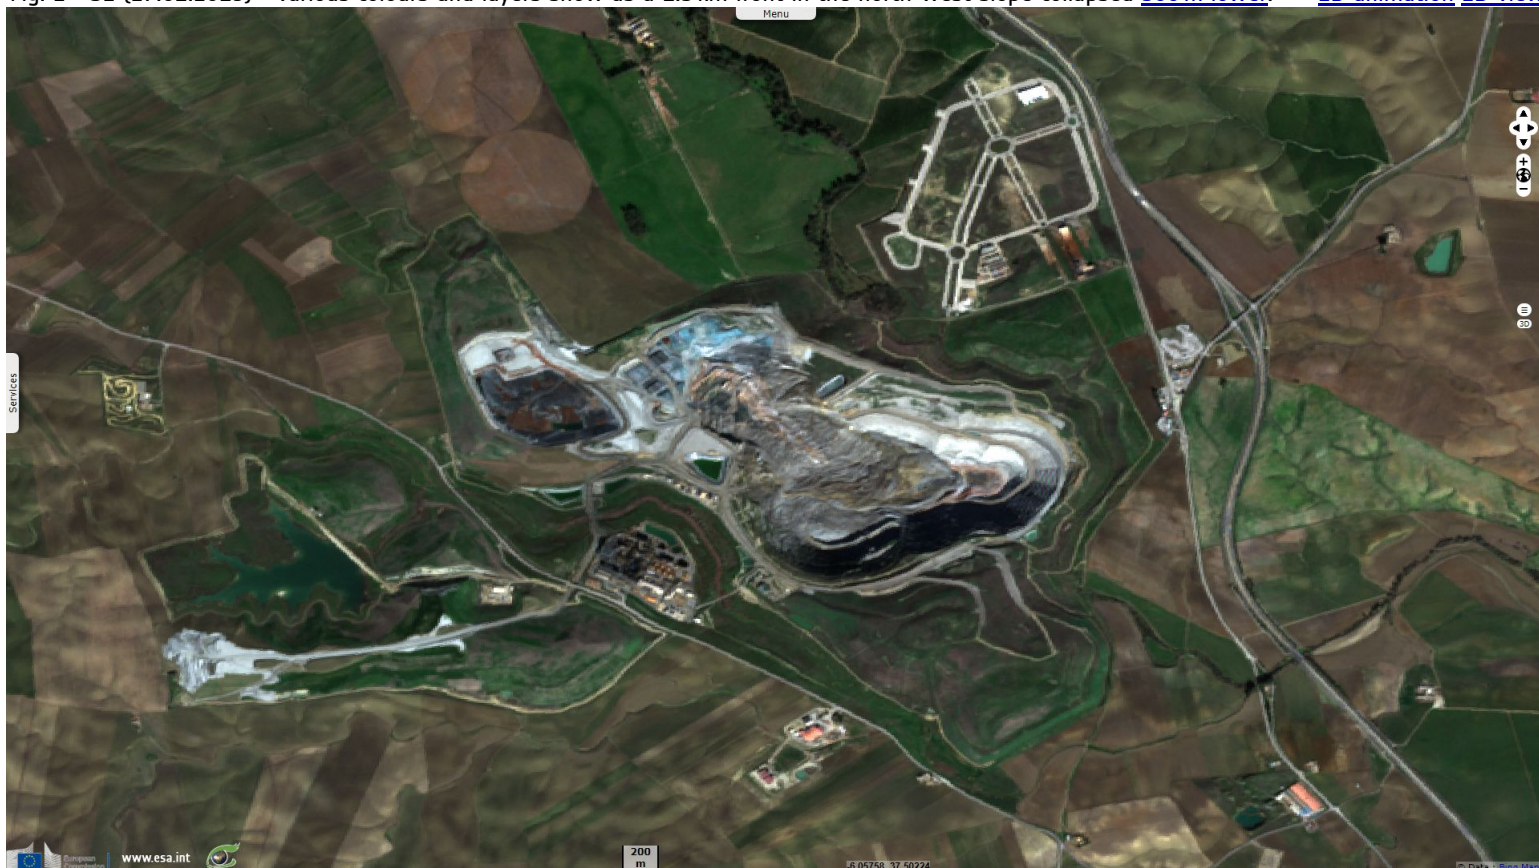
Fig. 2 - S2 (27.01.2019) - Various colours and layers show as a 1.3 km front in the north-west slope collapsed [300 m lower](#).

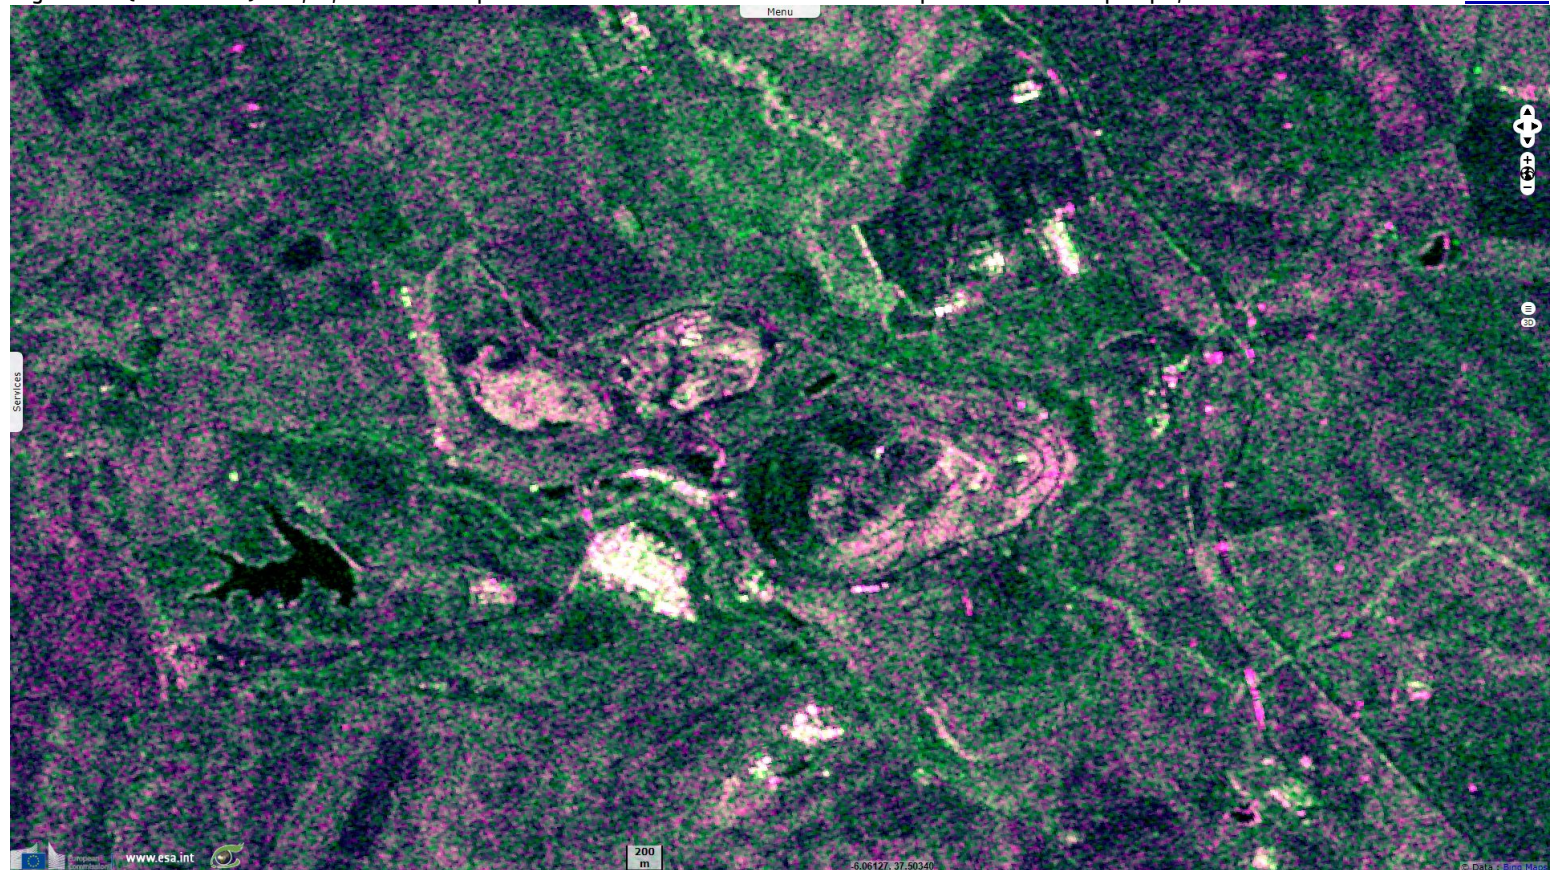
Fig. 3 - S1 (16.01.2019) - vv,vh,vv colour composite - 15 millions cubic meters material spread inside the open pit, more than in Brumadinho. [2D view](#)

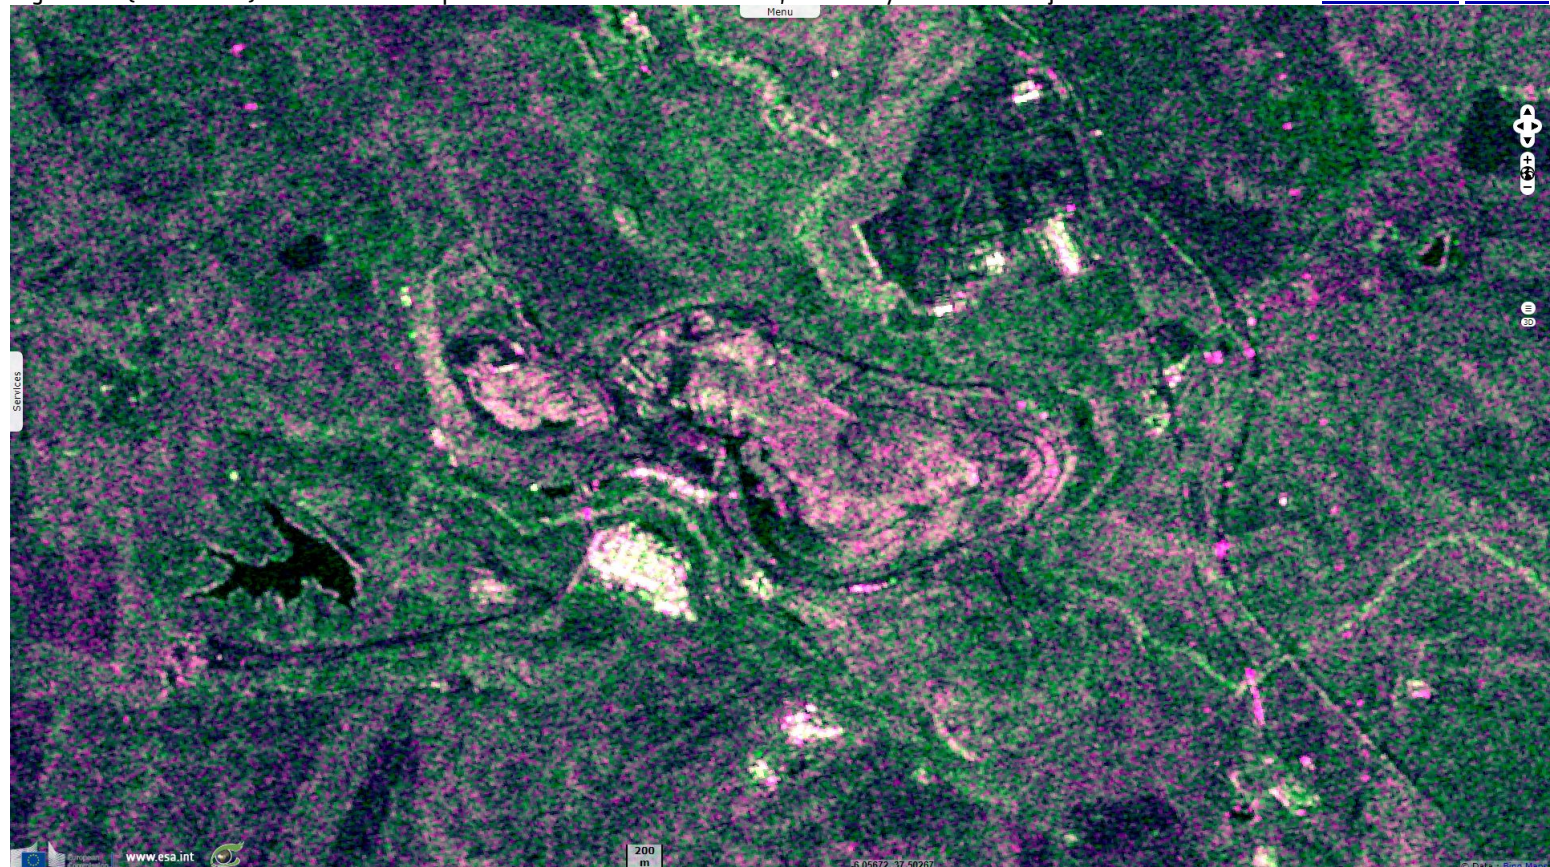
Fig. 4 - S1 (28.01.2019) - Production is expected to be halted for 6 months, but luckily no one was injured. [2D animation](#) [2D view](#)
