Floods in the north of Albania

Sentinel-2 MSI acquired on **27 November 2020** at 09:33:39 UTC
Sentinel-1 CSAR IW acquired on **06 January 2021** at 04:46:31 UTC
Sentinel-1 CSAR IW acquired on **06 January 2021** at 04:46:56 UTC
Sentinel-1 CSAR IW acquired on **12 January 2021** at 04:47:19 UTC

Author(s): Sentinel Vision team, VisioTerra, France - svp@visioterra.fr

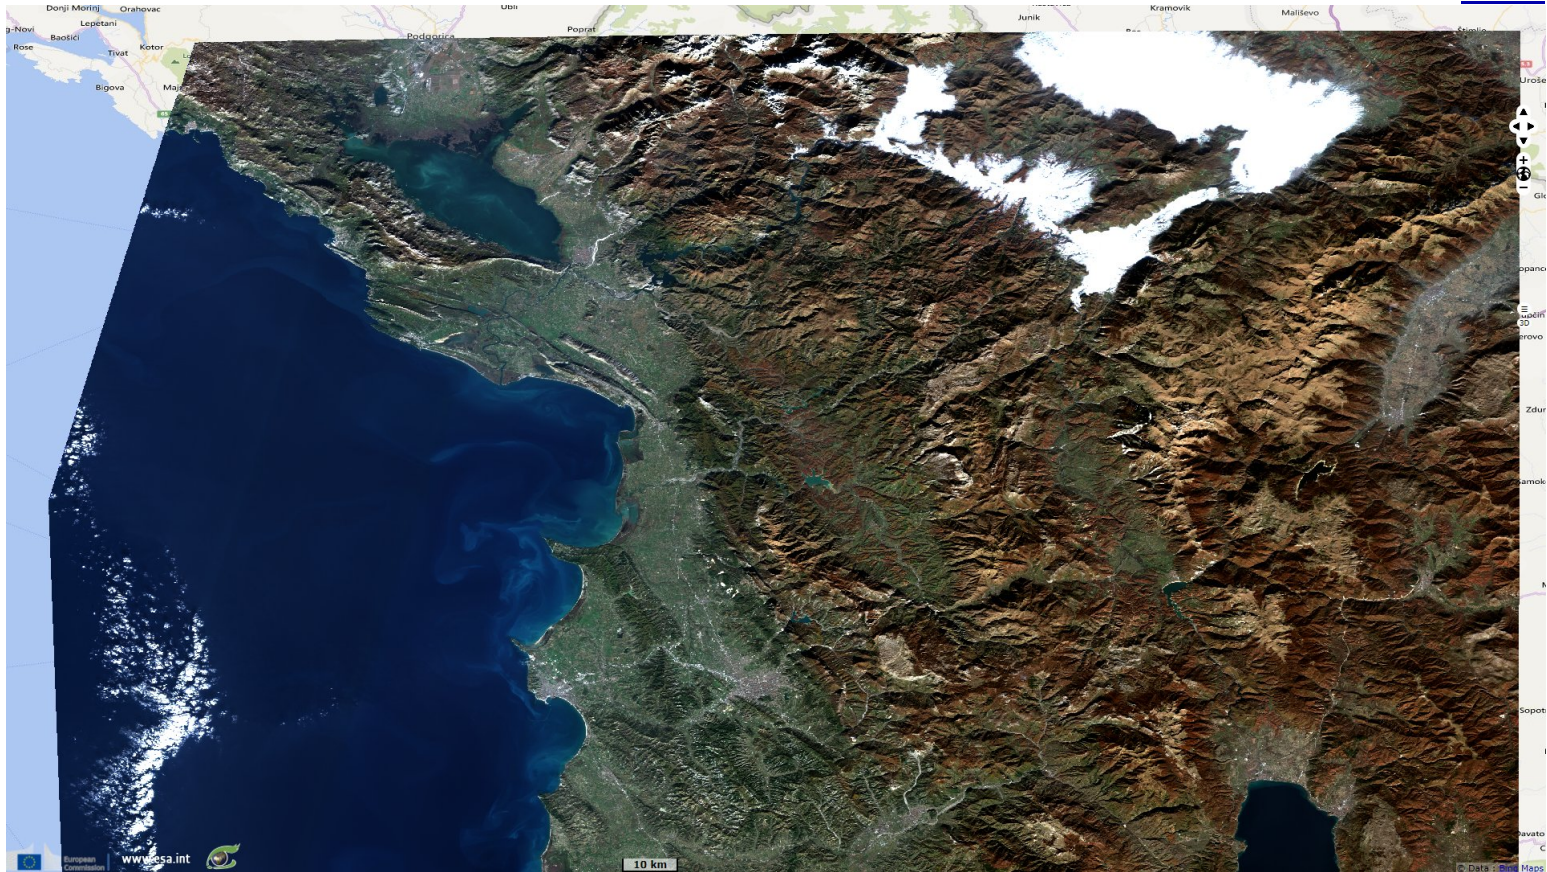
Fig. 1 - S2 (27.11.2020) - The government in Albania reported on 10.01.2021 that flooding had affected wide areas in the north of the country after heavy rain that began on 06 January.

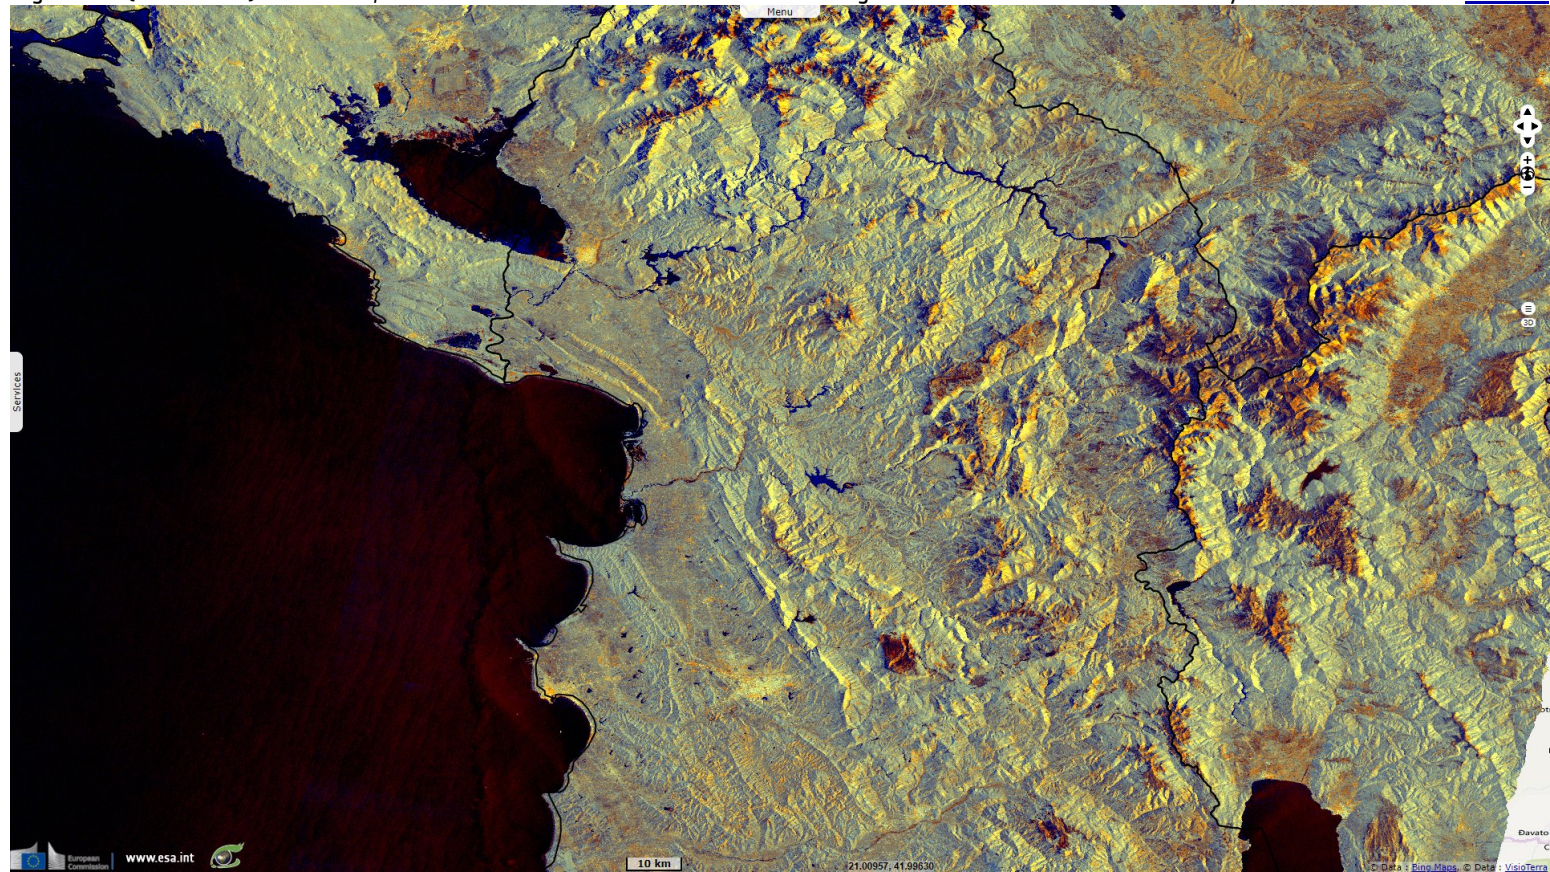
Fig. 2 - S1 (06.01.2021) - Around 2,850 ha of land was under water due to flooding from the Drin River in Lezhë County.

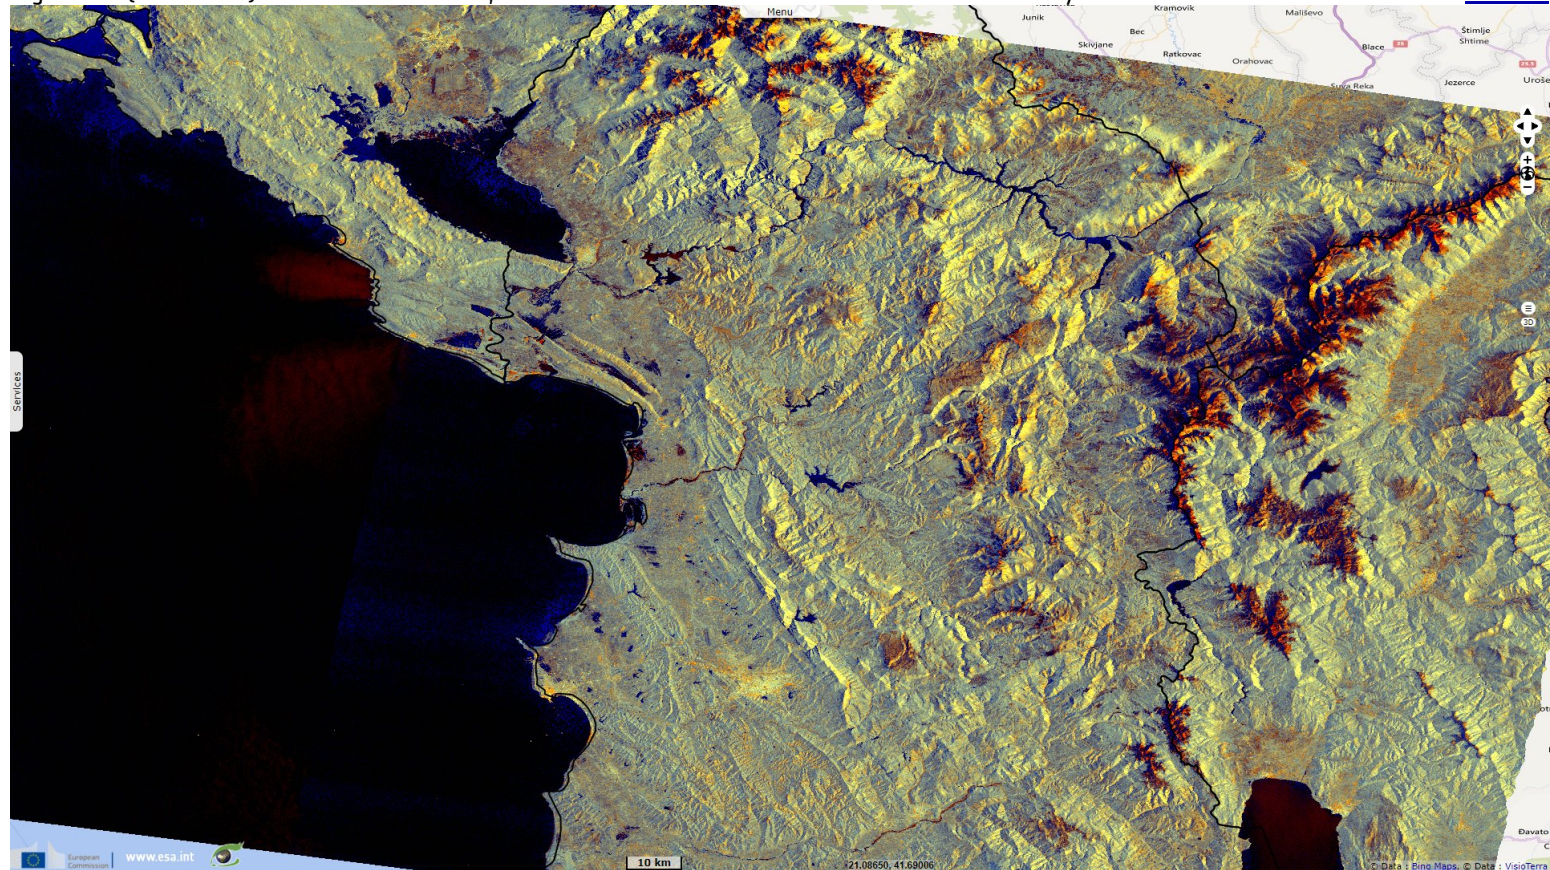
Fig. 3 - S1 (12.01.2021) - Meanwhile around 4,080 hectares of land was under water in Shkodër County.

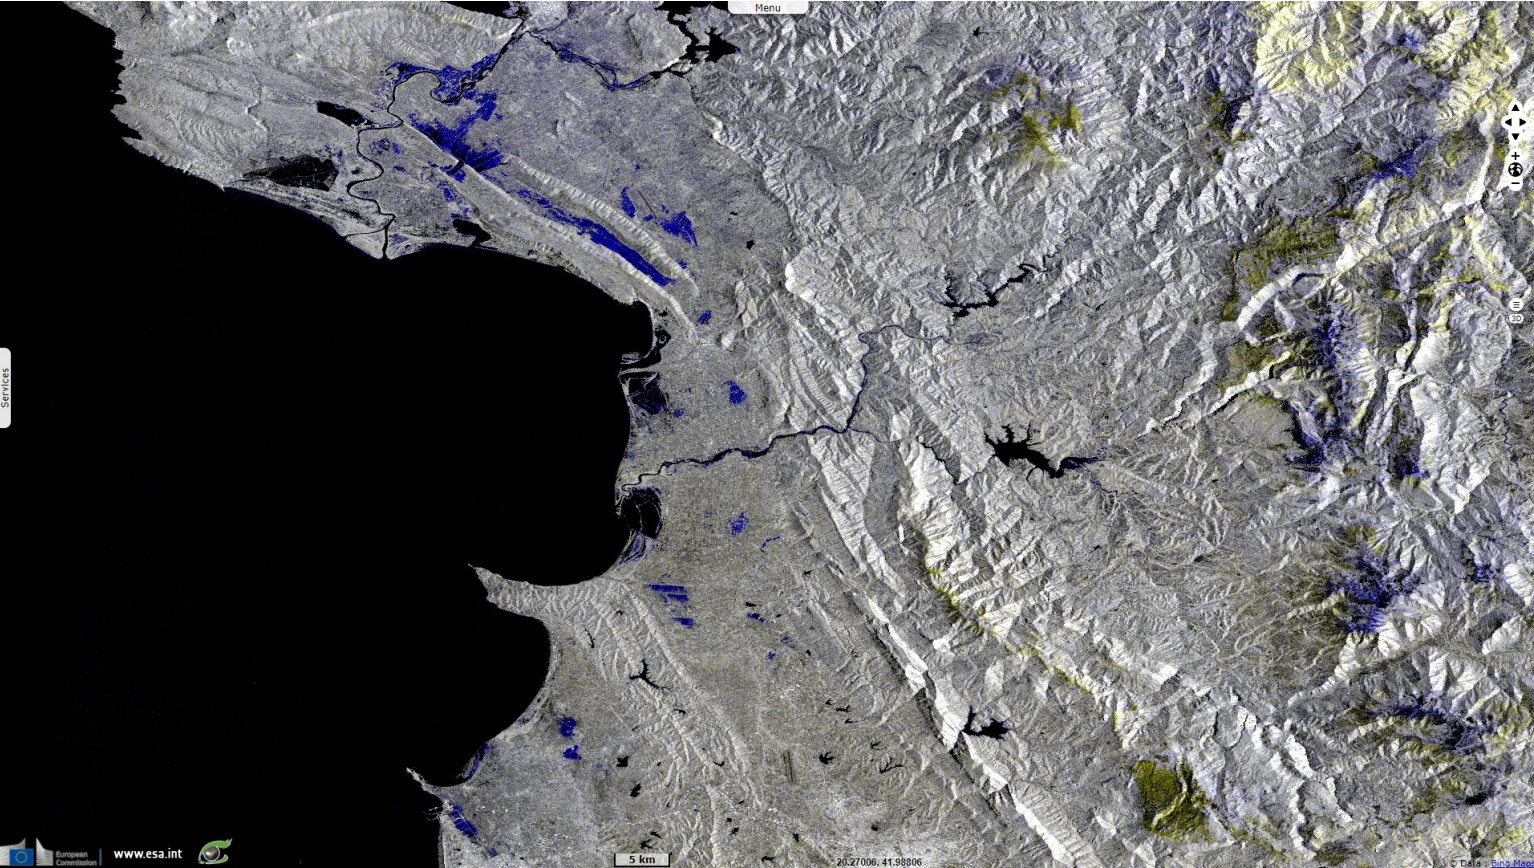
Fig. 4 - S1 (06 & 12.01.2021) - This multitime image highlights the affected areas.
