# Lasting arsenic pollution in Salsigne gold mine, France

Author(s): Sentinel Vision team, VisioTerra, France - [svp@visioterra.fr](mailto:svp@visioterra.fr)

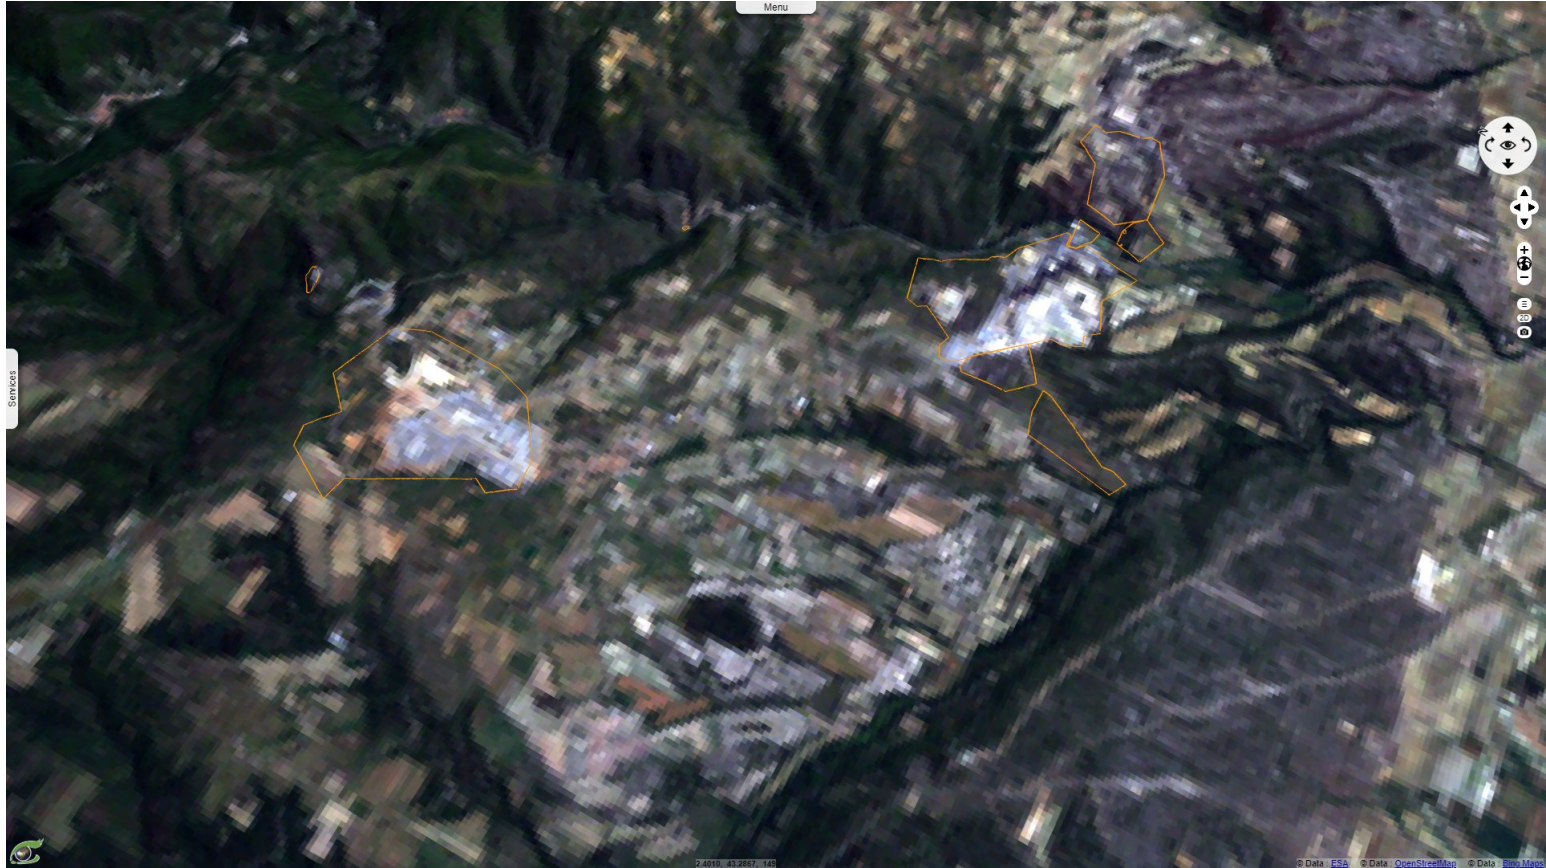
Fig. 3 - Landsat-5 (26.06.1984) - View of the sites while the mine was active.

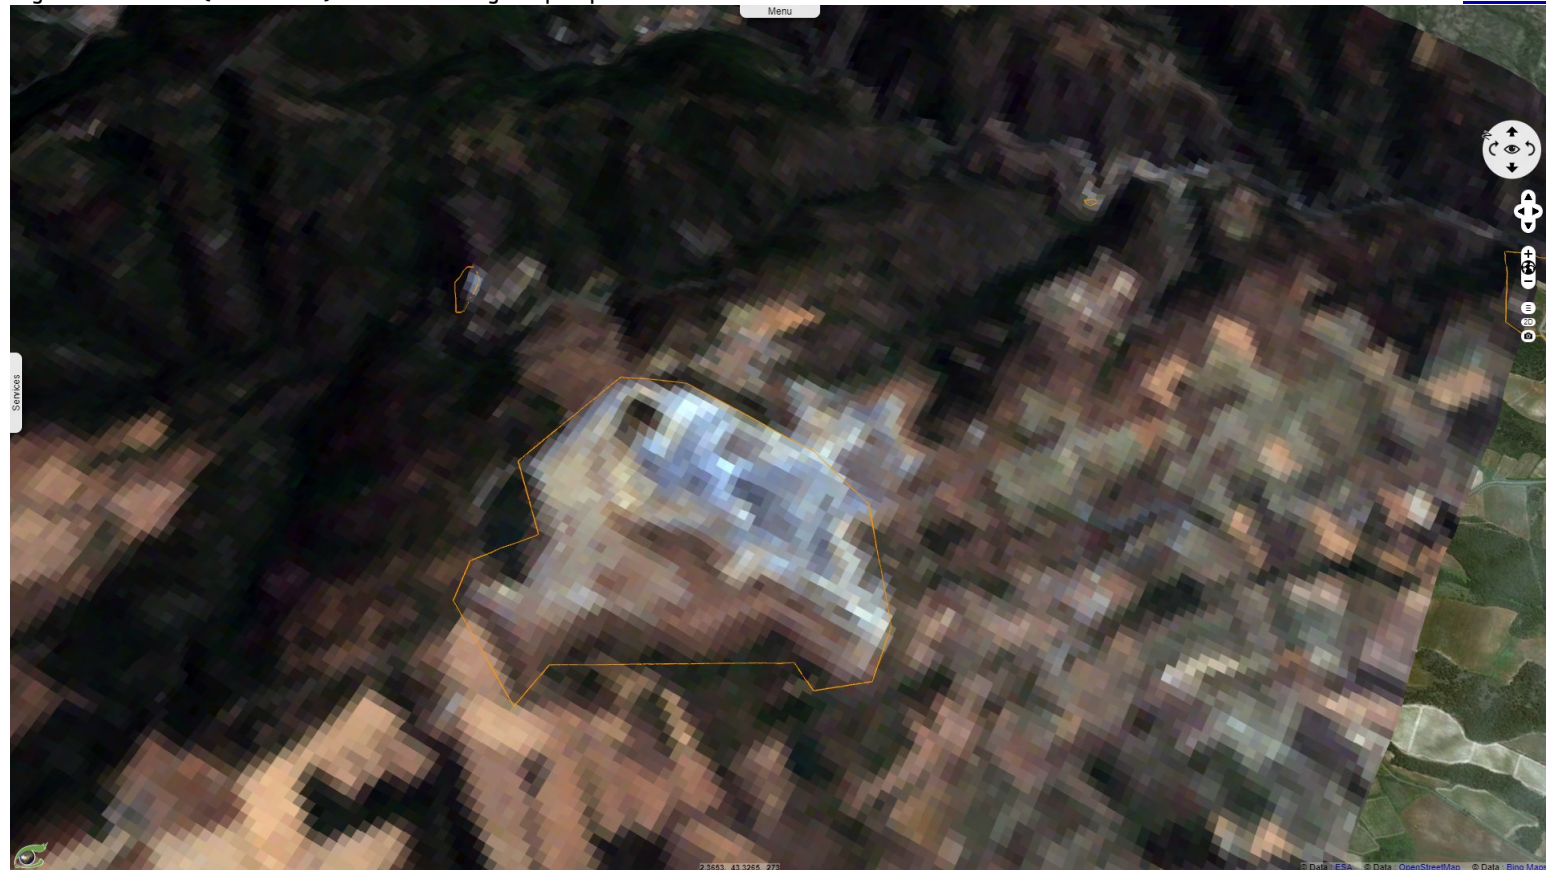
Fig. 5 - Landsat-7 (23.07.1999) - View of Salsigne open pit mine while it was active.

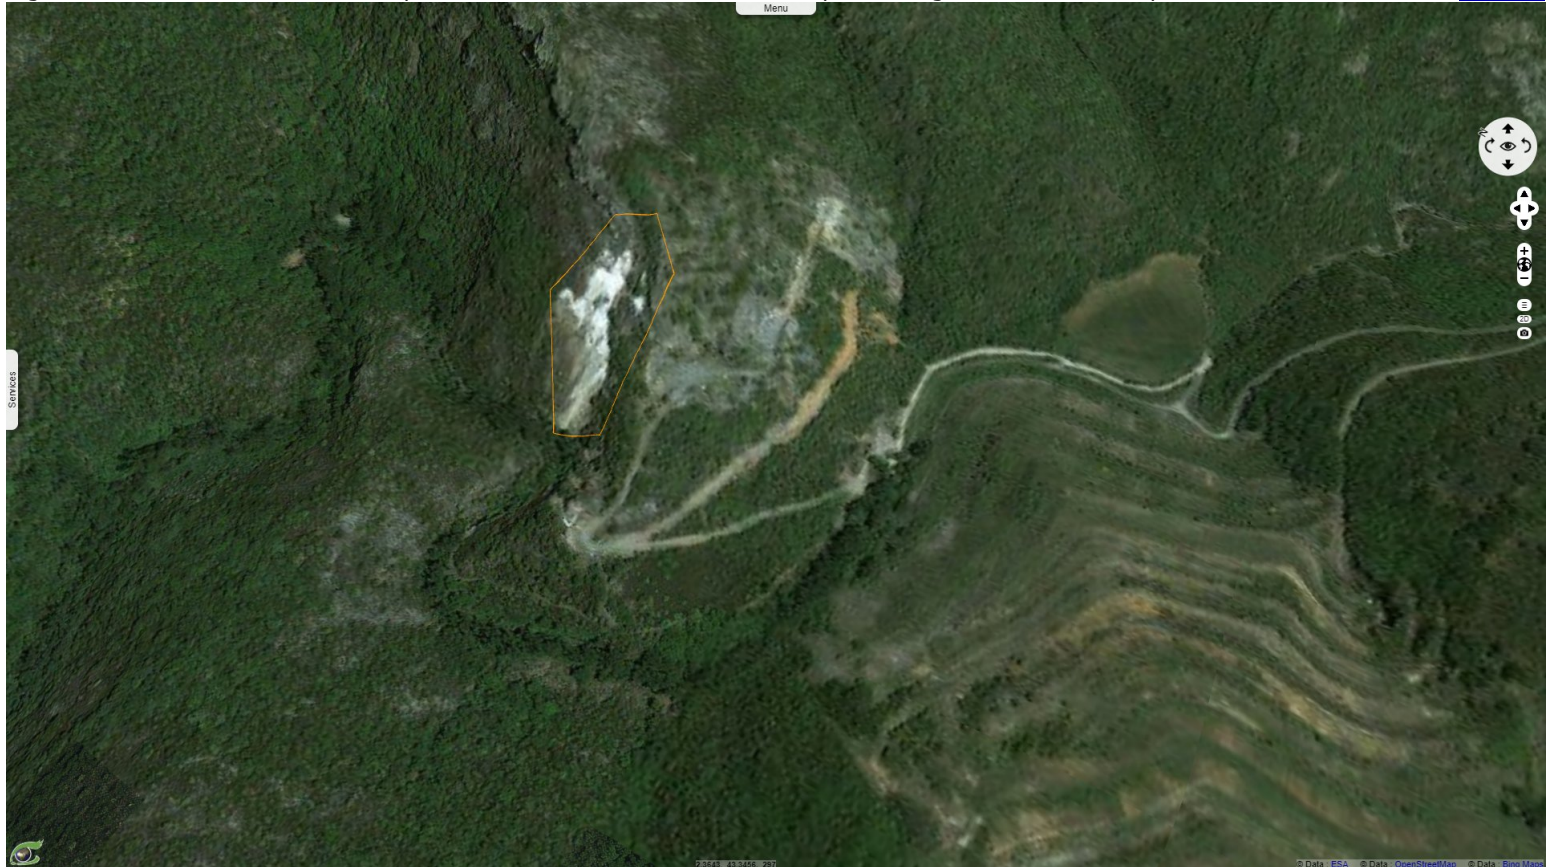
Fig. 7 - The white landmark on the slopes of the mountain is Nartau arsenic deposit, a large contributor to the pollution.

The Association SystExt wrote a report dedicated to the consequences of the exploitation of Salsigne mine. Regarding the arsenic deposit of the Nartau site, it [states](#): "This mine waste dump is located to the north of the Salsigne open pit mine and more precisely on the Nartau site. From 1896 to 1910, the Nartau deposit was mined underground for mispickel, the ore from which iron and arsenic were extracted. Excavation waste rock and residues from pyrometallurgical processing were stored on site, for a total estimated volume of 20 000 tonnes. These materials, which are estimated to contain between 10 and 20% arsenic, were simply dumped into the slope and then abandoned on site. The slope overhangs the Grésillou River which flows into the Orbiel. Thus, the erosion of this deposit, although limited by the presence of a toe protection, is at the origin of high concentrations of arsenic in these watercourses, even today."

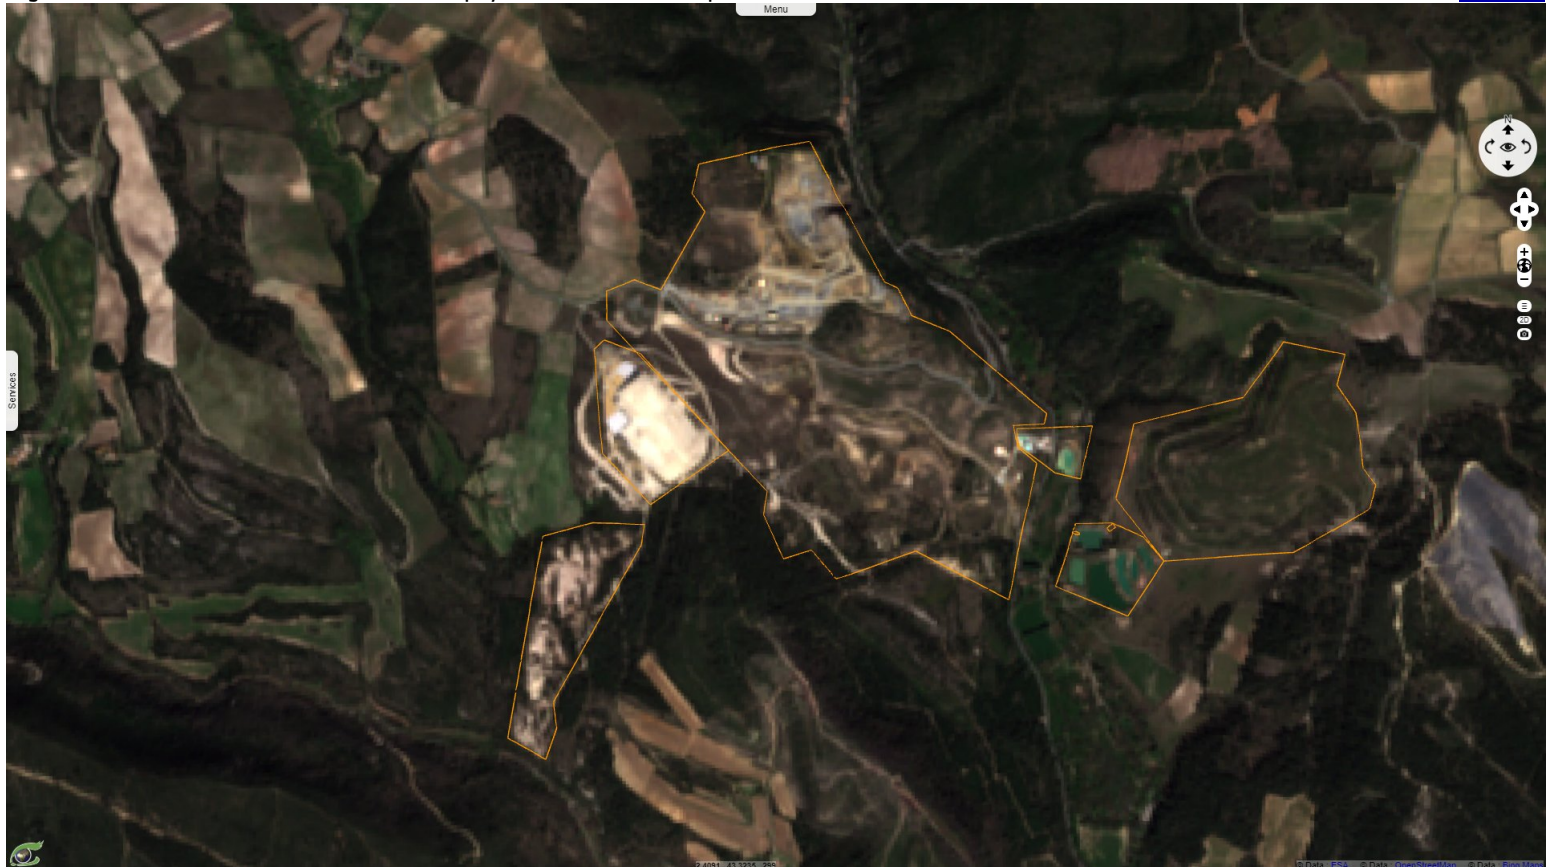
Fig. 9 - S2 (28.03.2021) - It is now under a phytoremediation attempt.

SystExt also [deals with](#) the phytoremediation attempt: "In the Salsigne district, the Combe du Sault site covers 120 hectares. The main ore processing facilities and numerous toxic product storage facilities were located there. The site was rehabilitated between 2000 and 2006 as part of the European "Difpolmine" programme. It consisted of dismantling and burying the infrastructure and waste, setting up a water management system and an extensive revegetation programme (the first in Europe to be applied on an industrial scale)."

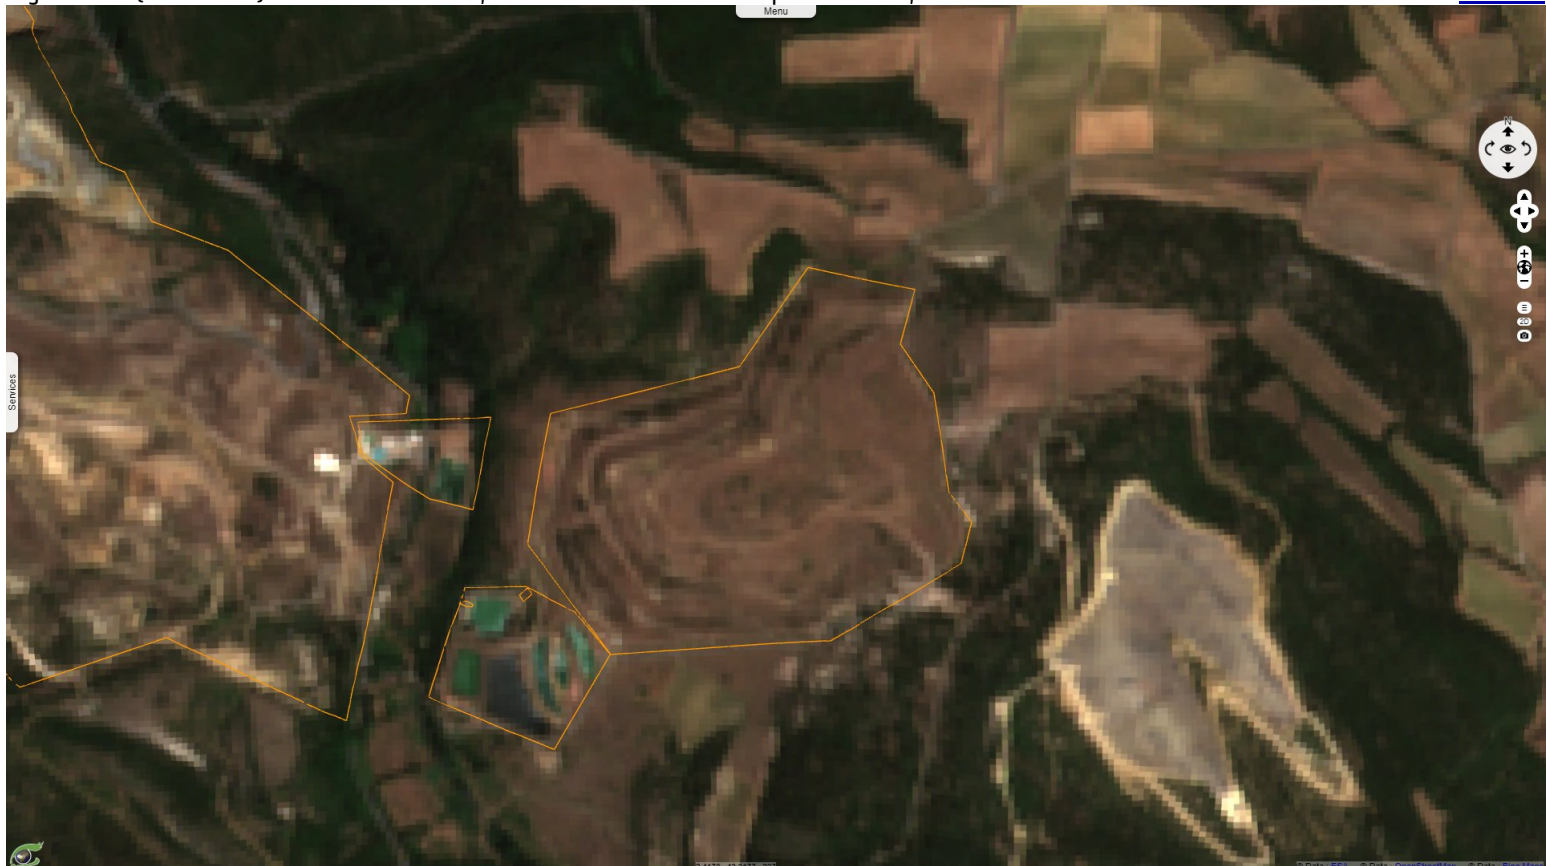
Fig. 10 - S2 (16.07.2015) - Artus dam in 2015, it hides ten million tons of polluted sand, 2% of which is arsenic.

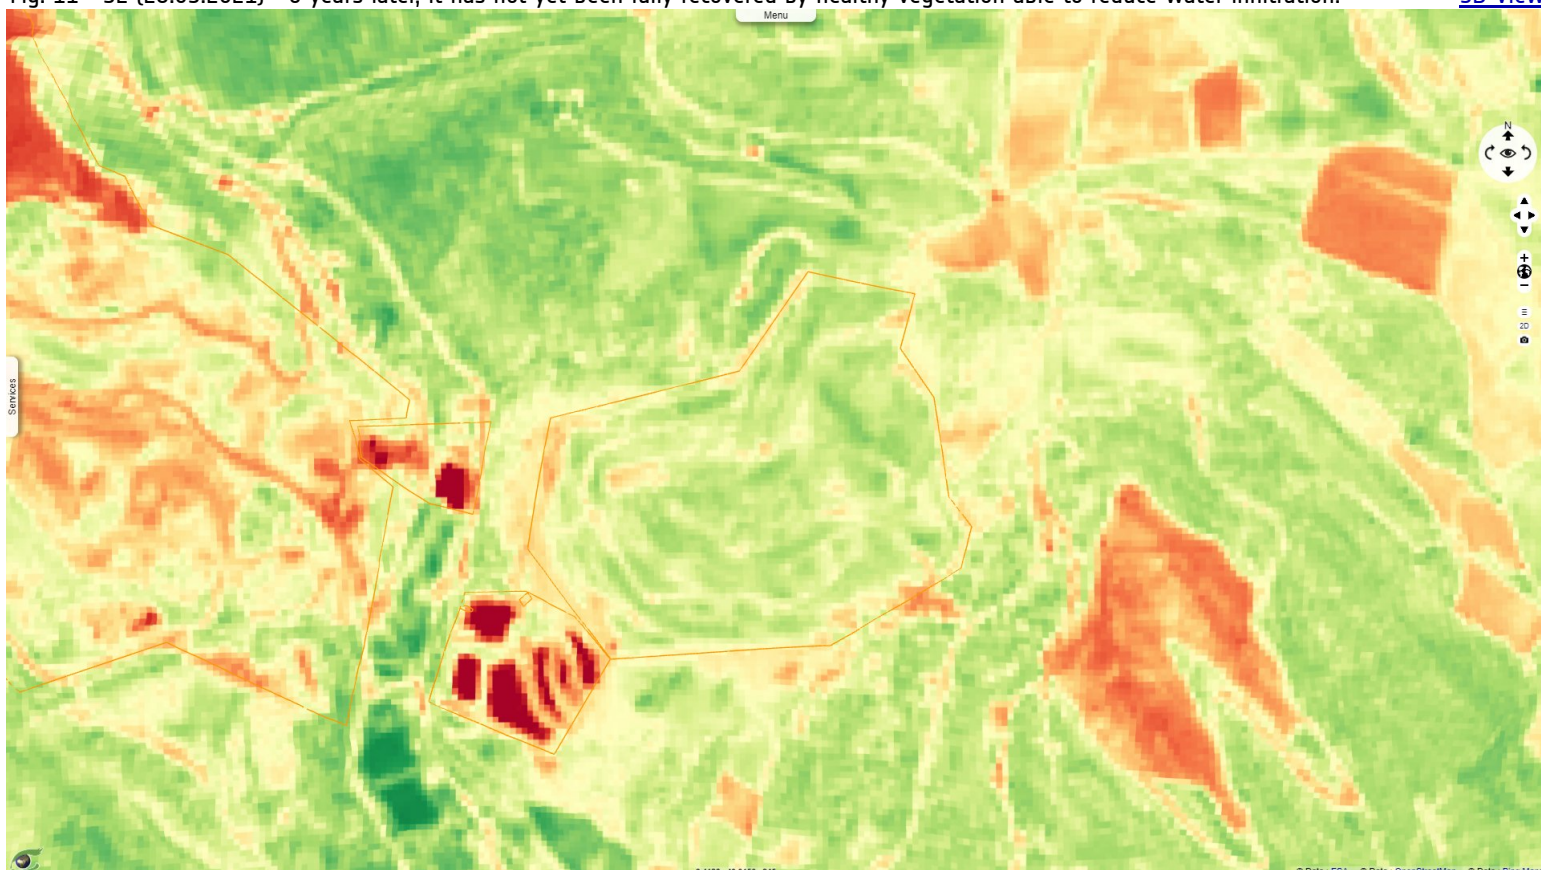
Fig. 11 - S2 (28.03.2021) - 6 years later, it has not yet been fully recovered by healthy vegetation able to reduce water infiltration.

The rehabilitation of the site has led to the creation of two large hills, the larger is known as Artus dam. SystExt [explains](#): "From 1989 to 1997, SNC Lastours installed a cyanidation unit on the Combe du Sault site to reprocess the residual gold from the tailings that had originally been stored there. The waste from this reprocessing, together with that produced in parallel by flotation, is stored in the Artus dam, for a total volume of 7 million cubic metres. This storage was made safe in 2004-2005 by modelling, placing a cover of clay and marl and then vegetating. As the Artus is not watertight, drains and 6 evaporation basins were installed at the foot of the dyke to recover the percolating water. This water represents a major environmental problem, as it constitutes 70% of the flow entering the water treatment plant."

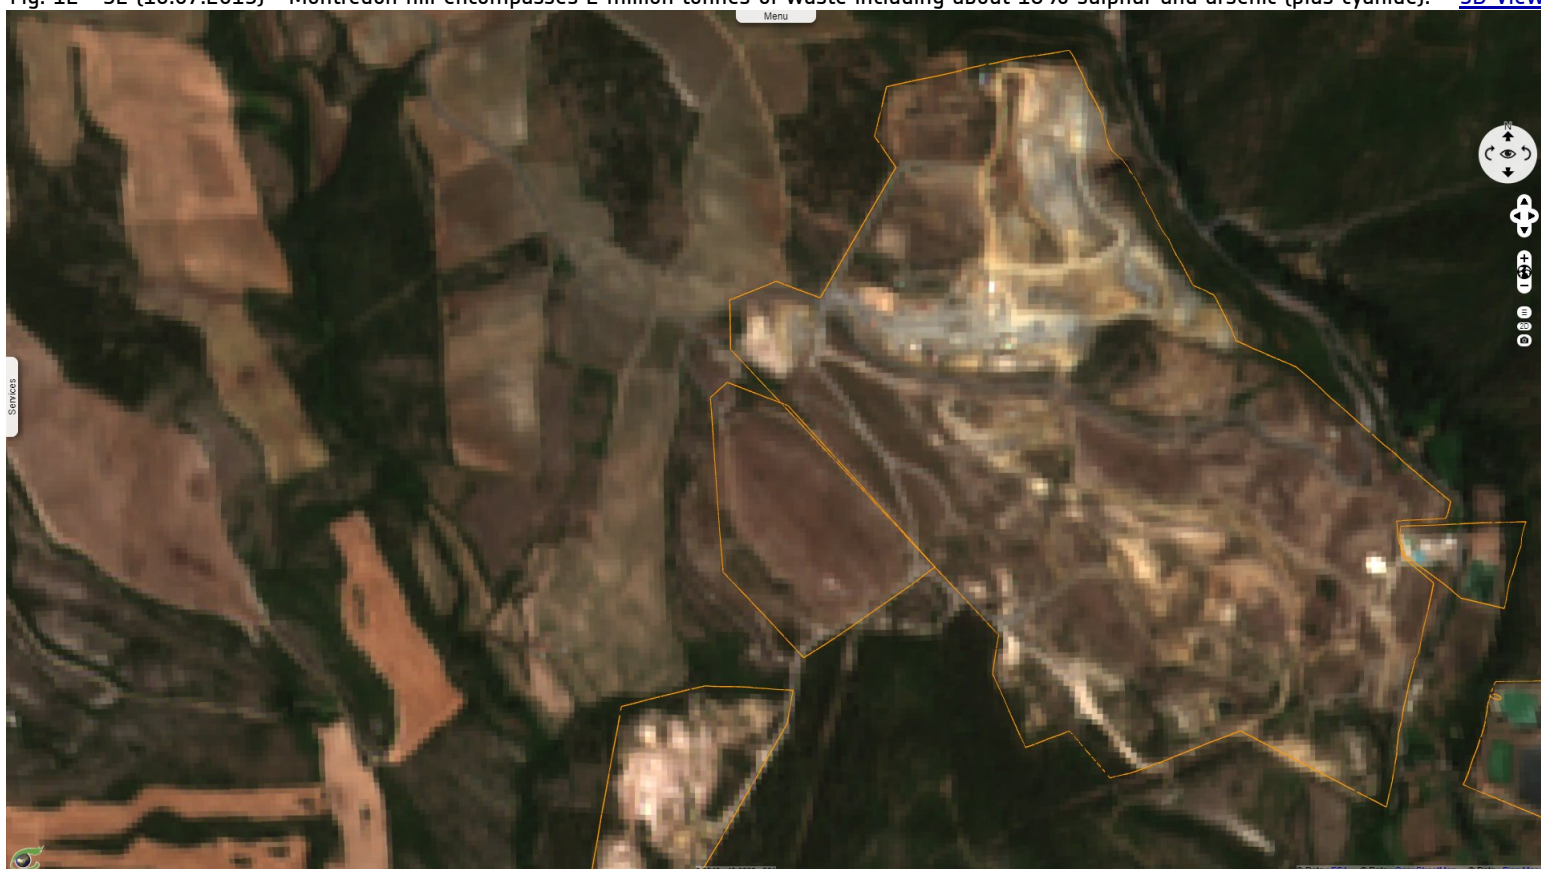
Fig. 12 - S2 (16.07.2015) - Montredon hill encompasses 2 million tonnes of waste including about 18% sulphur and arsenic (plus cyanide).

Its size has been increased since the study, this hill with arid vegetation located on the left bank of the Orbiel now hides ten million tons of polluted sand, 2% of which is arsenic. Quad bikes and 4x4s visit the Artus storage site, damaging its vegetation and reducing its protecting capabilities. SystExt [addresses](#) the topic of neighbouring Montredon hill: "In 1993, a new treatment unit was built, which residues filled the Montredon dam. When it was rehabilitated in 2004-2005, it was reinforced with 400 000 tonnes of 'low-concentration' tailings before storing an equivalent quantity of highly contaminated waste. This operation raises questions, even though signs of instability had been reported since 1997. The dam was secured in the same way as the Artus dam, but was confined at the base and surface by a geomembrane to ensure watertightness. Containing more than one million cubic metres of waste, Montredon has waterproofing defects and reinforcement work is underway. Costly earthworks and monitoring since the 1990s have not succeeded in reducing the geotechnical and environmental risks." More recent sources estimate Montredon dam encompasses 2 million tonnes of waste including about 18% sulphur and arsenic (plus cyanide inside).

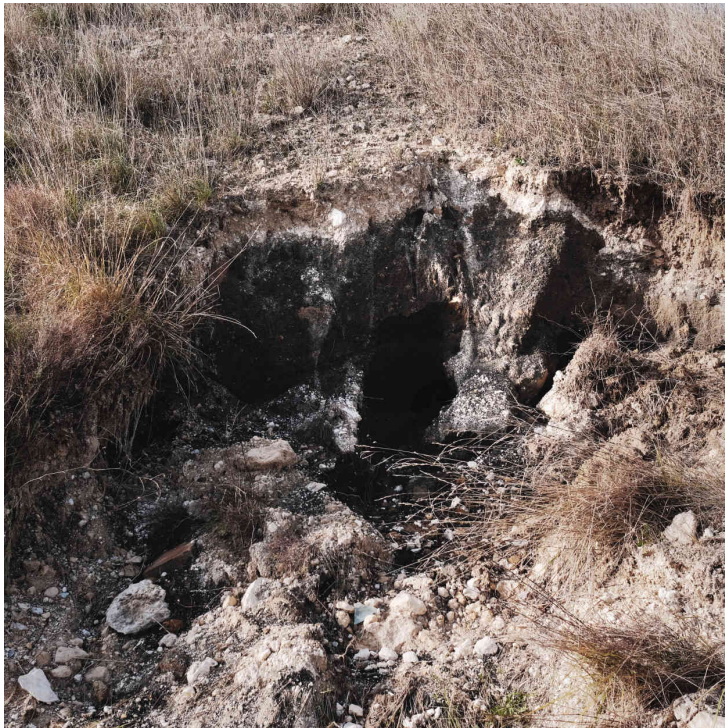
Left: "The Montredon storage area hidden under the hill is 27 metres high. In 1994 it was only 17 metres high. The work to raise it in 1999 was poorly done. As a result, the hill is collapsing in places, revealing, as here, holes through which arsenic-laden water is escaping - Source: [Guillaume Riviere](#) for Le Monde."

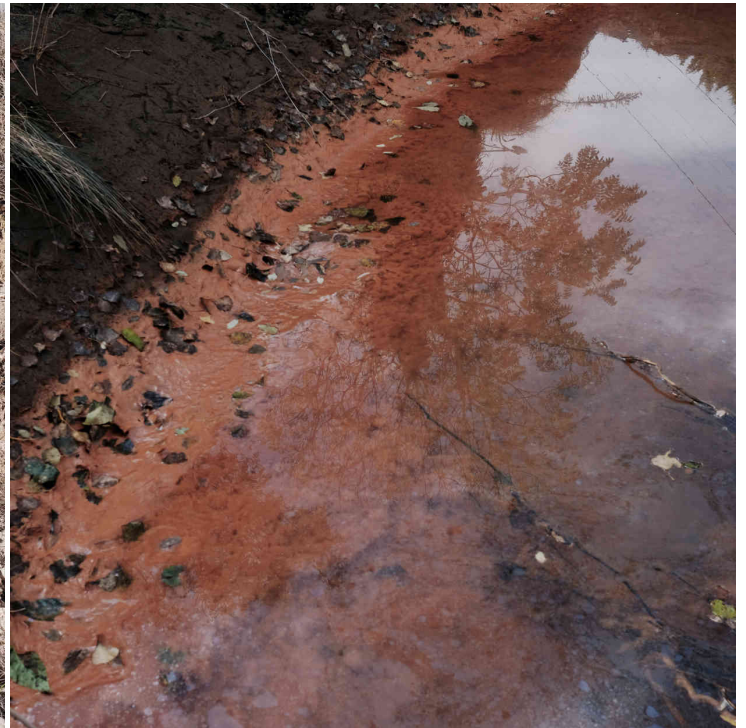
Right: "Some parts of the Orbiel, after the flood of 15 October, have taken on a rusty hue, reminiscent of the episode of the Sindilla channel. In 2013, this small watercourse parallel to the Orbiel and intended for irrigation suddenly turned red. The local residents had then asked for analyses. Results, according to the prefecture: 20 micrograms of arsenic per litre. The real results, revealed by 'Le Canard enchaîné': 4469 micrograms of arsenic per litre". This is 450 times higher than the WHO standard, wildlife does not sustain such levels. The poison came from a leak in the Montredon storage facility, two kilometres above. The prefect had to leave his post. - Source: [Guillaume Riviere](#) for Le Monde.

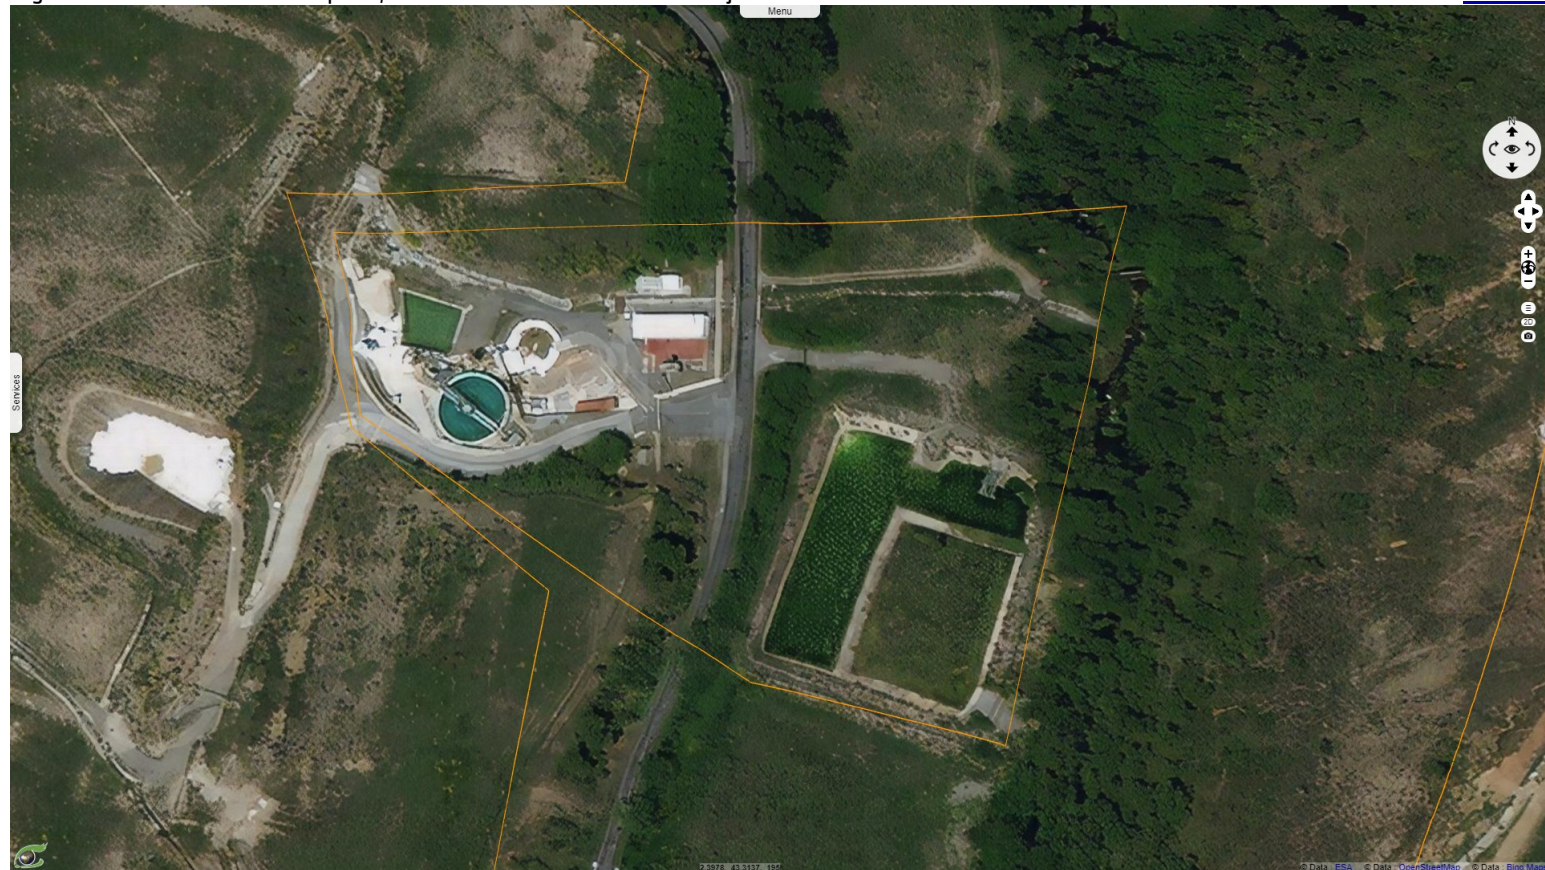
Fig. 14 - The water treatment plant, east of Combe du Sault site and just above the Grésillou.

The SystExt report finally [focuses](#) on the water treatment plant: it is "supplied with arsenic-contaminated water from: the Montredon dam, the ADEME containment (Combe du Sault), the 'Point V' spring, and the Artus dam. The treatment consists of precipitating the arsenic by adding lime. The lime arsenate sludge resulting from this operation is packaged in big bags and stored in a cell. The latter is left in the open air and is already full, causing concern to associations and local residents. As for the residual water from this treatment, it is sent to an infiltration lagoon. At this point, despite the treatment, arsenic concentrations remain very high, at around  $1100\mu\text{g/l}$ , but 15 times less than what it is before the big bags. "This water then infiltrates the soil and flows into the Orbiel. The station, now managed by the BRGM, was not intended to last but is still in operation in the absence of an alternative solution." It is estimated only 20% of the contaminated water is processed through the treatment plant.

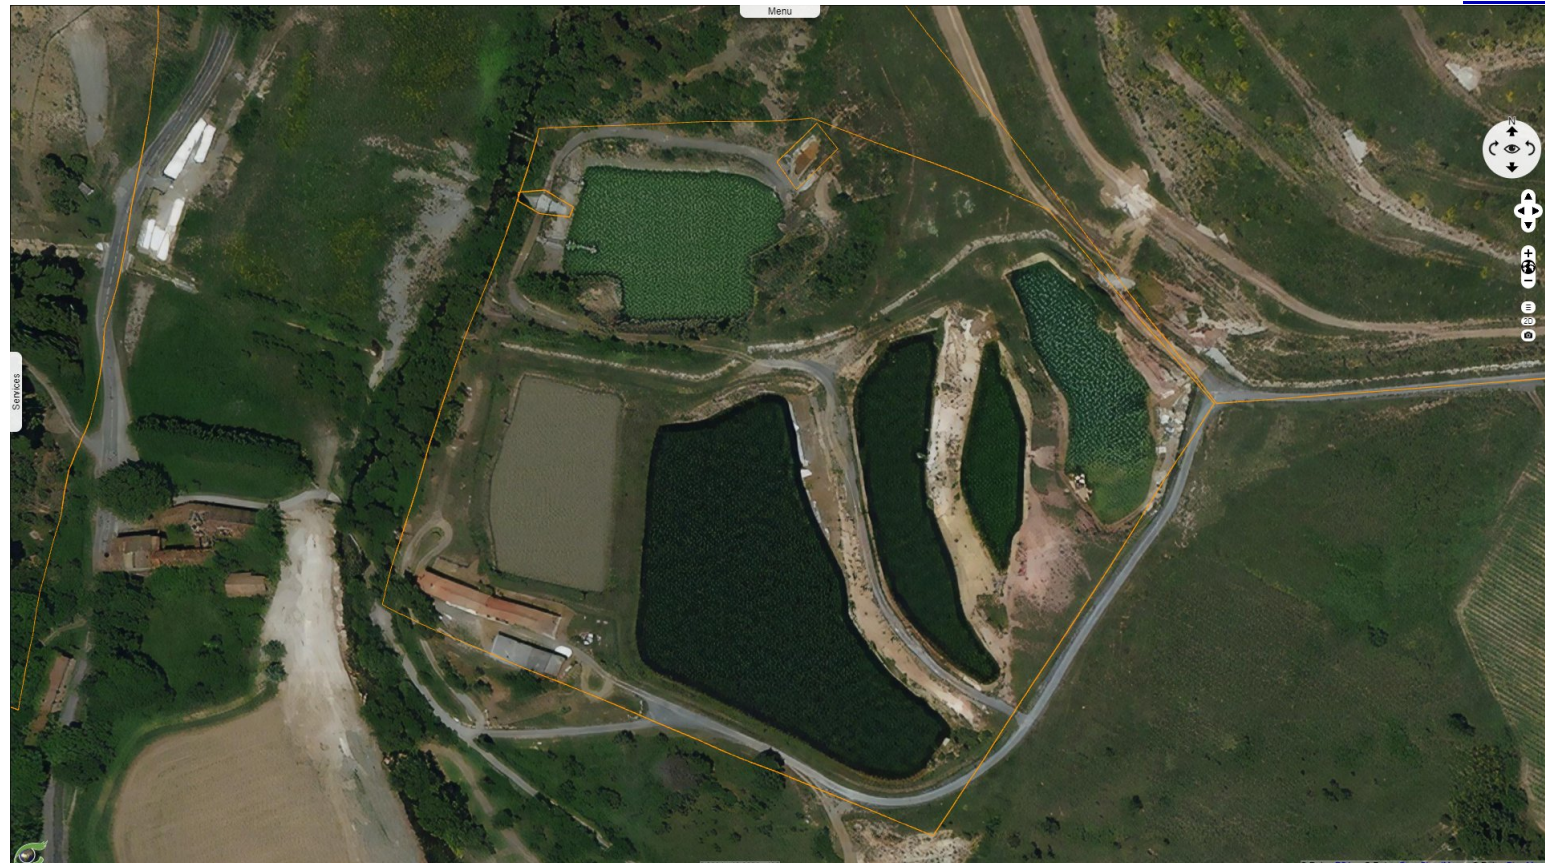
Fig. 15 - The filtration basins. The orange spot at east shows infiltrations from non watertight Artus hill. At north-west, the white trace shows arsenic overflow right into the Grésillou

The study of the Geological Society of France [adds](#): "The pollution of the Grésillou is partly due to the former Nartau mine, but mainly due to the discharge of water from the mine. In the Combe du Saut, the pollution is mainly linked to heavy rainfall. In the Ru sec (high water), the pollution

comes mainly from runoff from the old mines and the associated metallurgical districts of Malabau, and to a lesser extent from Gourg Peyris." Runoff transports a large quantity of arsenic to the Orbiel River: 1300 kg/year on average and 1260 kg of arsenic during the storm of 1999 alone.

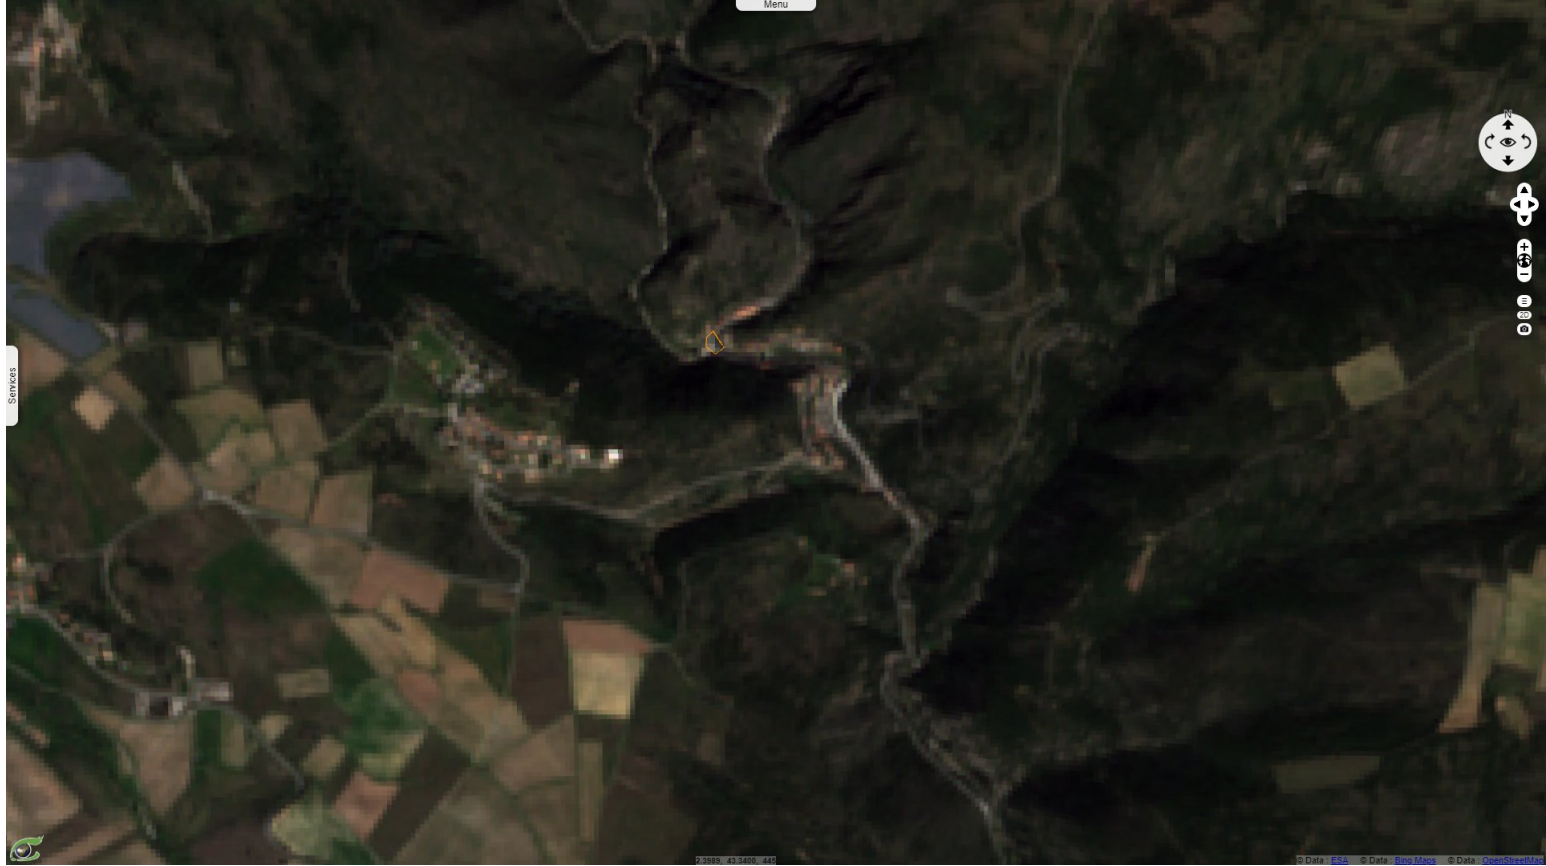
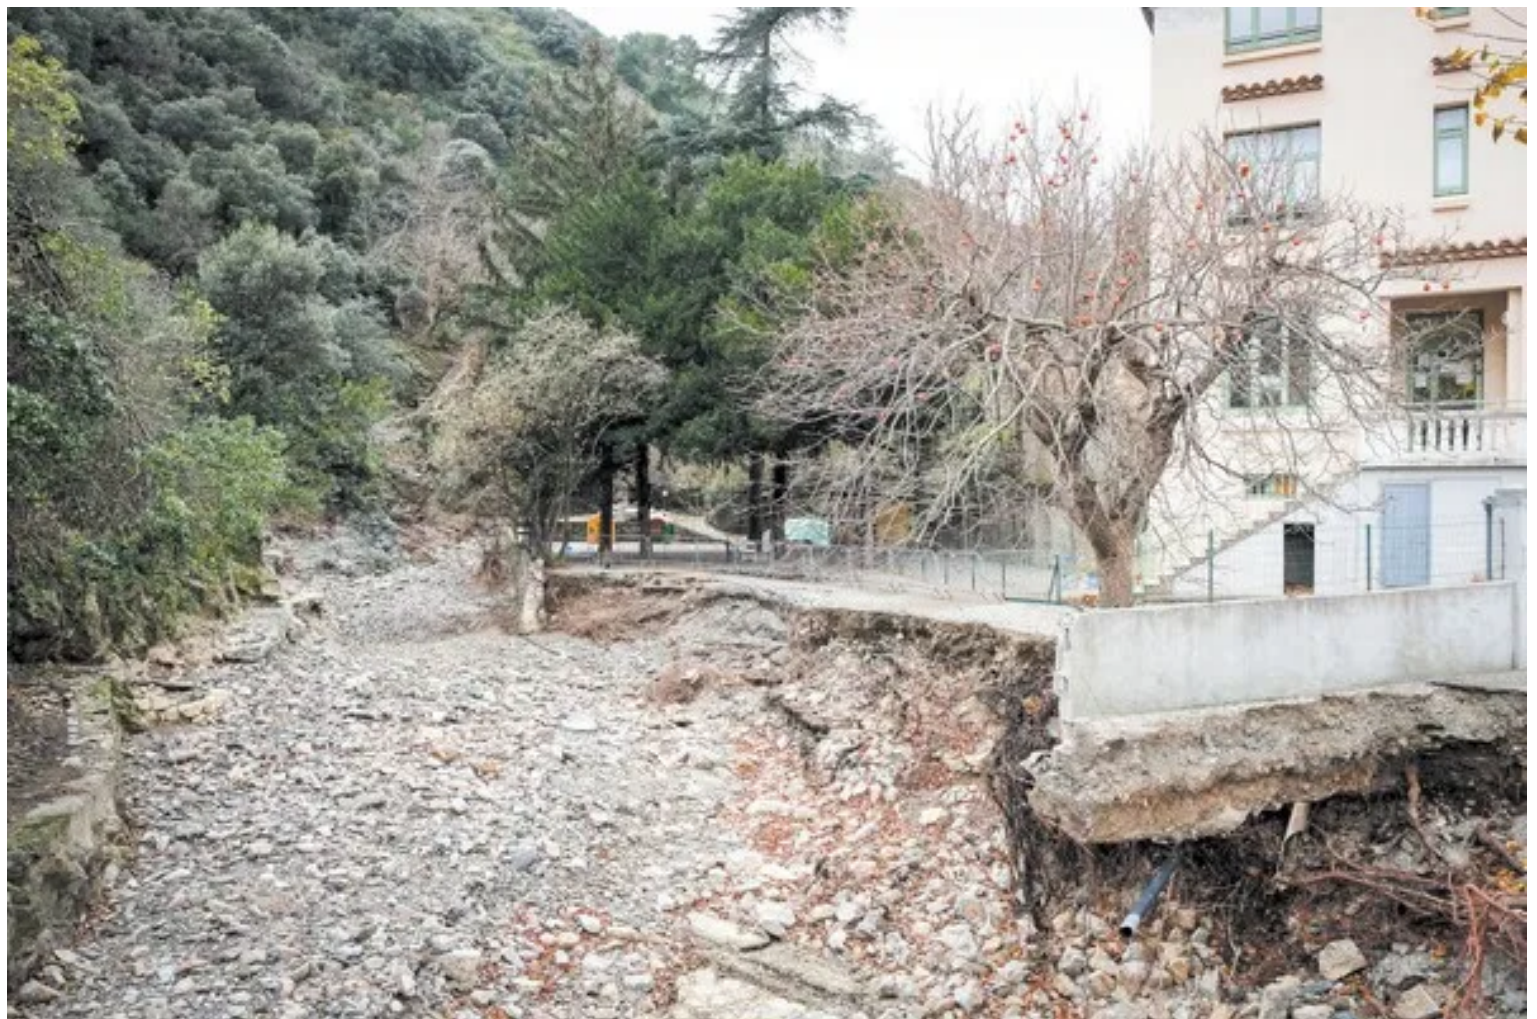
Fig. 16 - S2 (28.03.2021) - Lastours schoolyard lied at the confluent of Orbiel & Grésillou rivers until the 2018 flood and its arsenic pollution. [3D View](#)

The region is prone to catastrophic rainfalls such as on 14-15 February 2017. The schoolyard of Lastours was washed away by the flood of 15 October 2018. Sediments full of arsenic were deposited there. The levels in arsenic are five times that or the WHO recommendations. Many schoolchildren were poisoned. - Source: [Olivier Saint-Hilaire](#).
