# Optima empty reservoir Lake, Oklahoma, USA

Sentinel-2 MSI acquired on 25 February 2019 at 17:33:11 UTC  
Sentinel-2 MSI acquired on 05 September 2019 at 17:18:59 UTC

Author(s): Sentinel Vision team, VisioTerra, France - [svp@visioterra.fr](mailto:svp@visioterra.fr)

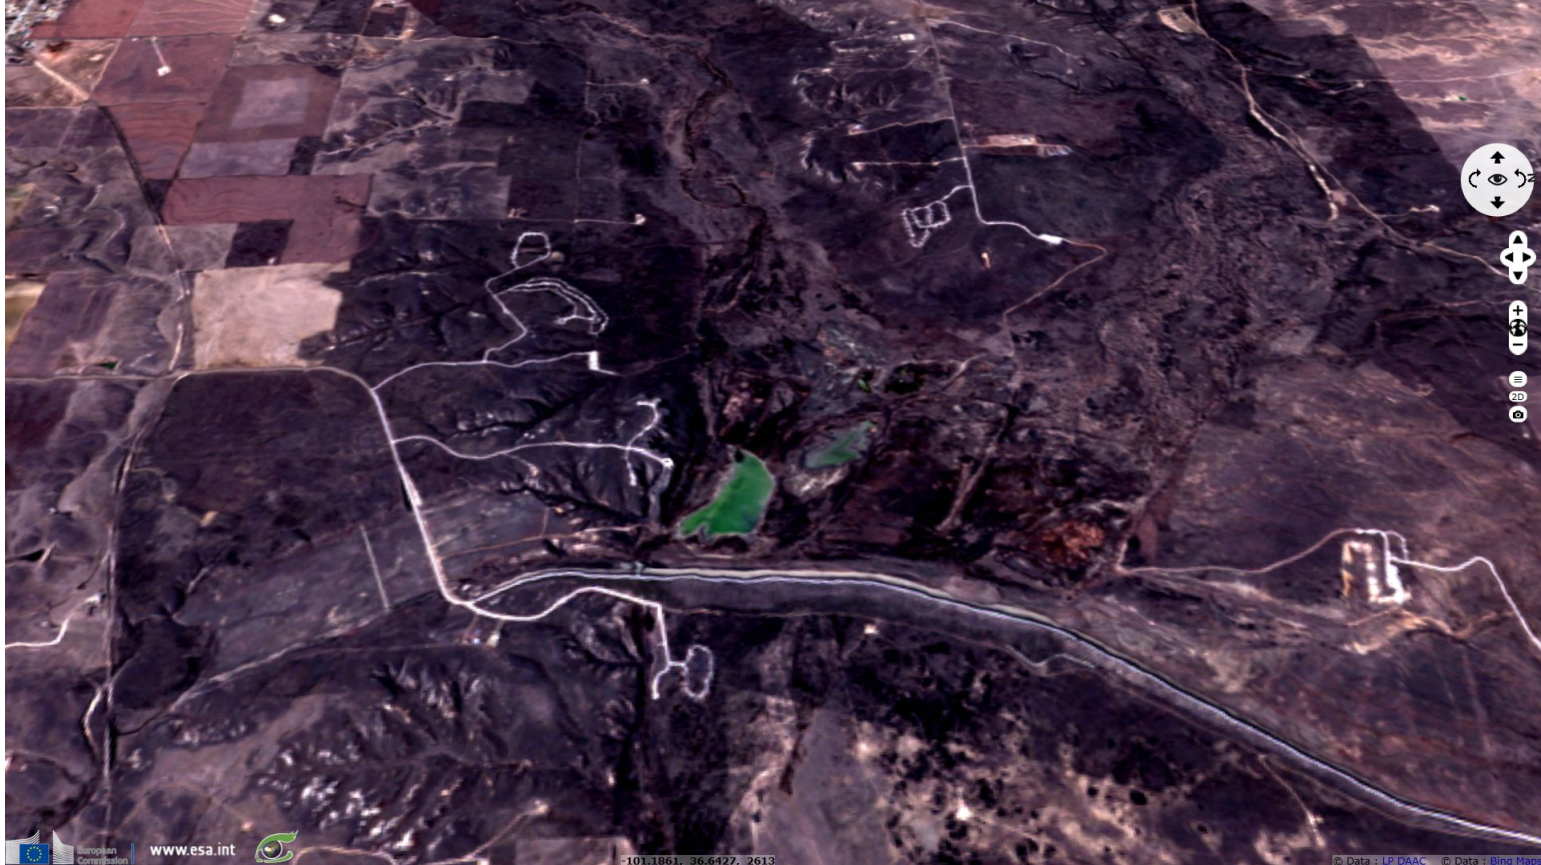
Fig. 1 - S2 (25.02.2019) - 4,3,2 natural, relief x3 - Building Optima dam took \$50 million & 10 years of planning & construction. [2D view](#) [3D view](#)

Decided after decades of debate, it should have provide flood control, supply drinking water and attract millions of campers, water skiers & anglers.

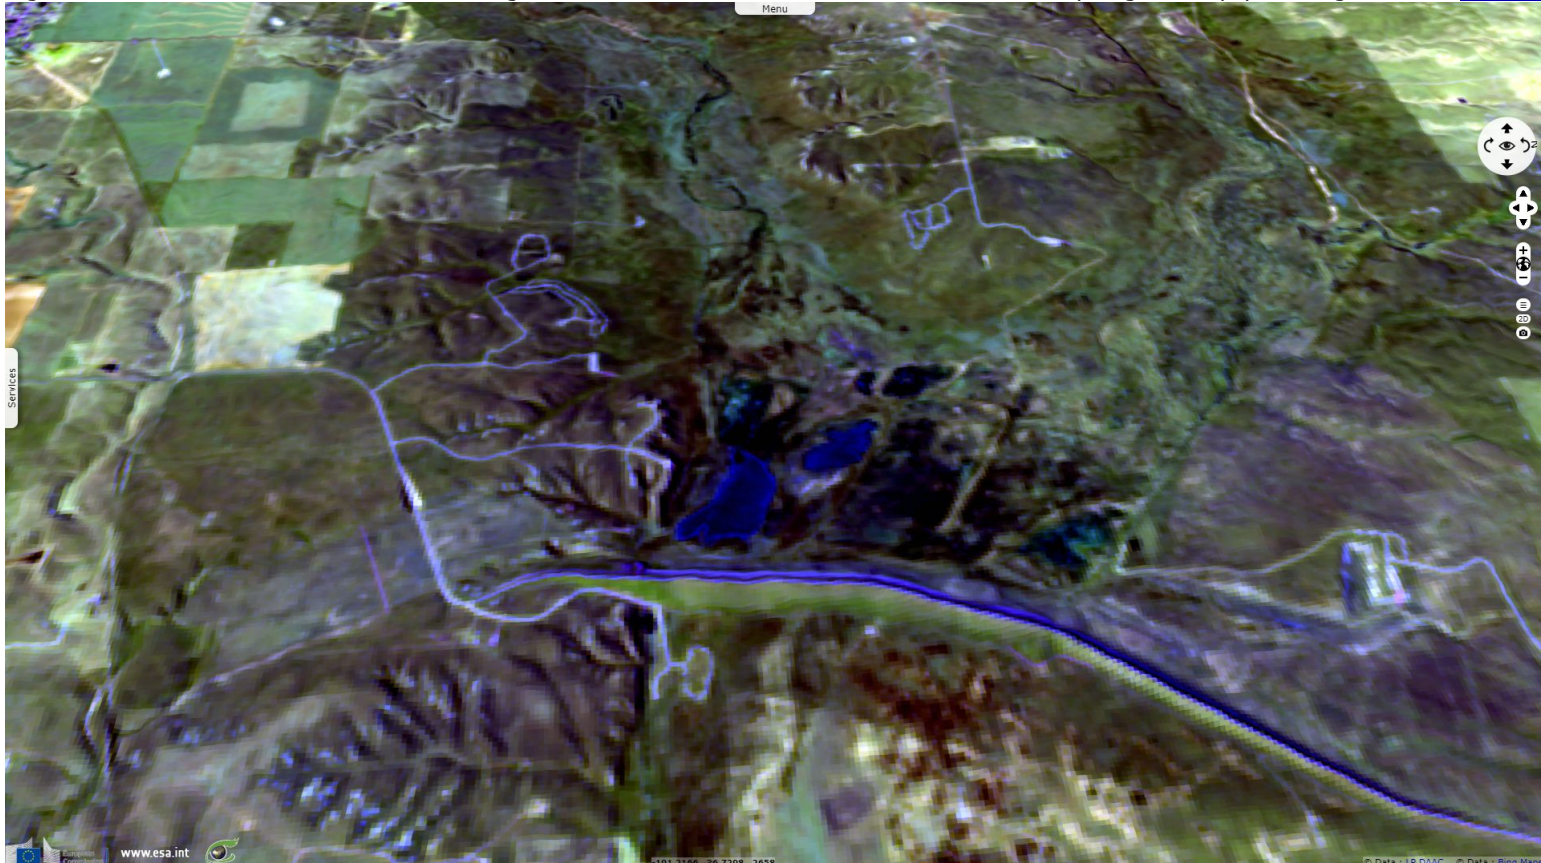
Fig. 2 - 12,11,2 - In-between, Beaver river average flow fell from 0.87 to 0.19 m<sup>3</sup>/s due to increased crop irrigation & population growth. [3D view](#)

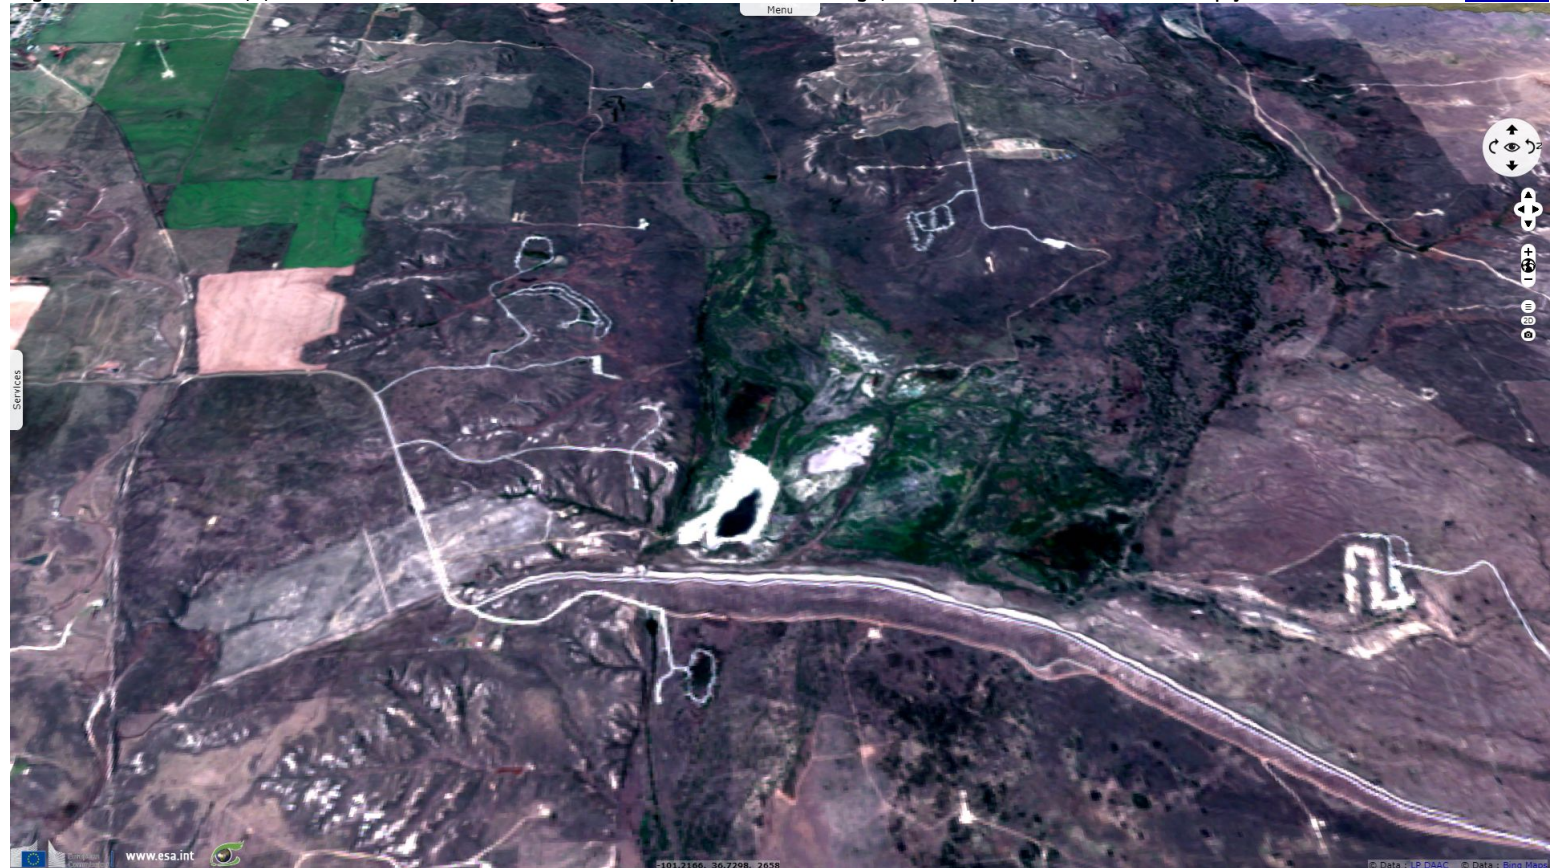
Fig. 3 - 05.09.2019 - 4,3,2 natural colour - What's left of Lake Optima now is a large, muddy puddle about 15 cm deep just below the dam. [3D view](#)

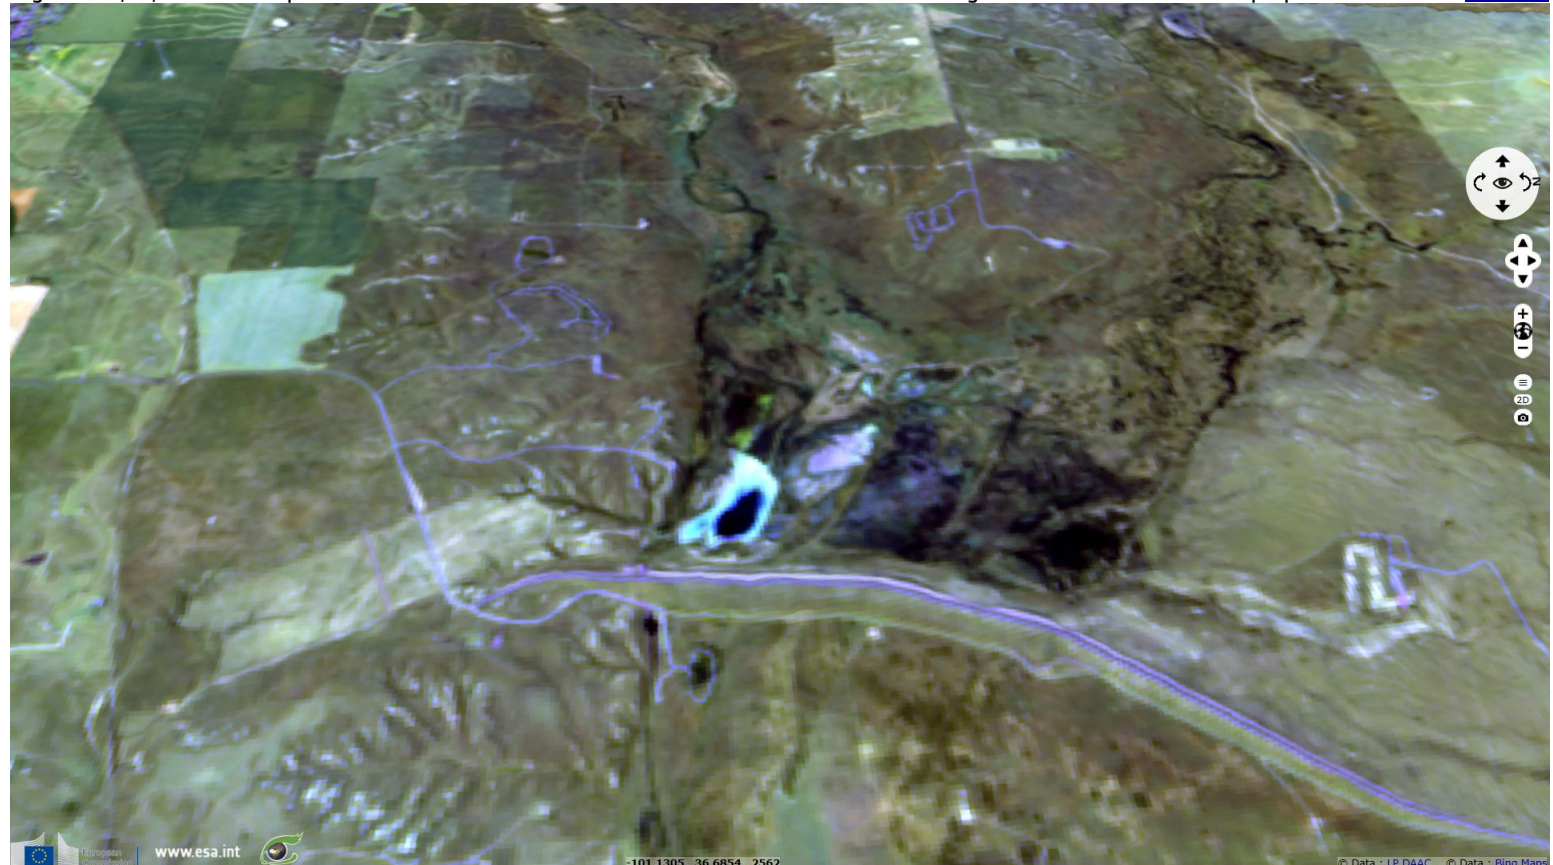
Fig. 4 - 12,11,2 colour composite - The result is a massive 5 km earthen dam & flood control gate that serves almost no purpose. [3D view](#)
