Deadly floods at NW of Lake Tanganyika, DRC, Burundi

Author(s): Sentinel Vision team, VisioTerra, France - svp@visioterra.fr

EVT-655-SentinelVision

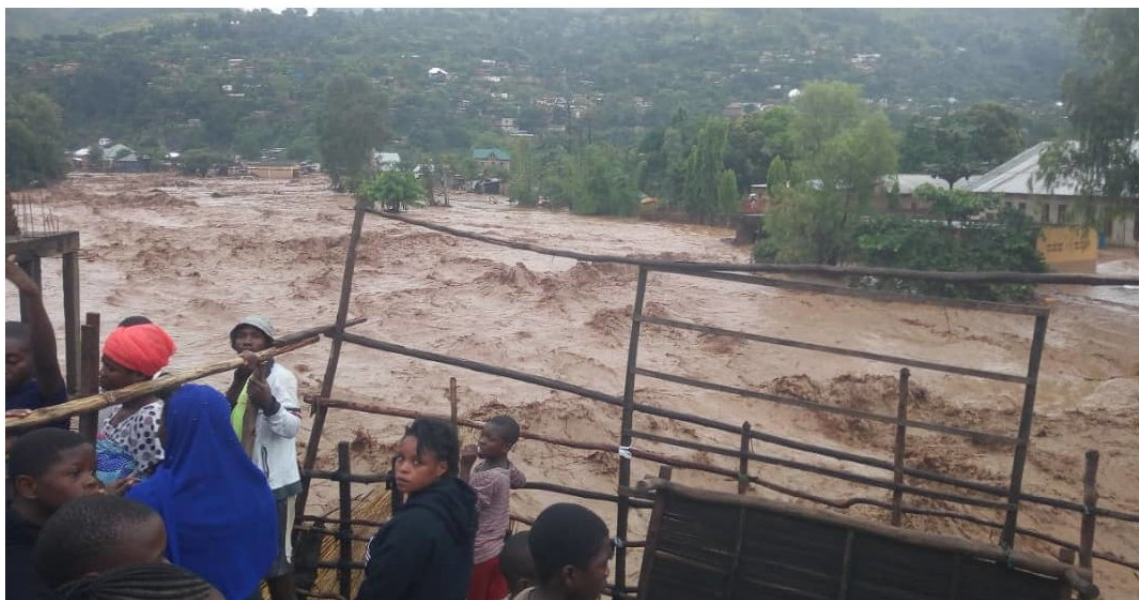
Mulungwe river during its flooding in Uvira, 18 April 2020 – Source: Fidele Kasangandjo Mwagalwa.

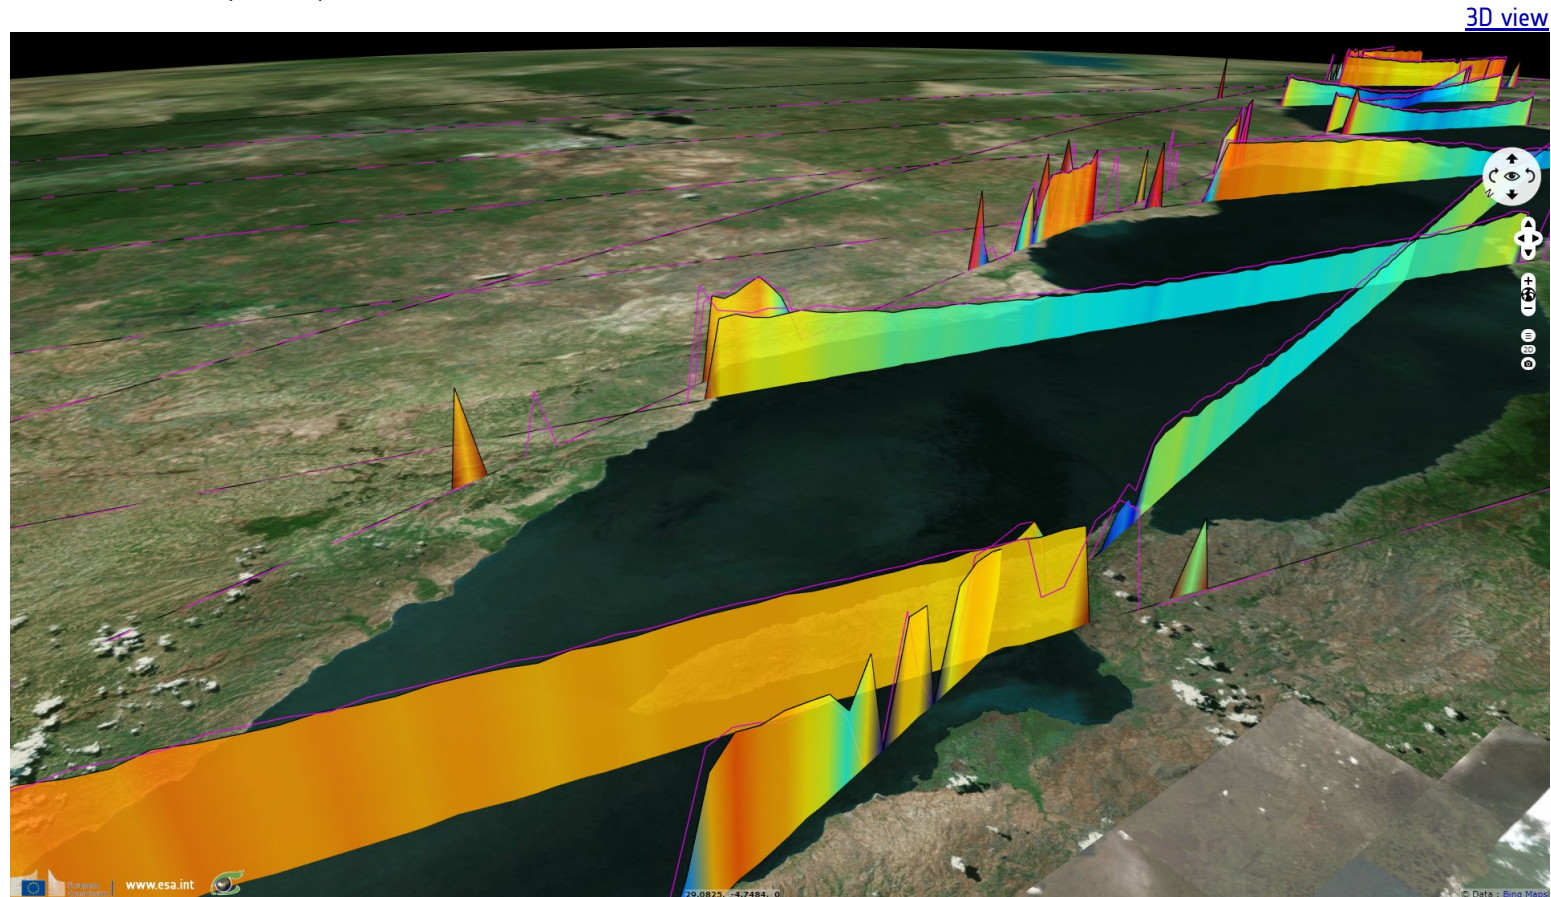
Fig. 2 - SRAL - Height 20Hz Ku-band – The height of Lake Tanganyika between 16 March & 04 April 2020 (rainbow filling) is near-continually below that measured 27 days later (pink line).

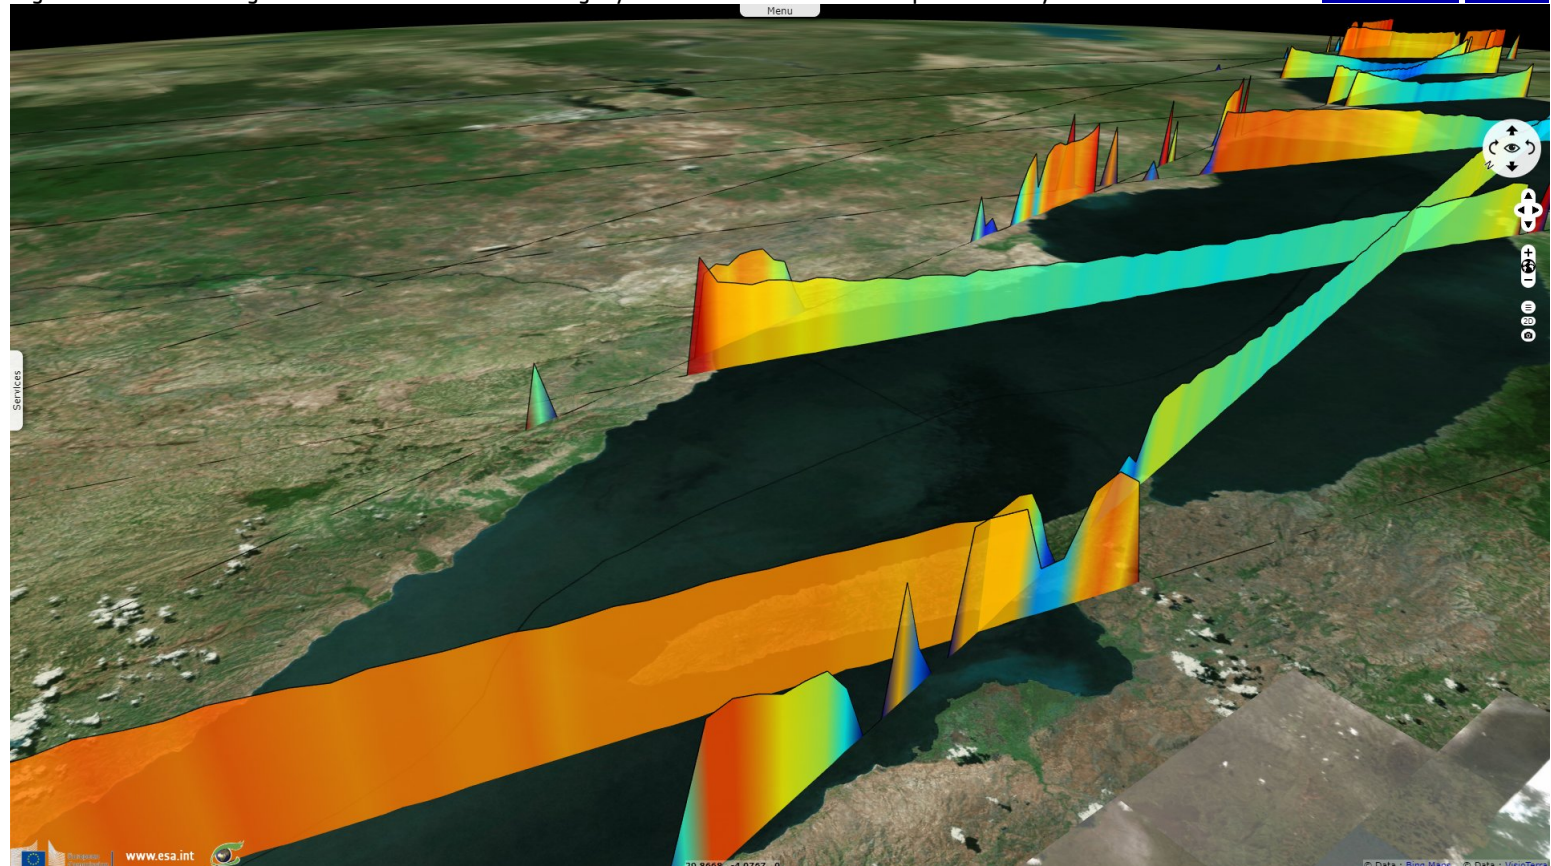
Fig. 3 - SRAL - The height of the surface of Lake Tanganyika measured between 12 April & 01 May 2020.

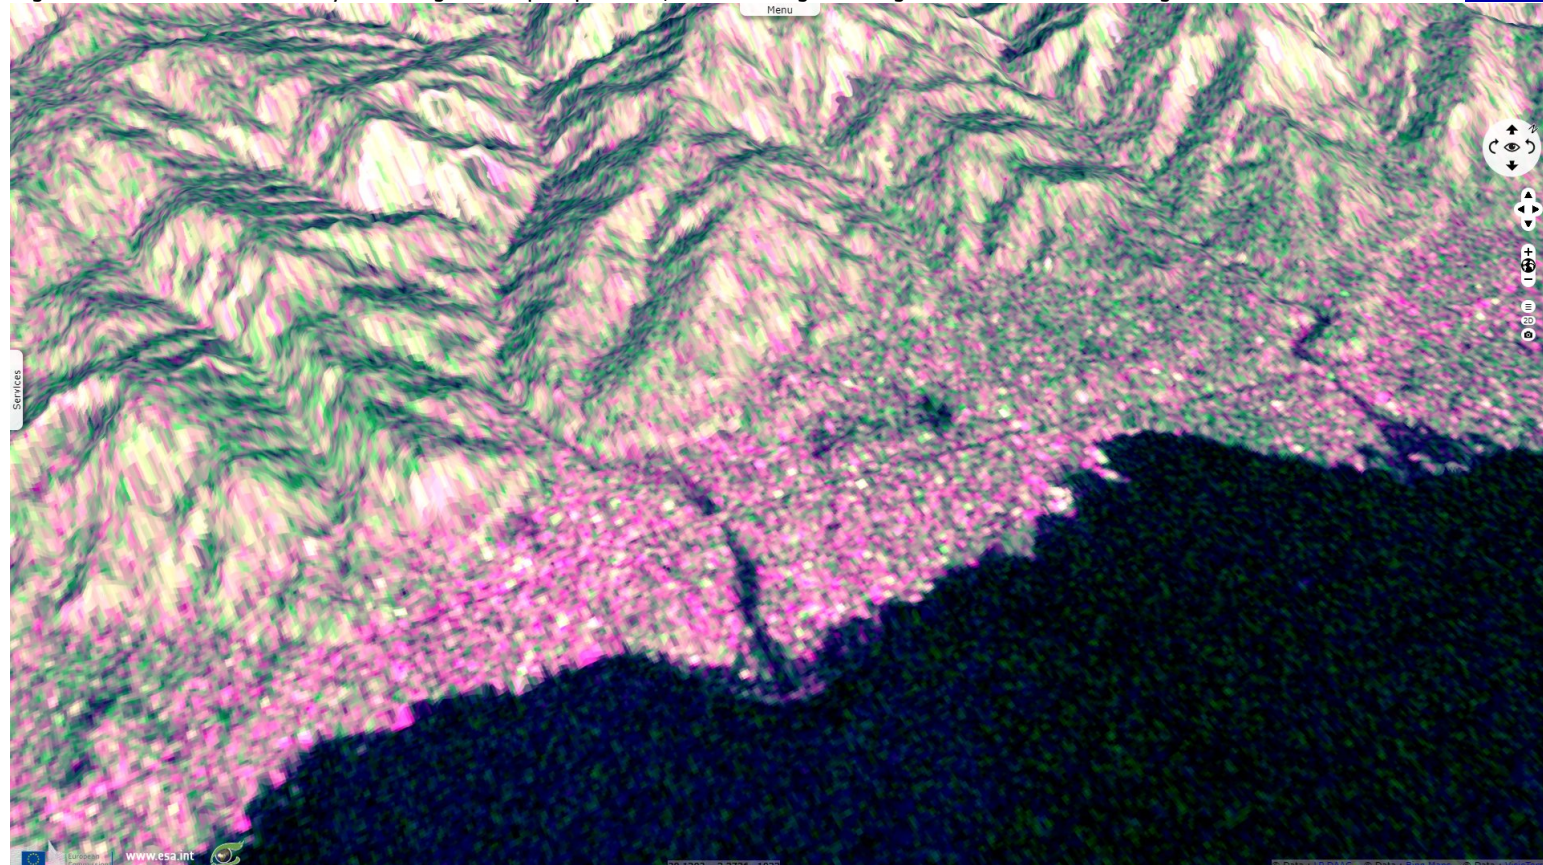
Fig. 5 - S1 (20.04.2020) – 3 days after significant precipitations, River Mulongwe (foreground) & Kavimvira (background) overflowed their bed. [3D view](#)

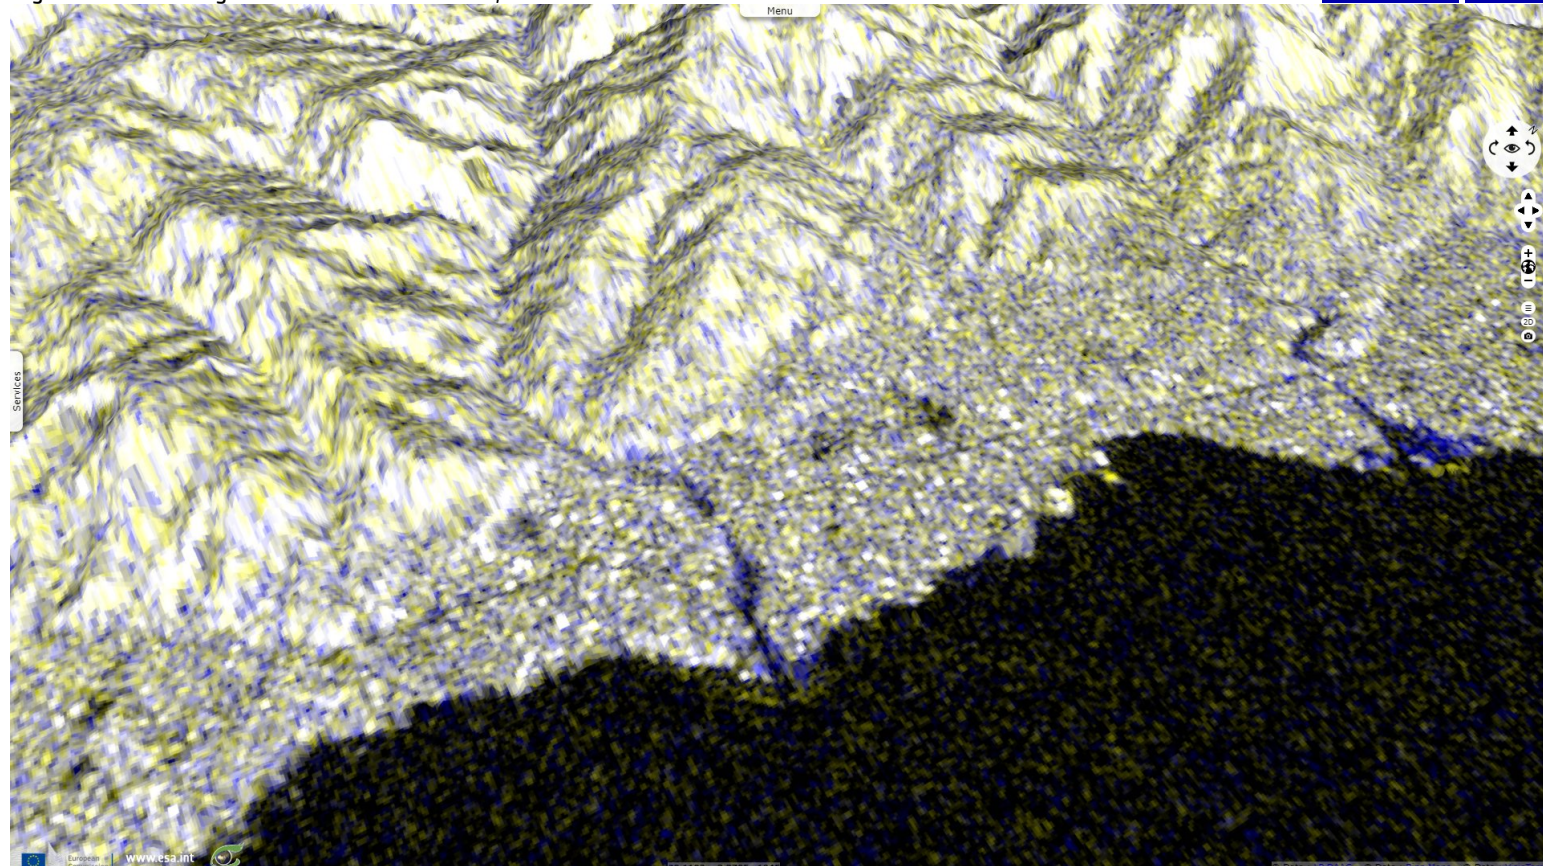
Fig. 6 - S1 – red & green channels: 20.04.2020, blue channel: 08.04.2020 – The flooded areas show in blue. [3D animation](#) [3D view](#)

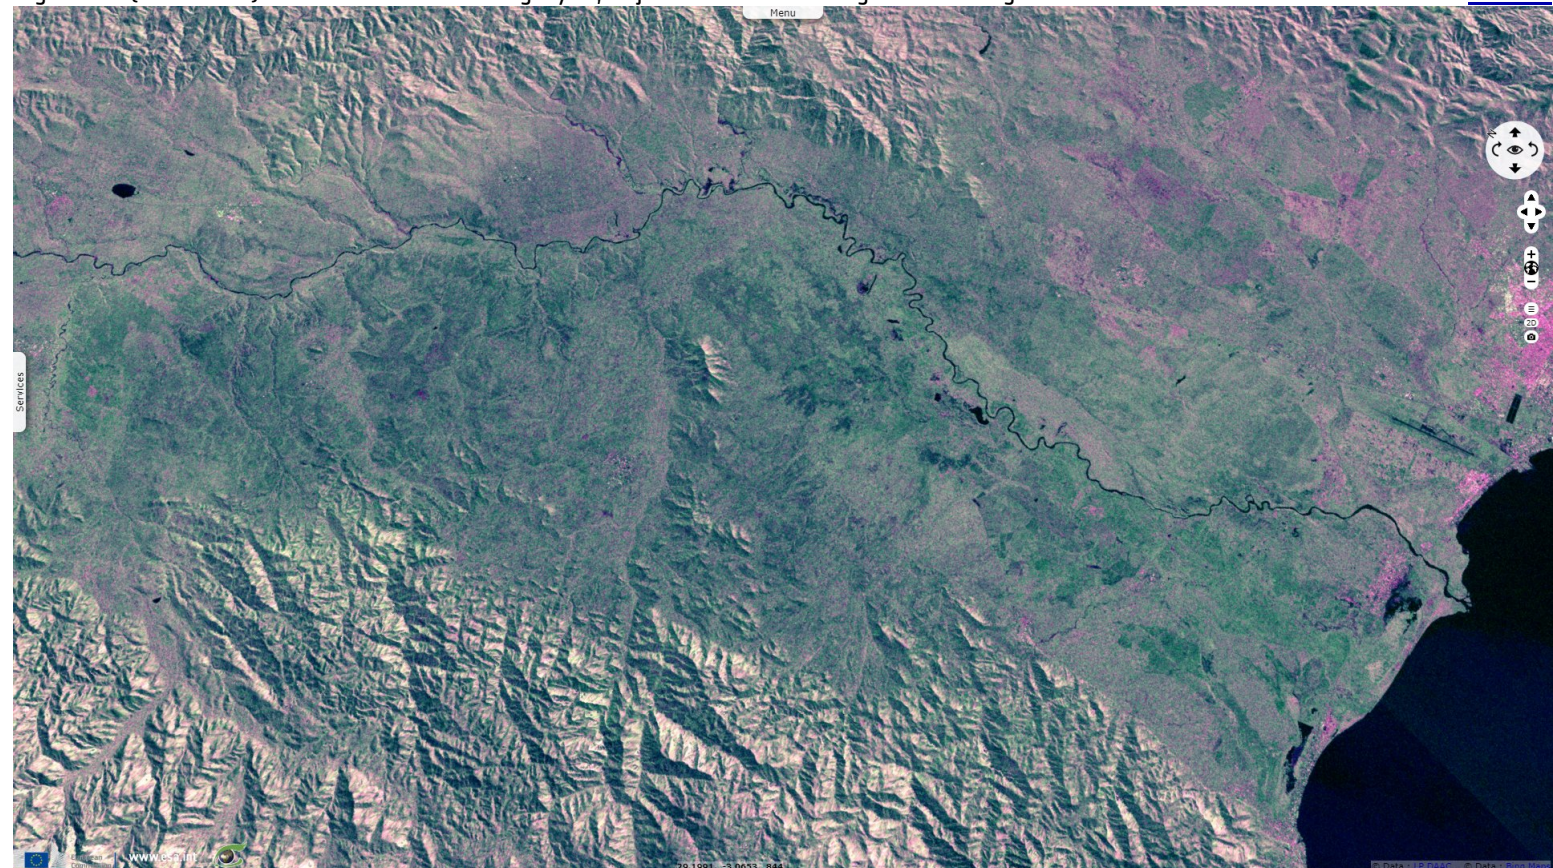
Fig. 7 - S1 (08.04.2020) – Area north of Lake Tanganyika, Bujumbura lies on the right of the image.

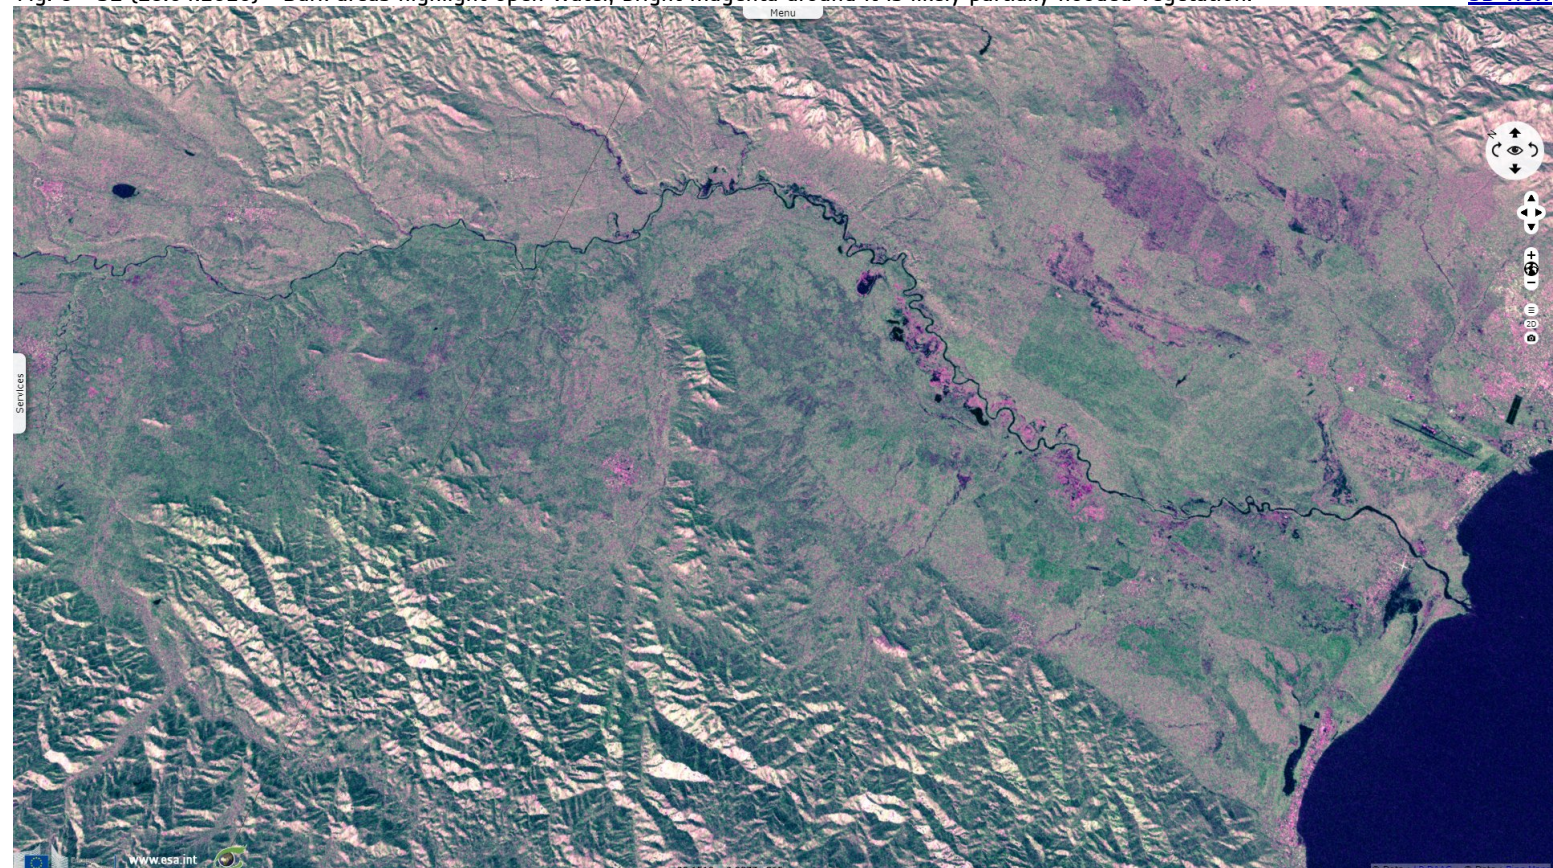
Fig. 8 - S1 (18.04.2020) - Dark areas highlight open water, bright magenta around it is likely partially flooded vegetation.

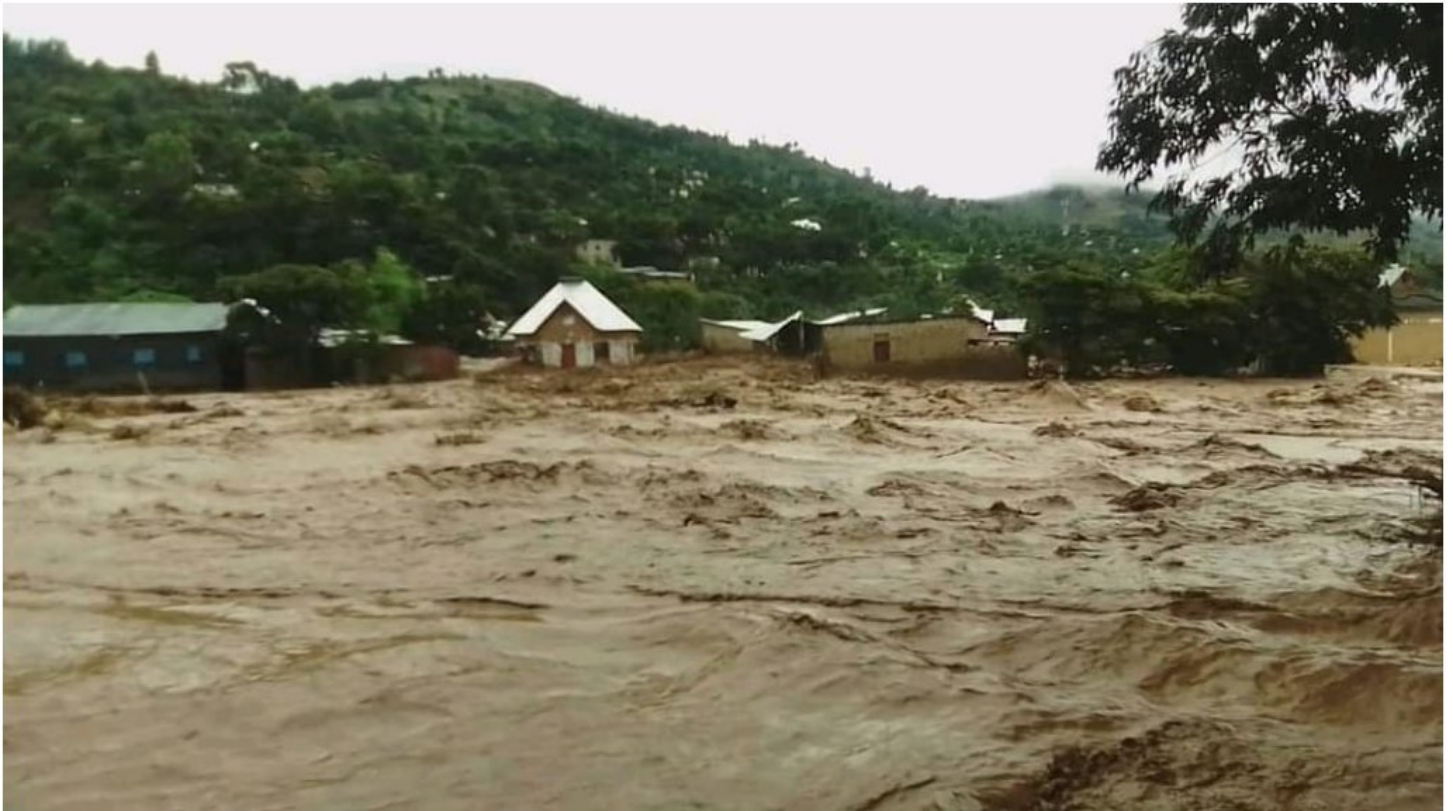
The Mulongwe flooding damaged and destroyed houses and buildings near the river bed in Uvira, 18 April 2020 – Source: Fidele Kasangandjo.

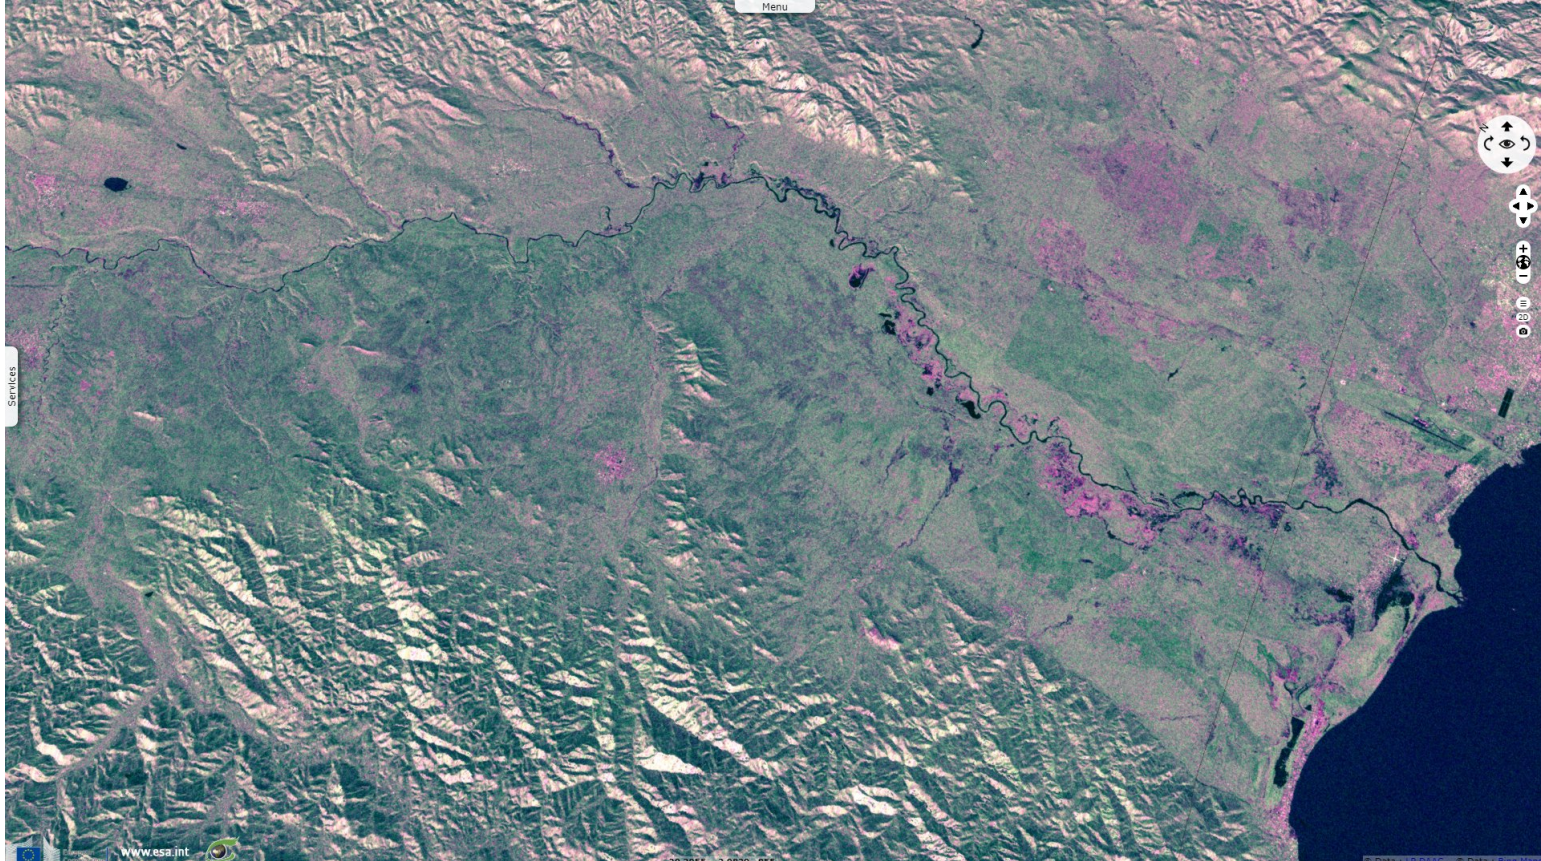
Fig. 9 - S1 (24.04.2020) - Excess water flows downstream of the Rusizi river, and leaves the flooded crops north of Bujumbura.

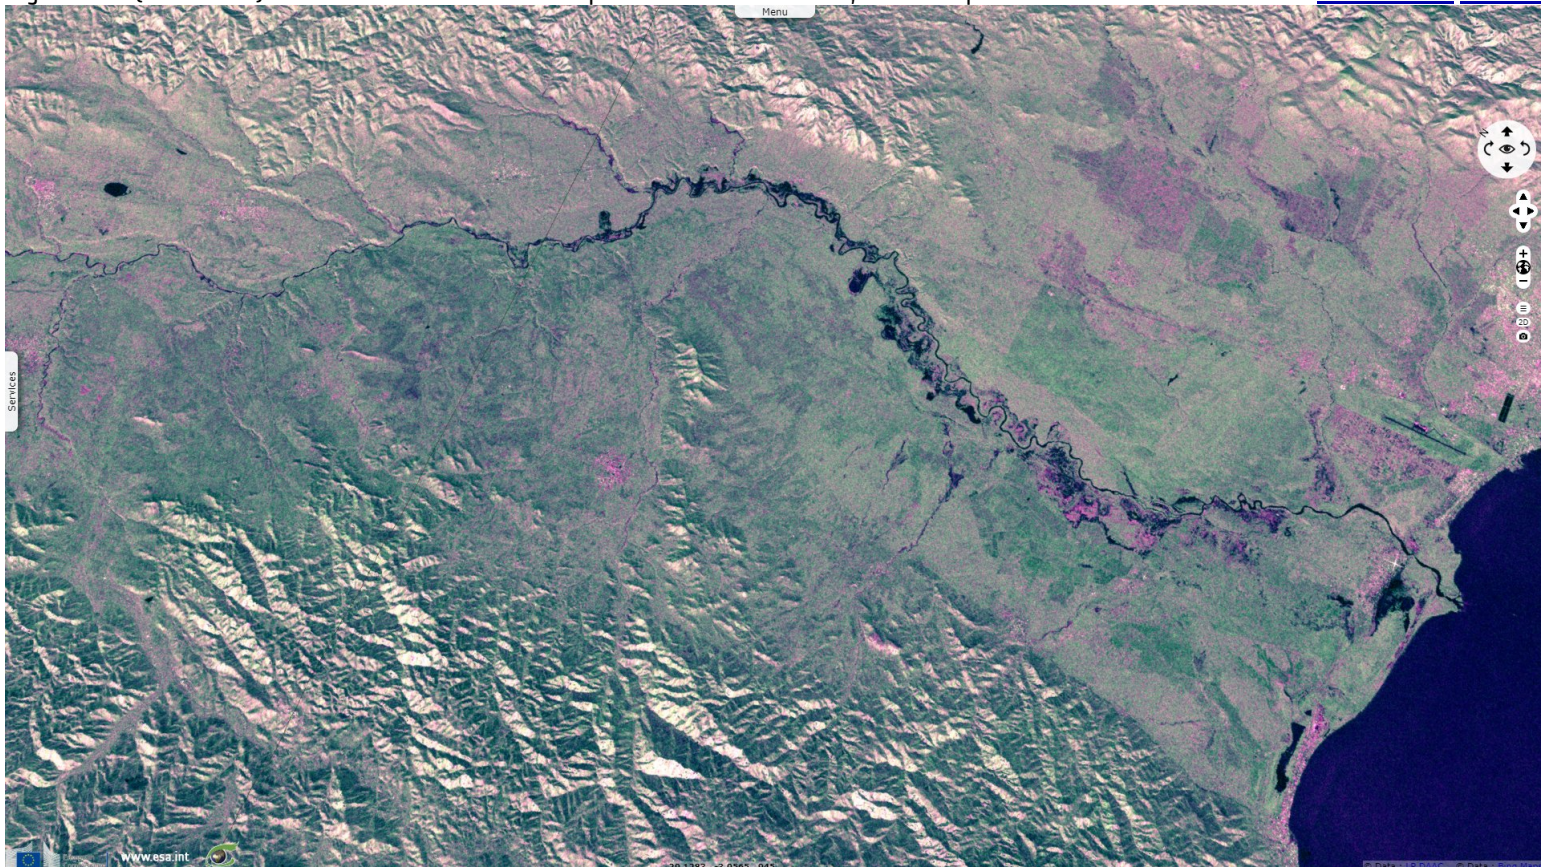
Fig. 10 - S1 (30.04.2020) - The situation worsens both upstream and downstream, as more open water is visible.

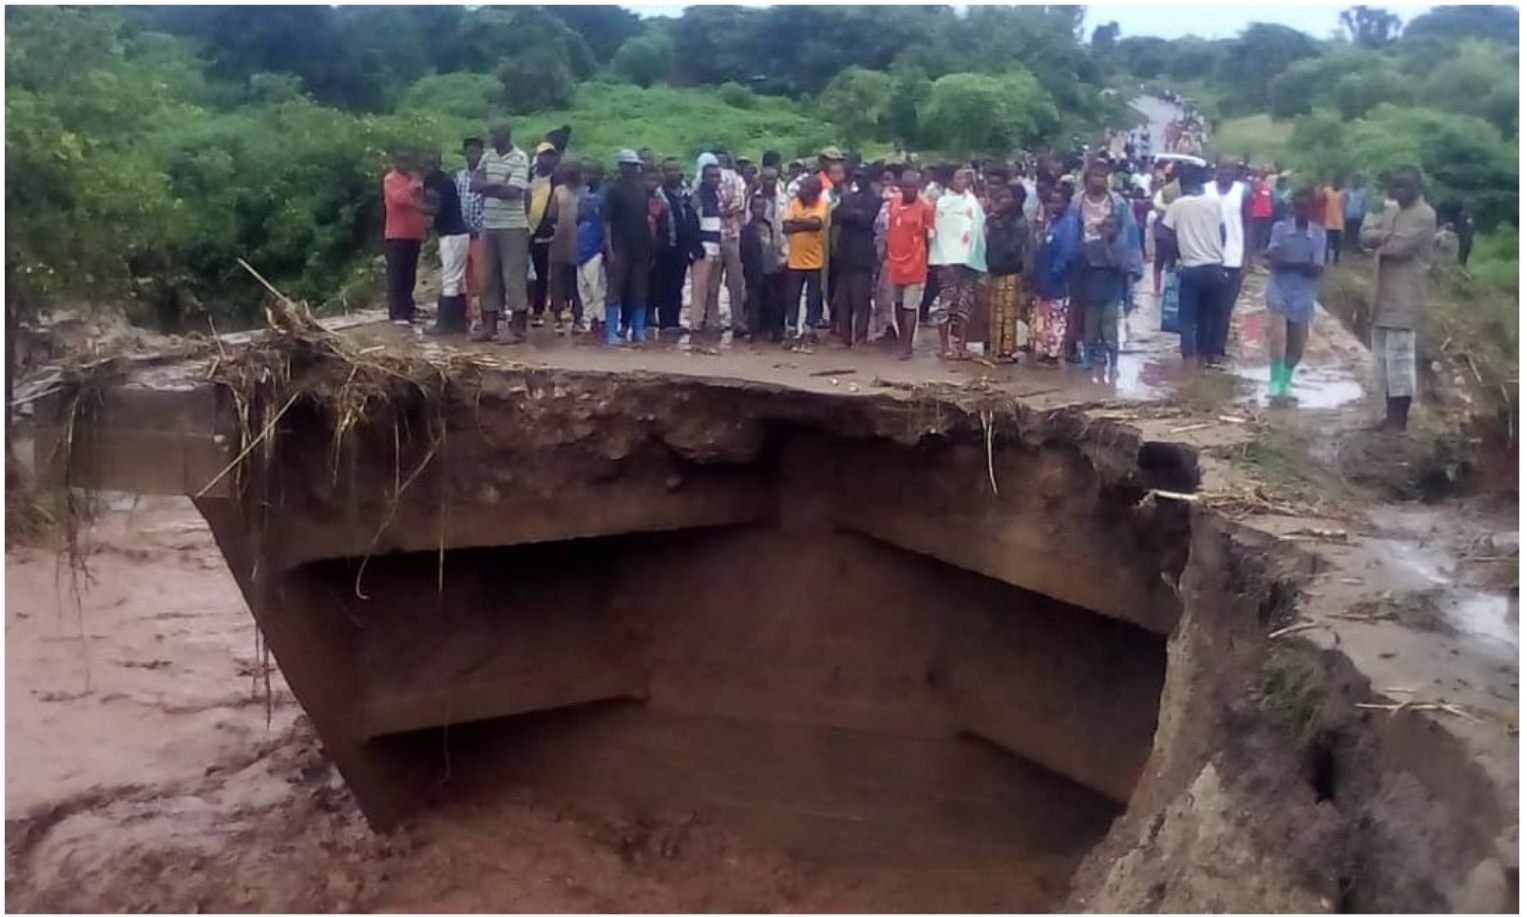
The might of the river damaged or destroyed 7 bridges in Uvira, 18 April 2020 – Source: Fidele Kasangandjo.

The subsequent flooding caused extensive property damage. Provincial Governor Theo Kassi reported that, as at 17 April, at least 3500 houses had been destroyed. MONUSCO reported that 15 000 houses had been damaged or destroyed and 7 bridges damaged or completely collapsed."

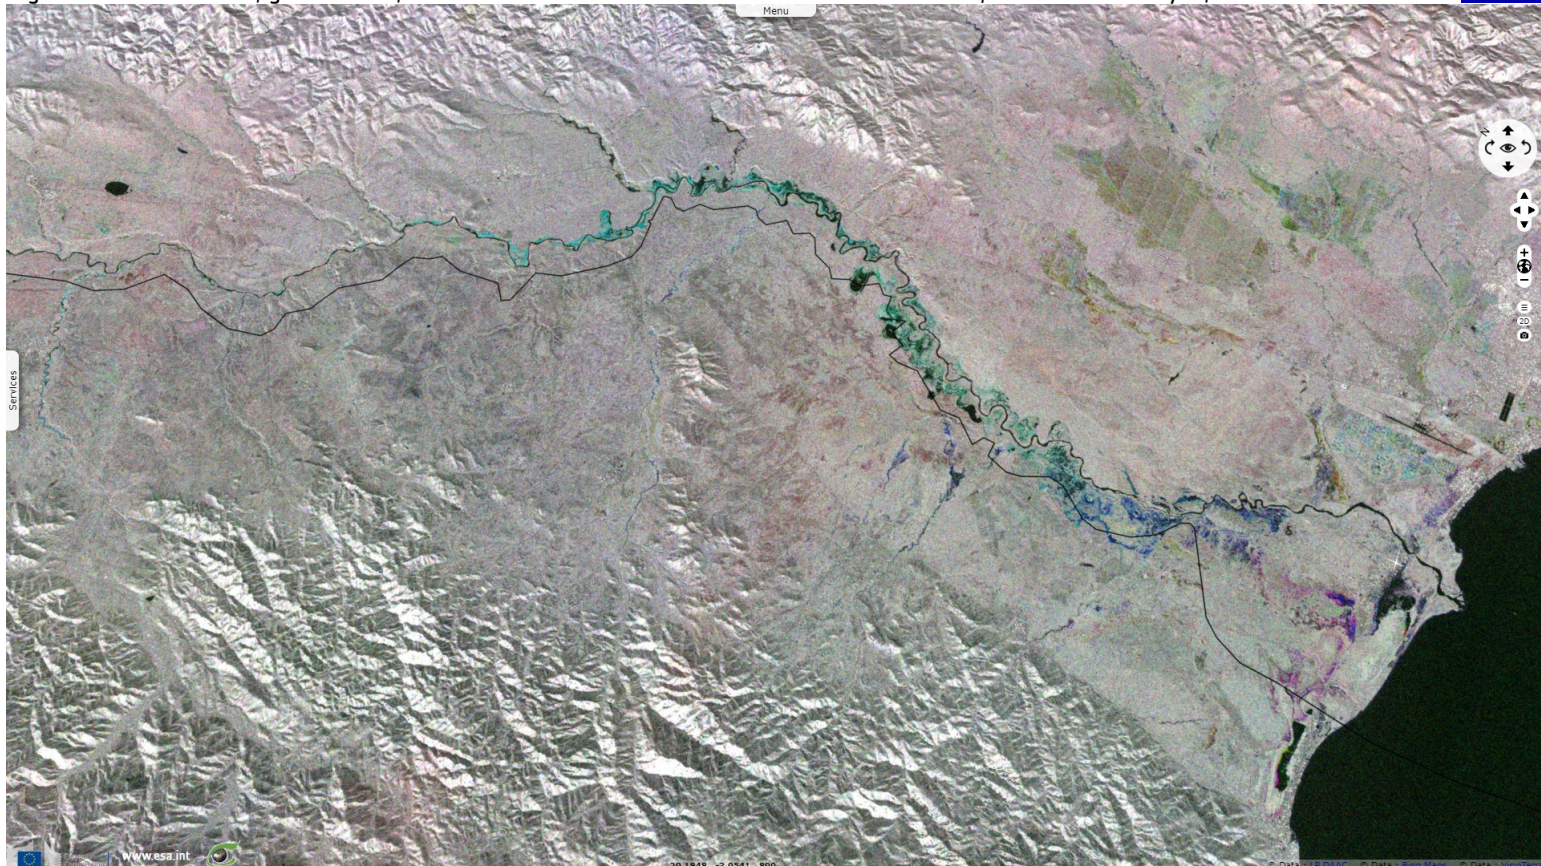
Fig. 11 - S1 - red: 30.04; green: 24.04; blue: 18.04 - Areas flooded on all 3 dates show in black, on the last 2 in cyan; on the last in blue.

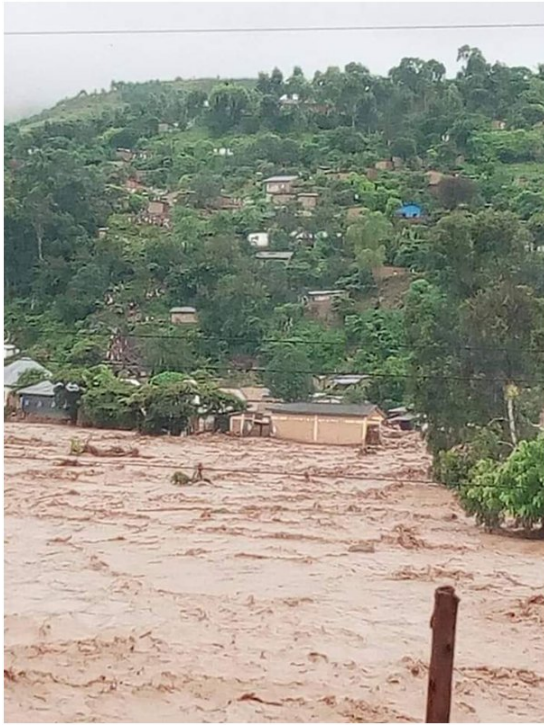
The steep slopes caused a rapid runoff to the river bed, 18 April 2020.– Source: Fidele Kasangandjo.
Children in streets flooded by the River Mulongwe in Uvira, 18 April 2020 – Source: Fidele Kasangandjo.

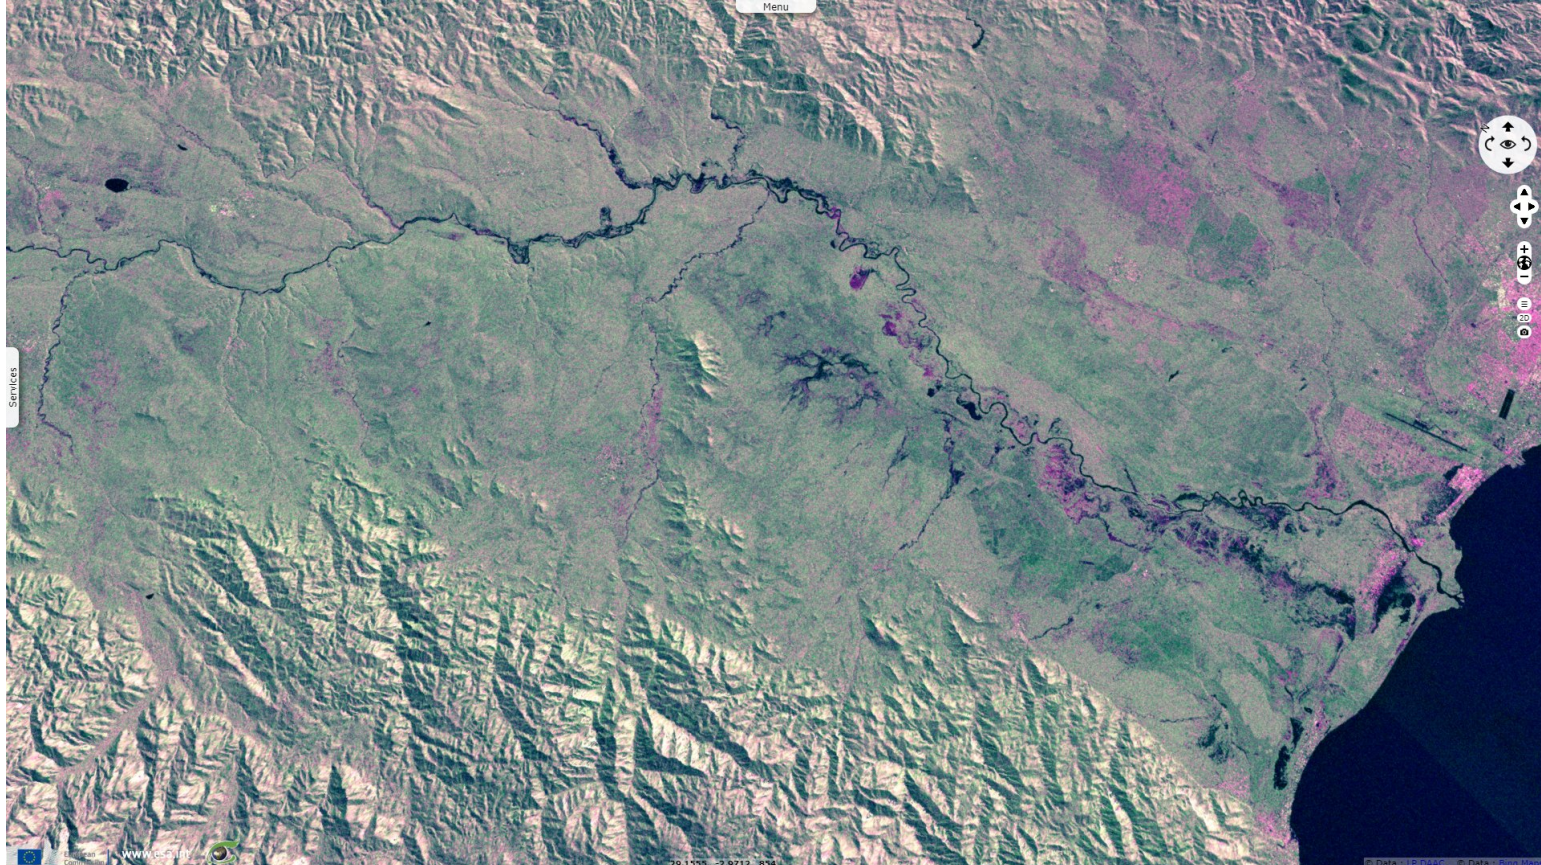
Fig. 12 - S1 (02.05.2020) - In early May, flooded areas decrease upstream but increases close to the river mouth.
