# Oil spills offshore Republic of Congo

Author(s): Sentinel Vision team, VisioTerra, France - [svp@visioterra.fr](mailto:svp@visioterra.fr)

Keyword(s): Oil spill, Republic of Congo

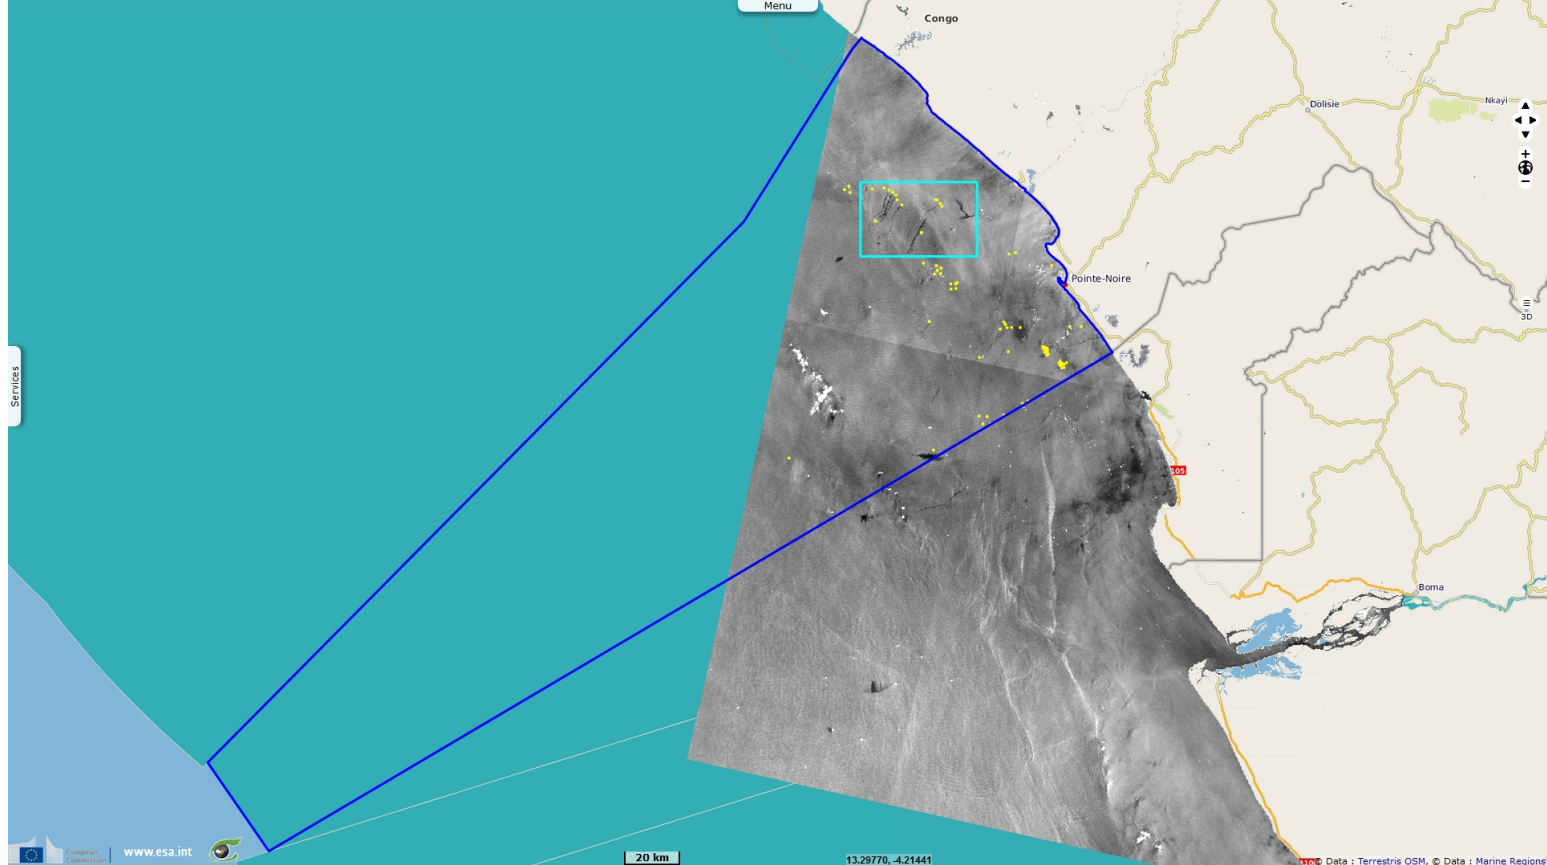
Fig. 1 - S1A (12.04.2019) - VV polarisation Radar Cross Section Equalisation (RCSE) - Oil spills from platforms (yellow), Republic of Congo ZEE. [2D view](#)

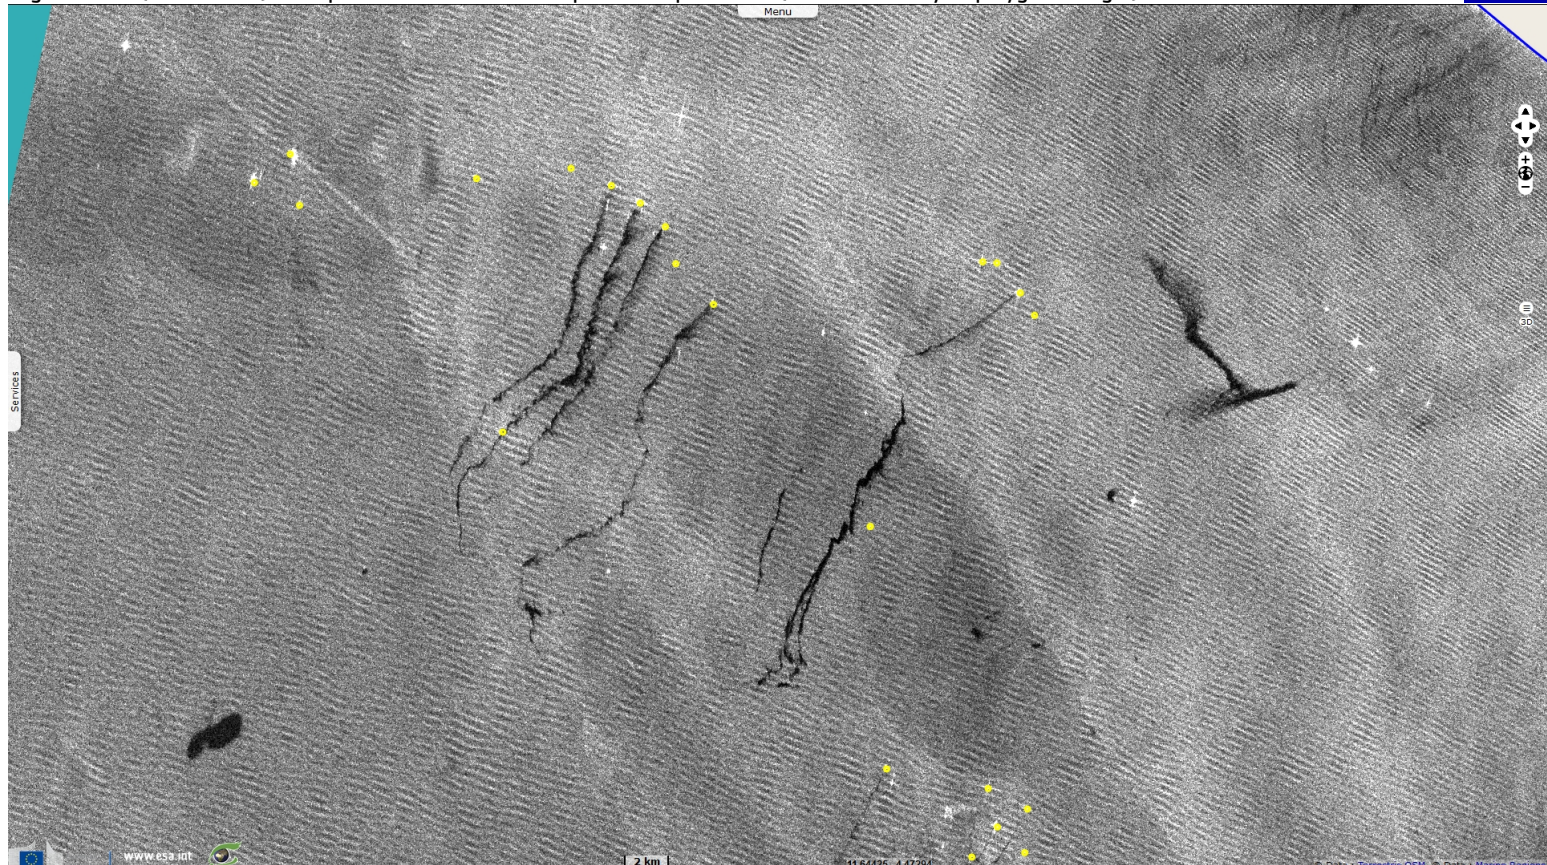
Fig. 2 - S1A (12.04.2019) - VV polarisation RCSE - Oil spills from platforms (zoom on the cyan polygon of fig.1). [2D view](#)

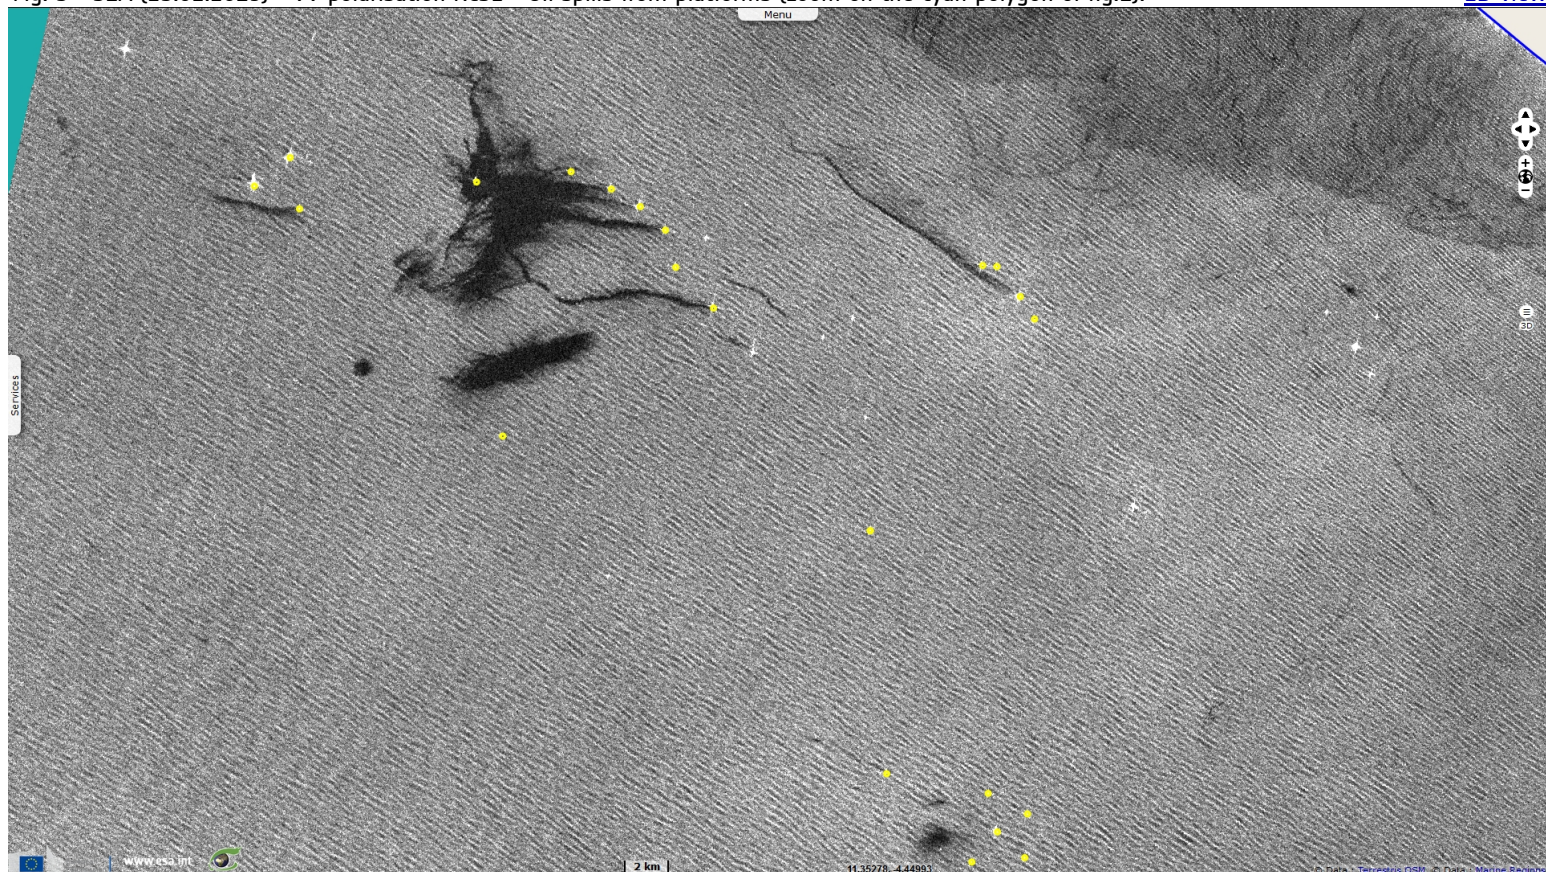
Fig. 3 - S1A (23.02.2019) - VV polarisation RCSE - Oil spills from platforms (zoom on the cyan polygon of fig.1).

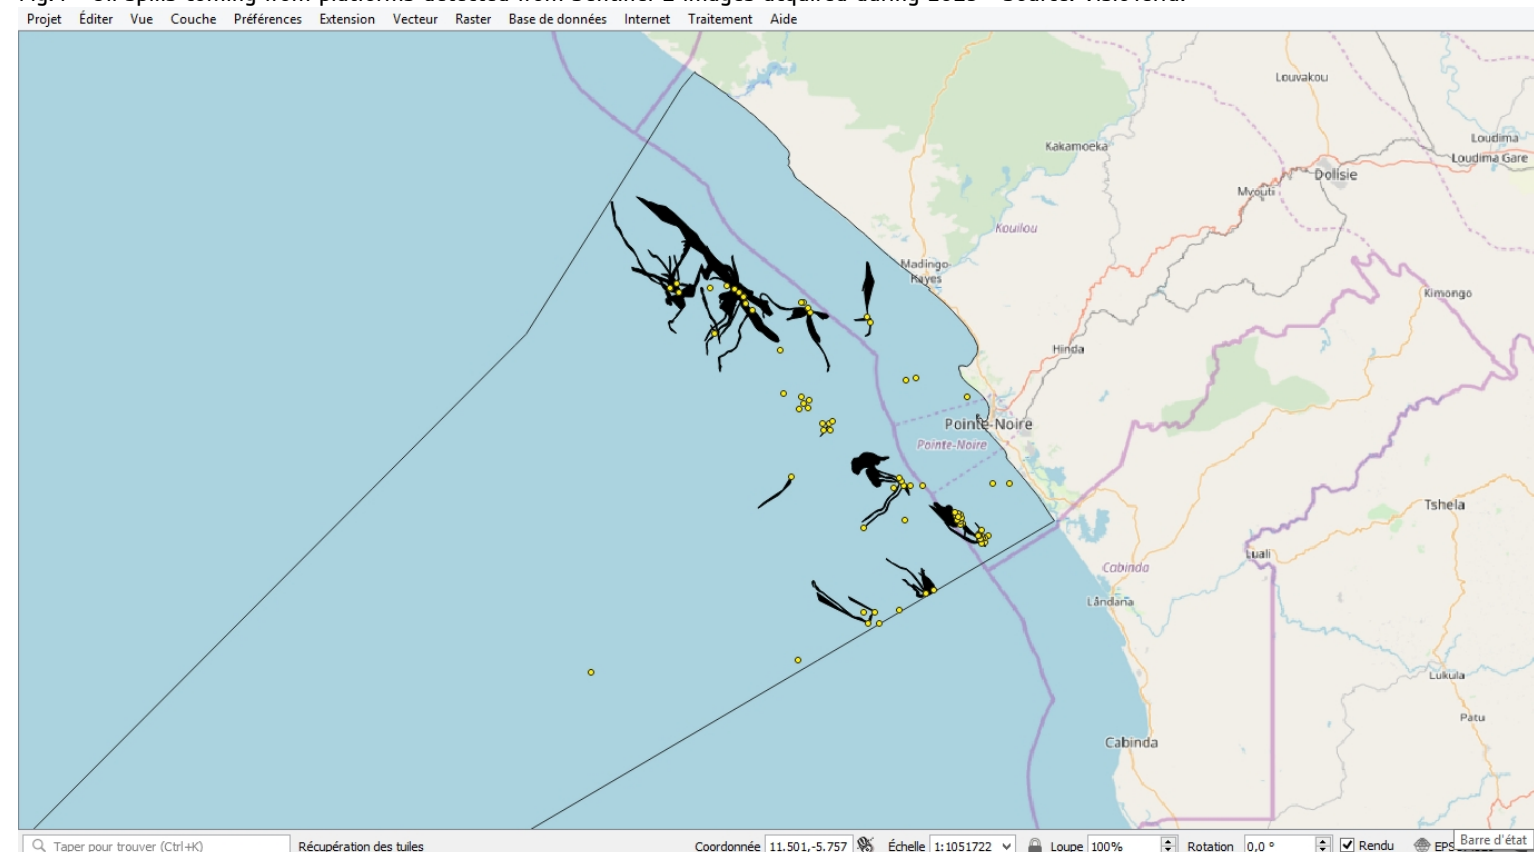
Fig.4 - Oil spills coming from platforms detected from Sentinel-1 images acquired during 2019 - Source: VisioTerra.
