# Torrential rainfalls over Qatar

Sentinel-2 MSI acquired on 12 October 2018 at 07:08:21 UTC  
Sentinel-2 MSI acquired on 22 October 2018 at 07:09:31 UTC

Author(s): Sentinel Vision team, VisioTerra, France - [svp@visioterra.fr](mailto:svp@visioterra.fr)

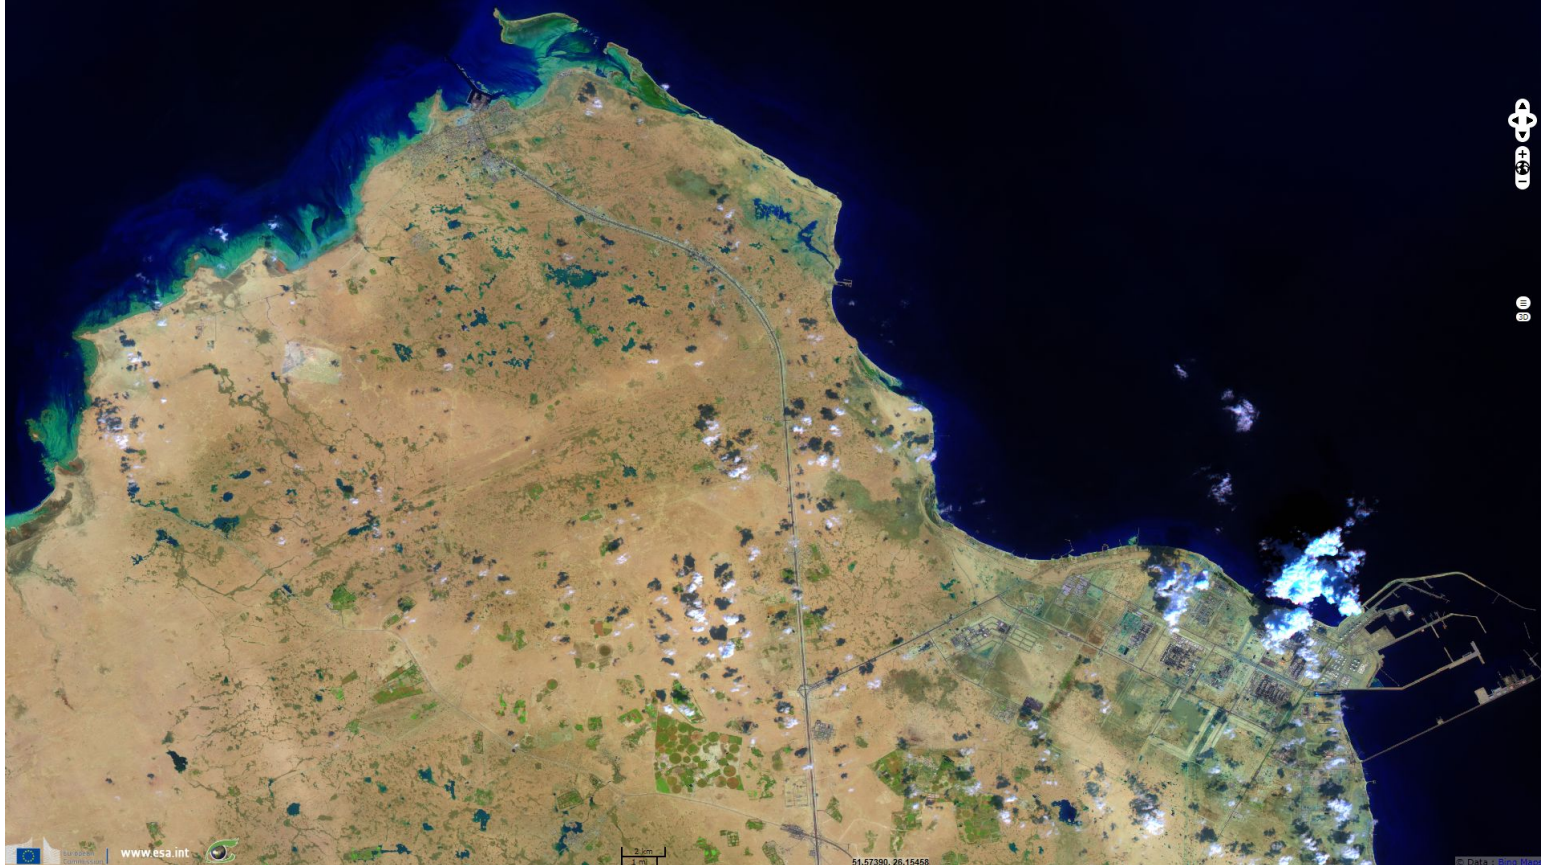
Fig. 1 - S2 (12 & 22.10.2018) - 11,8,2 colour composite - Thunderstorms & torrential rain caused floods across Qatar. [2D animation](#) [2D view](#) [2D view](#)

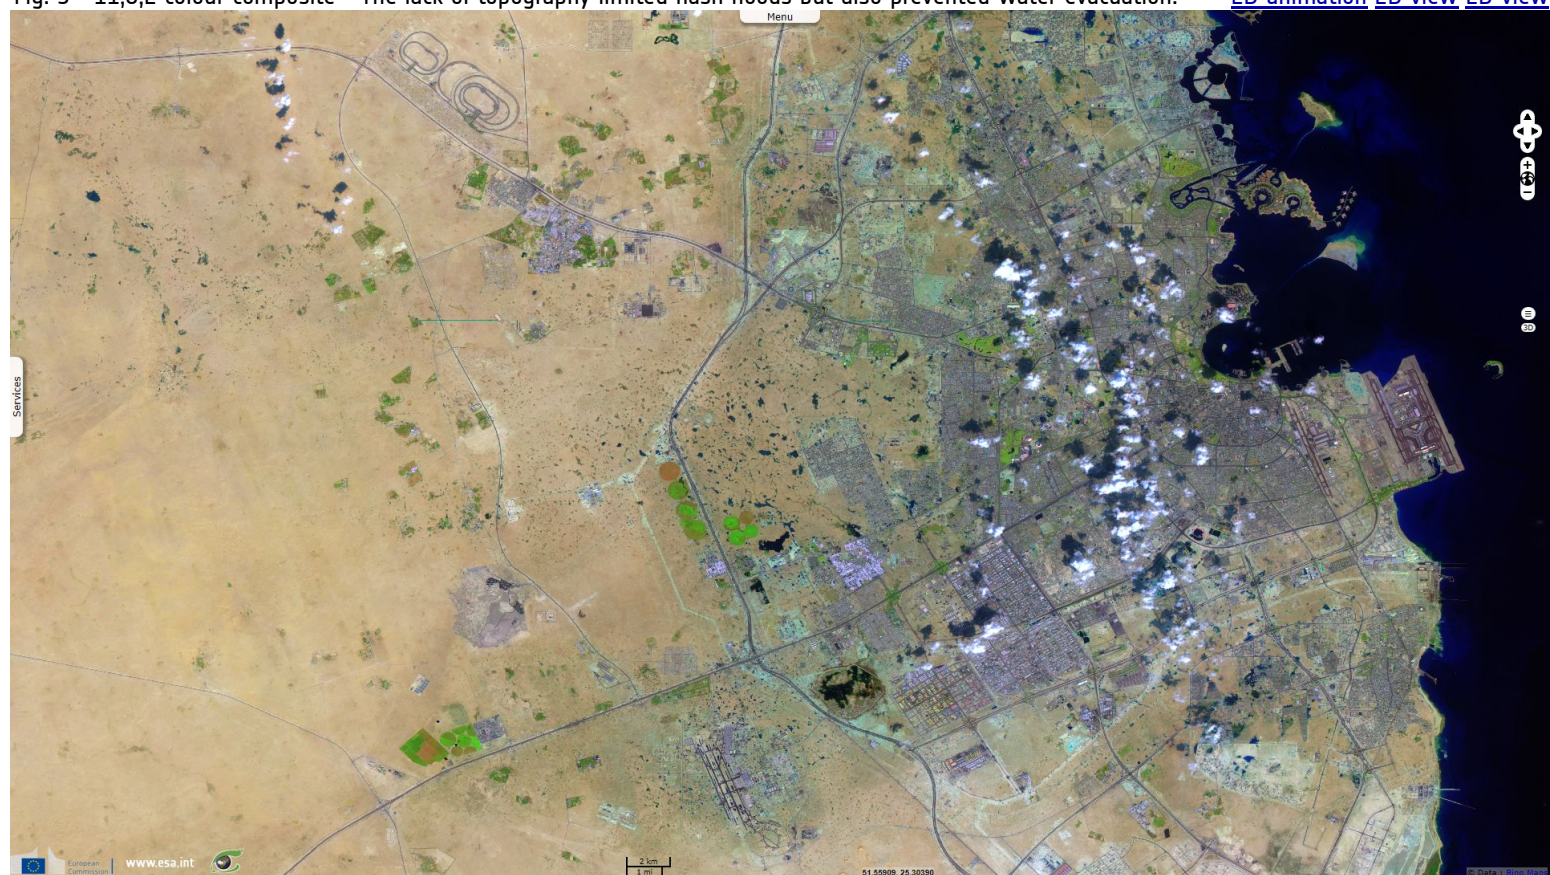
Fig. 3 - 11,8,2 colour composite - The lack of topography limited flash floods but also prevented water evacuation. [2D animation](#) [2D view](#) [2D view](#)
