# Deadly dam collapse in a diamond mine, RSA

Author(s): Sentinel Vision team, VisioTerra, France - [svp@visioterra.fr](mailto:svp@visioterra.fr)

Keyword(s): Emergency, flooding, tailing dam, diamond mine, hydrology, RSA, South Africa

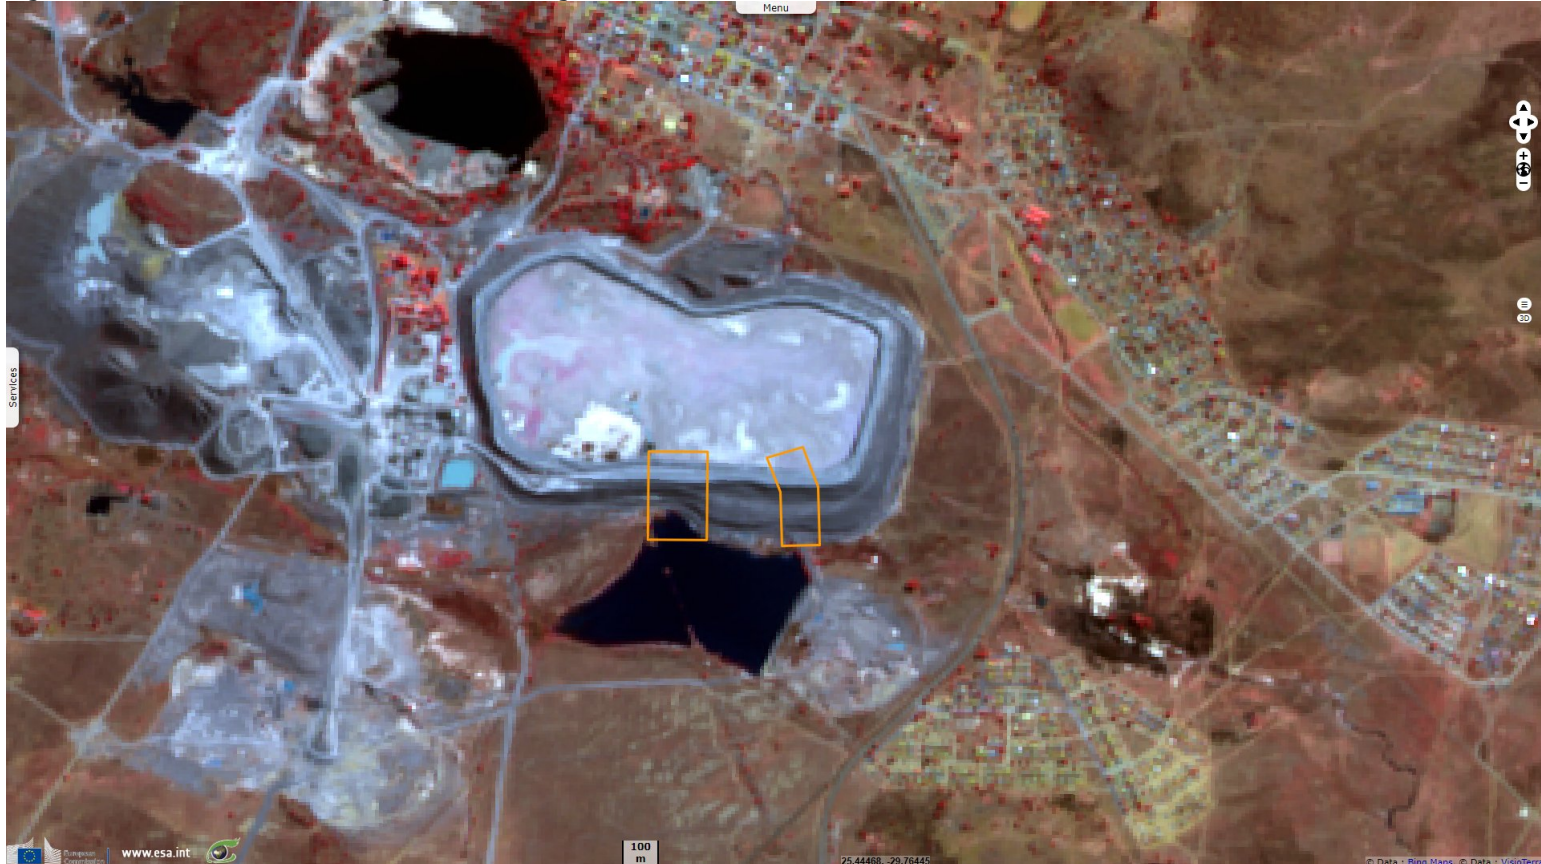
Fig. 1 - S2 (06.09.2022) - View of Jagersfontein mining dam in South Africa.

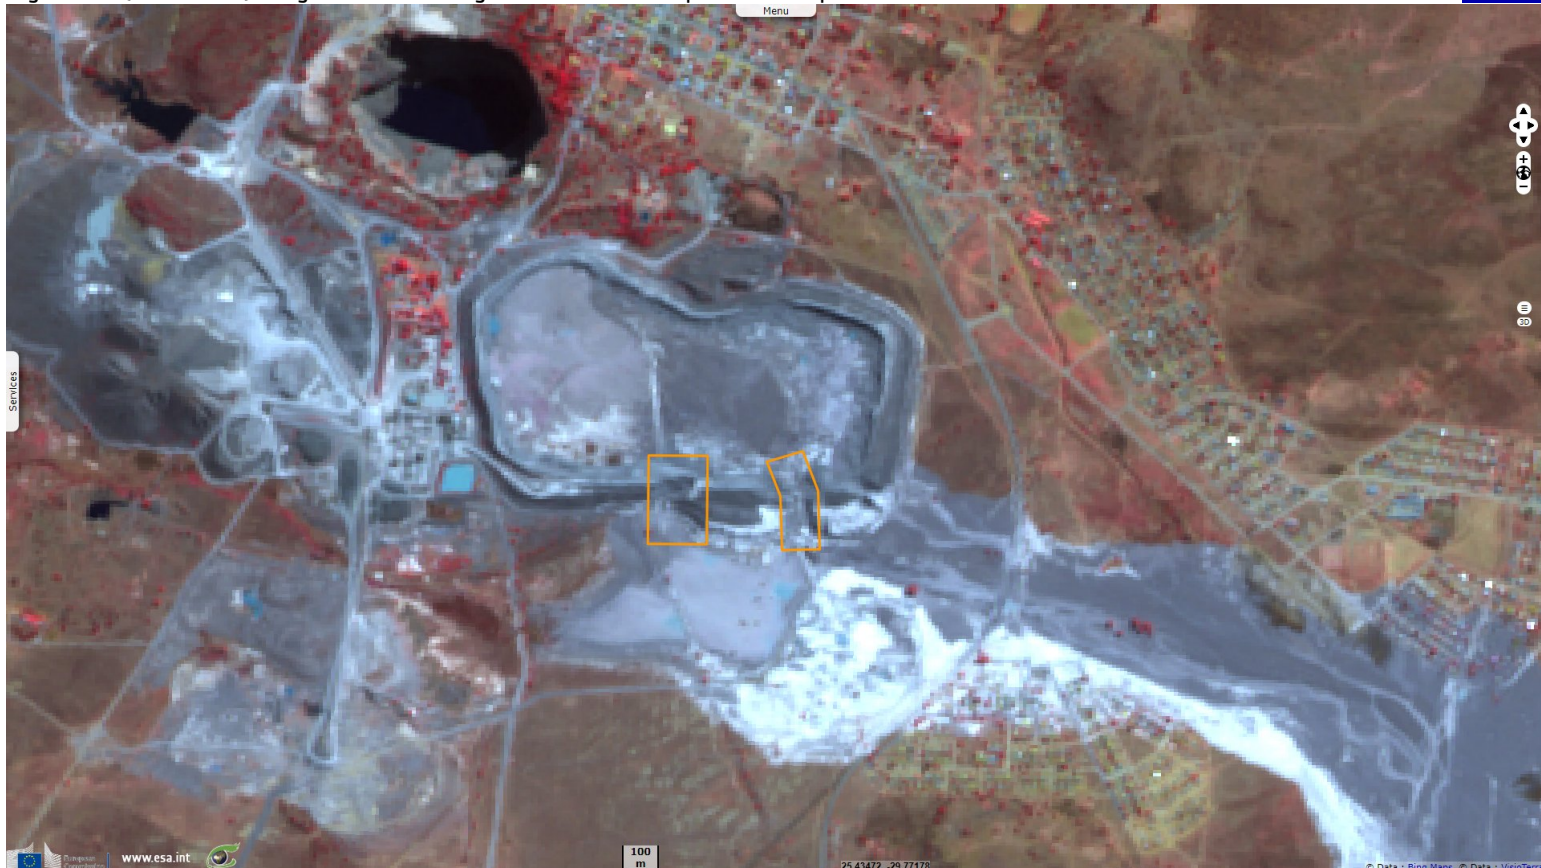
Fig. 2 - S2 (16.09.2022) - Jagersfontein mining dam after the collapse on 11 September 2022.

On 11 September 2022, the tailings dam of a diamond mining reprocessing area collapse in the mining city of Jagersfontein, South Africa. Floodlist [describes](#) the ensuing event: "A wall of a mining dam, also known as a tailings dam, broke in the early hours causing floods, mud and debris to flow into nearby settlements. Homes were damaged or destroyed and residents force to flee. Authorities said the disaster has left hundreds of people destitute. At least 3 people have lost their lives and 4 are missing, while around 40 people were taken to hospital including 23 with hypothermia and 4 with broken limbs."

"The plume of tailings extends about 8.5 km towards the southeast. It is up to about 1.5 km wide. The image shows a large breach in the southern wall of the facility. It appears that the pond, which is about 1 km long and 500 m wide, has largely emptied. Many houses downstream of the facility have been inundated. Worryingly, the satellite images also indicate that the tailings have entered the main channel."
