# A 77 hectares landslide makes 700 people homeless, Colombia

Keyword(s): Geohazard, landslide, urban planning, Colombia

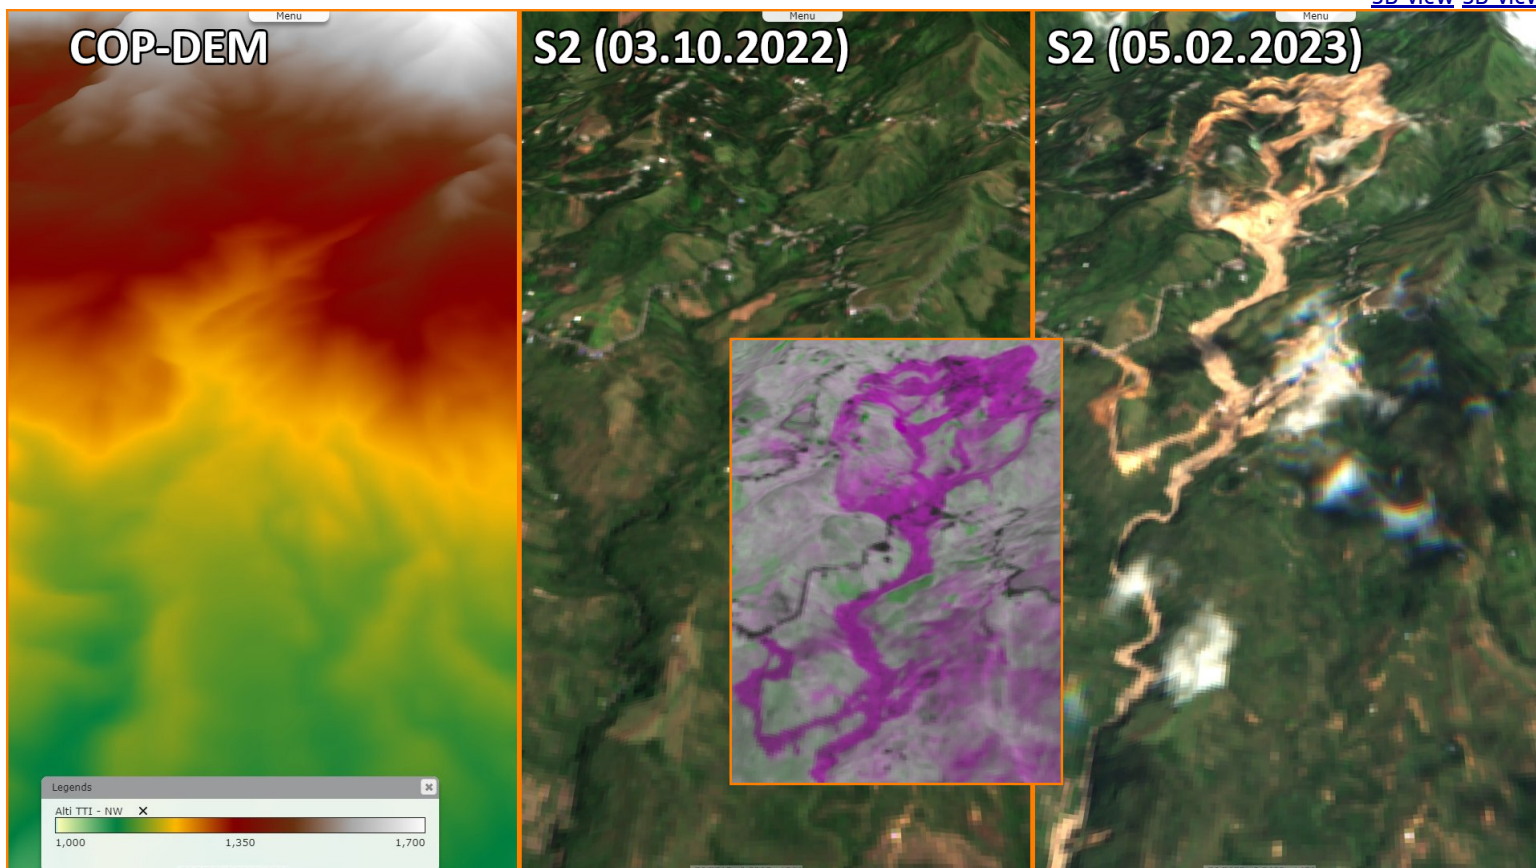
Fig. 1 - COP-DEM / S2 (03.10.2022 / 05.02.2023) - Since 09.01.2023, a 900 m x 850 m landslide has hit 3 villages in Rosas, Cauca.

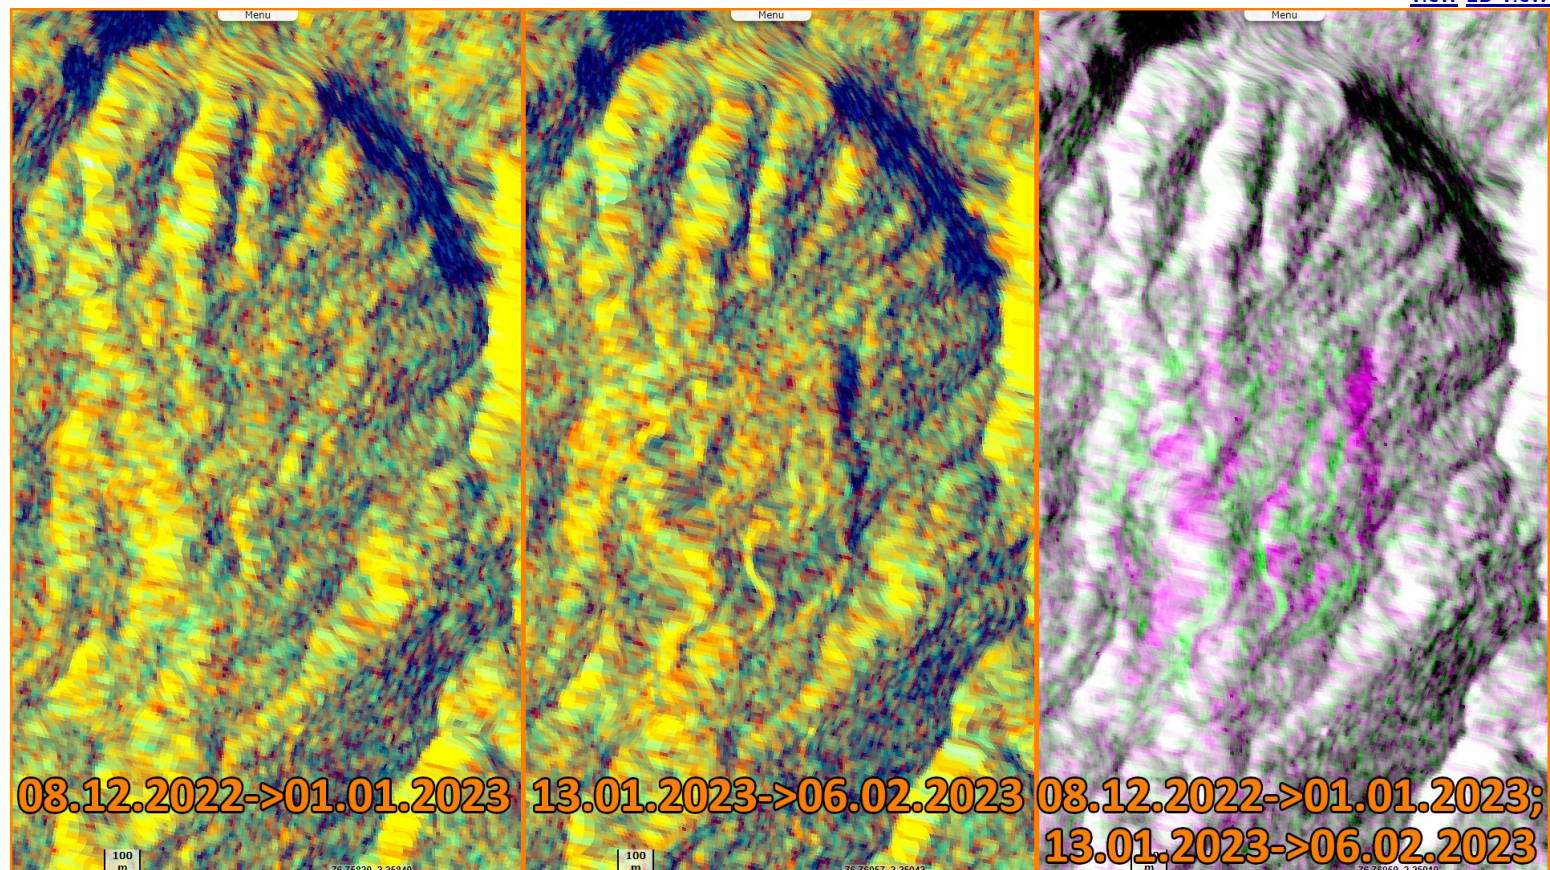
Fig. 2 - S1 (08.12.2022->01.01.2023; 13.01.2023->06.02.2023) - 64 homes have been destroyed, rendering over 700 people homeless. [2D view](#) [2D view](#) [view](#) [2D view](#)
