# Operational review of the record flood in Niamey, Niger

Author(s): Sentinel Vision team, VisioTerra, France - [svp@visioterra.fr](mailto:svp@visioterra.fr)

Keyword(s): Emergency, natural disaster, flooding, rainfall, precipitations, urban planning, Niger

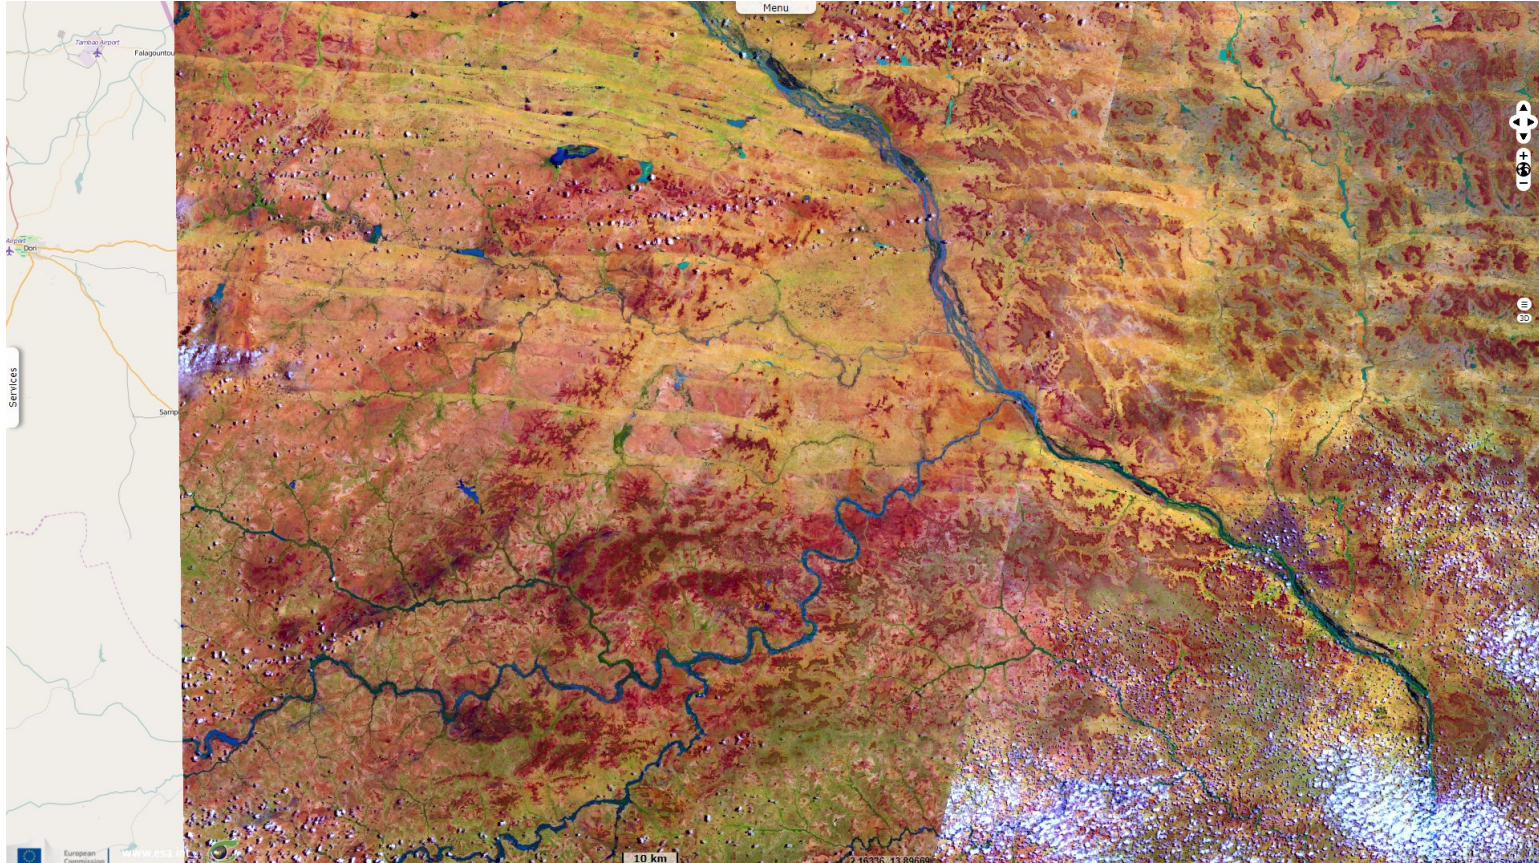
Fig. 1 - S2 (22 & 30.07.2020) - Global view of Niamey region before the Sirba and Niger flood.

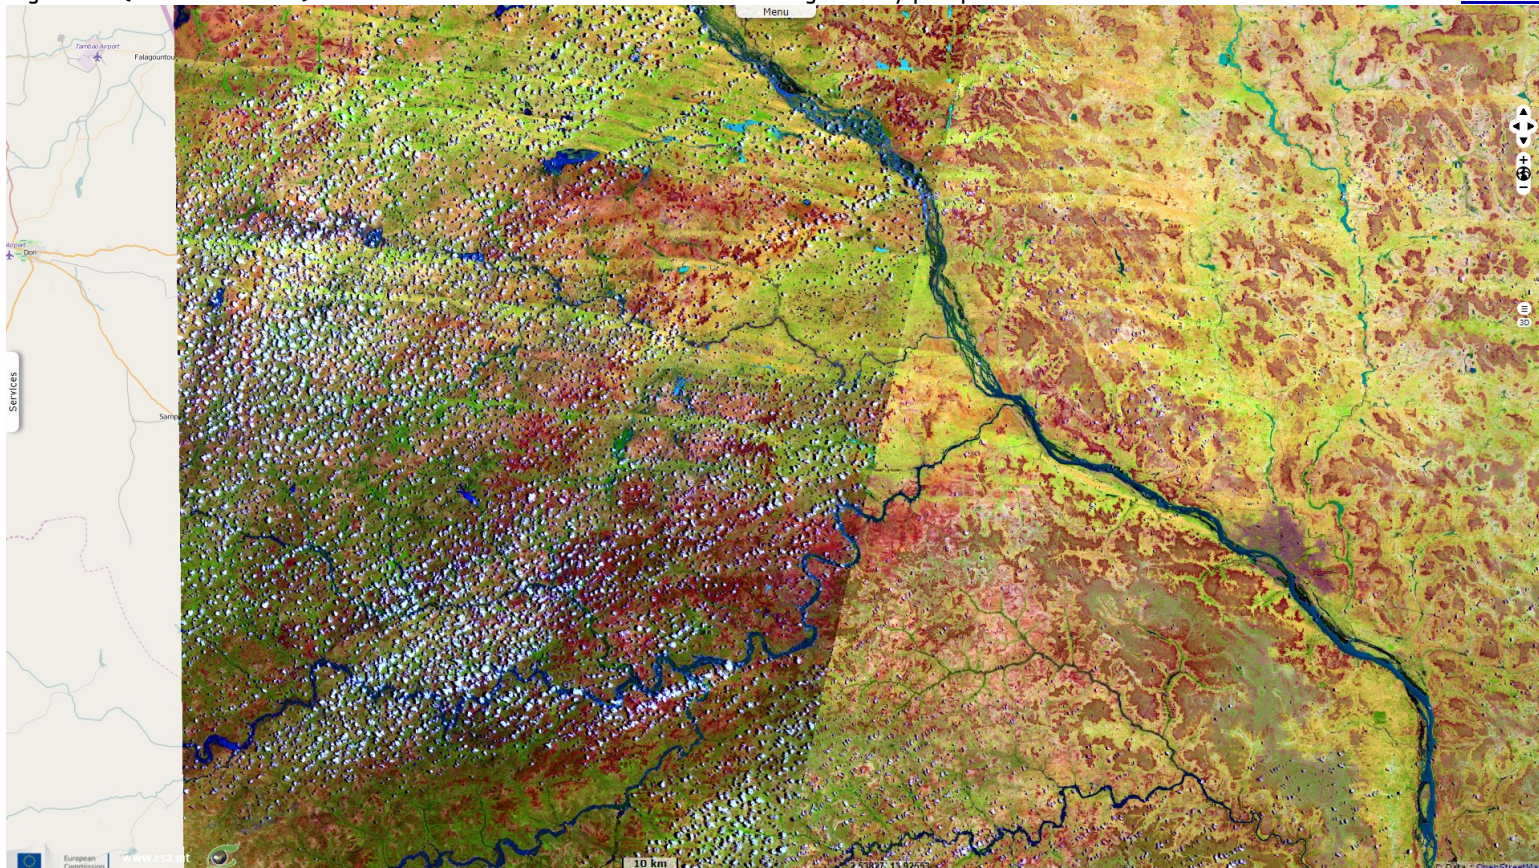
Fig. 2 - S2 (16 & 19.08.2020) - Several weeks later after the rain season brought heavy precipitations.

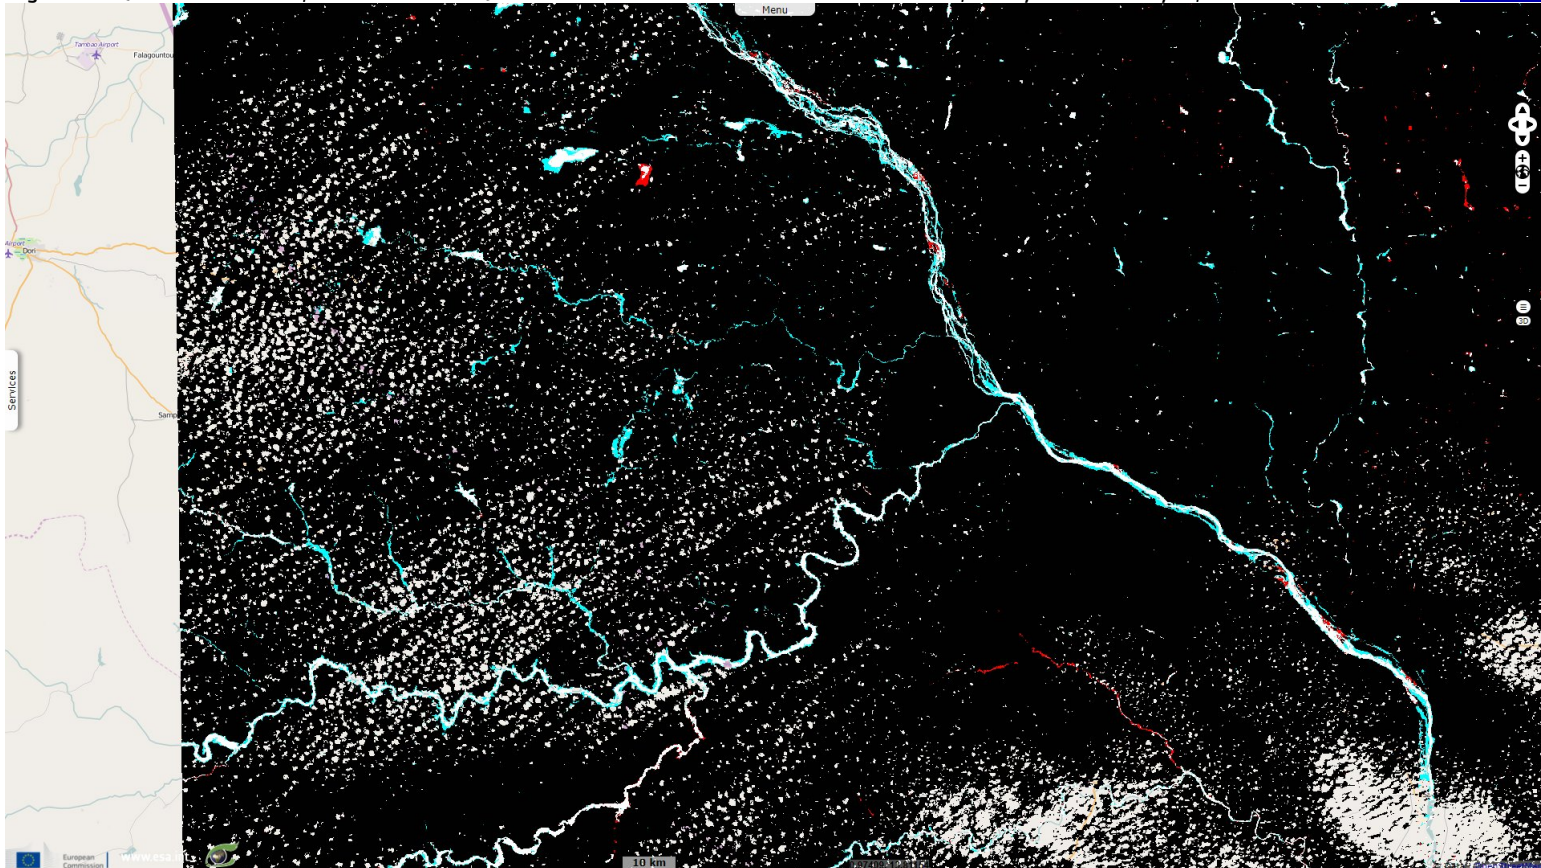
Fig. 3 - S2 [22 & 30.07.2020, 16 & 19.08.2020] - Areas flooded before & after show in white, newly flooded in cyan, no more flooded in red. [2D view](#)

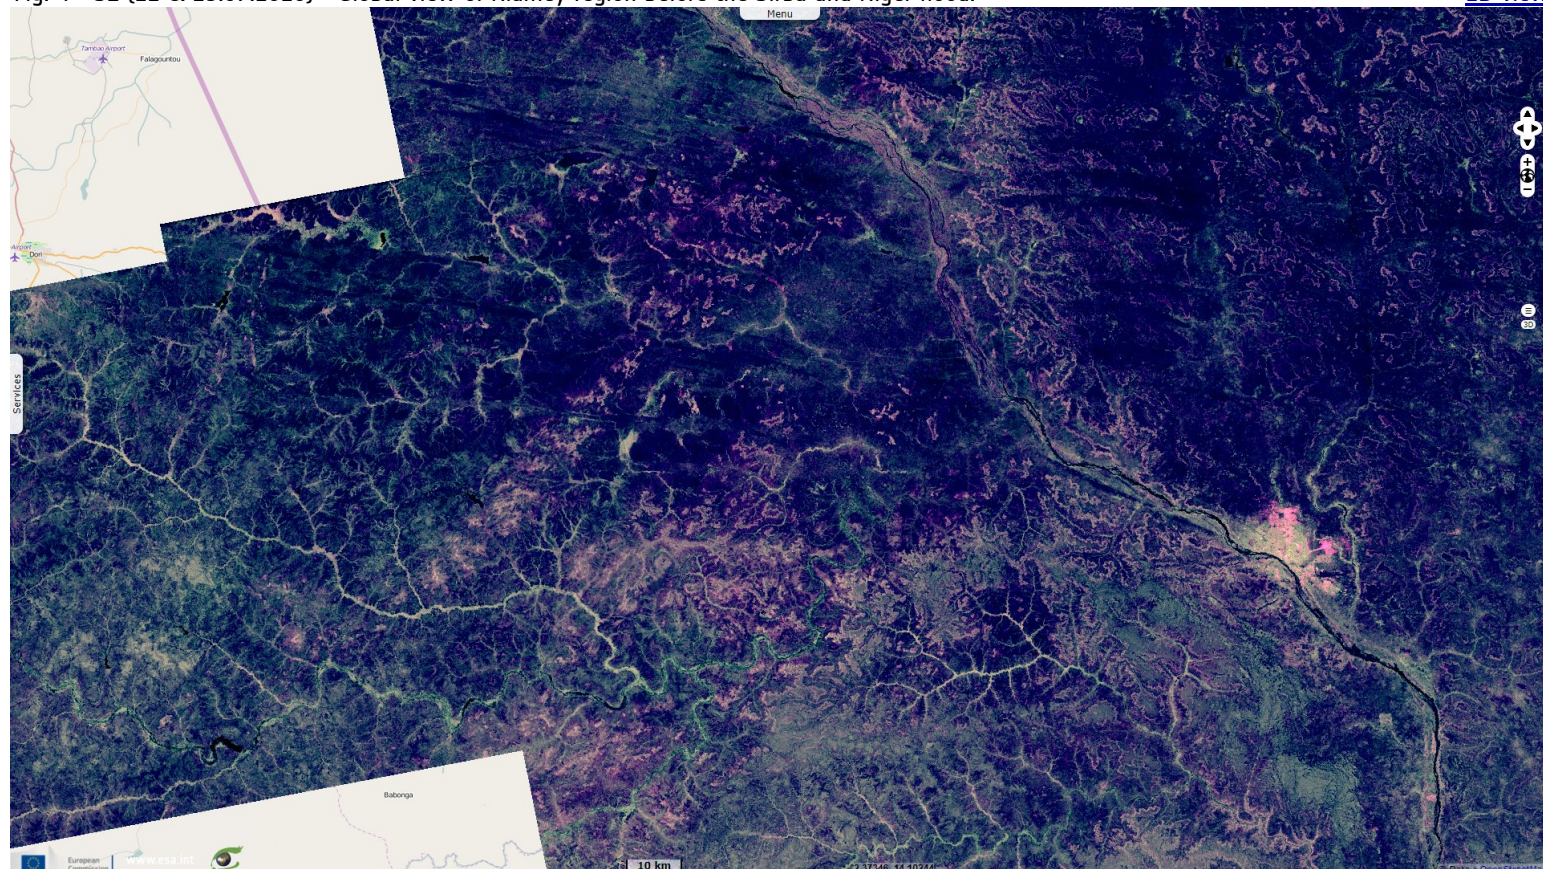
Fig. 4 - S1 [22 & 29.07.2020] - Global view of Niamey region before the Sirba and Niger flood.

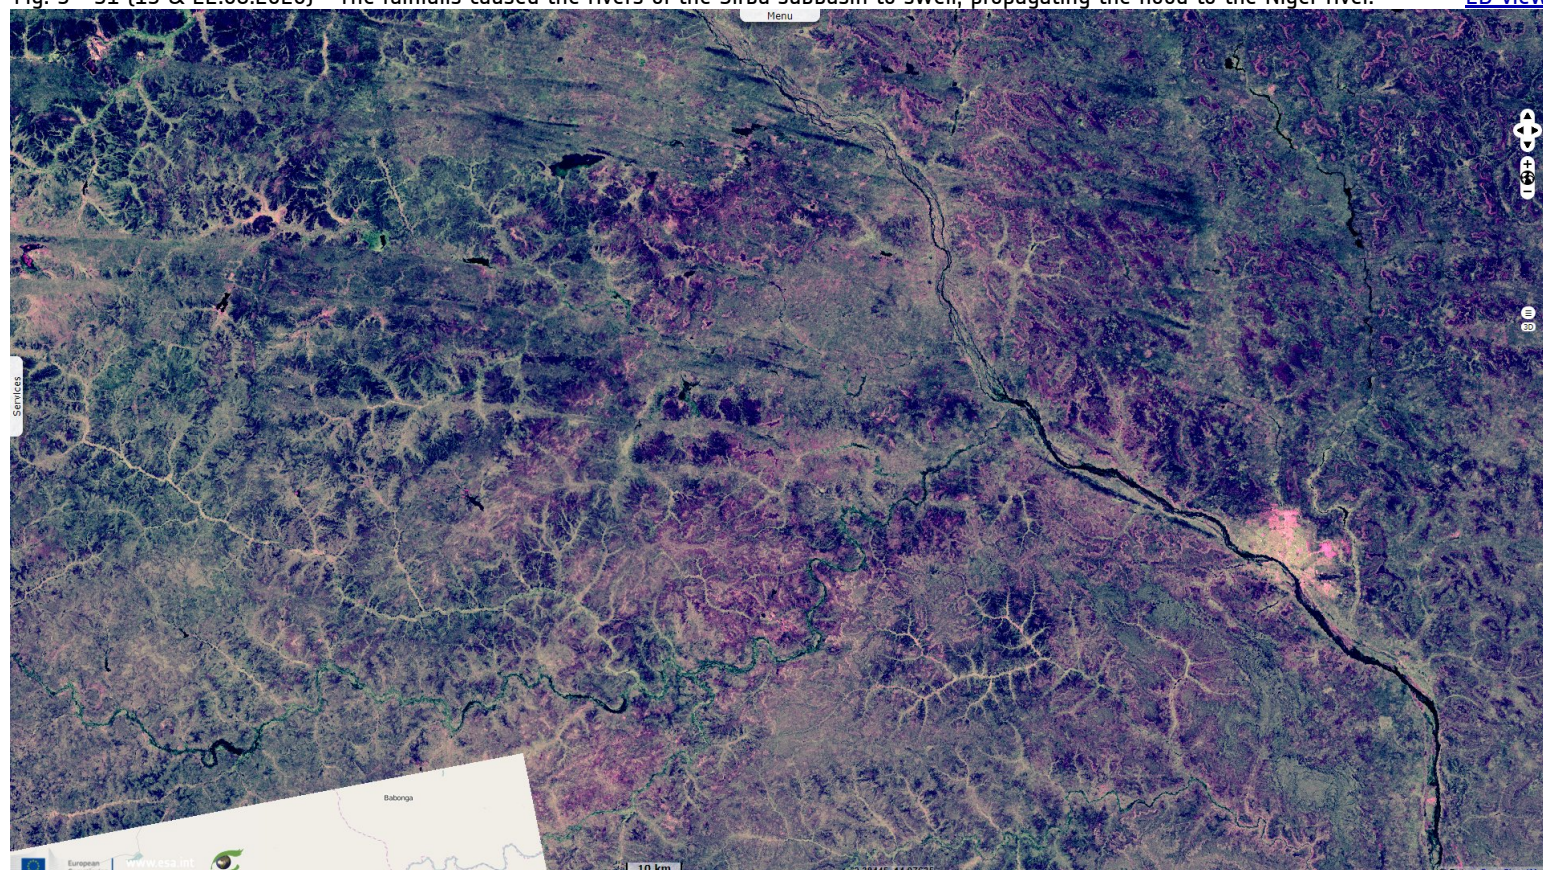
Fig. 5 - S1 [15 & 22.08.2020] - The rainfalls caused the rivers of the Sirba subbasin to swell, propagating the flood to the Niger river.

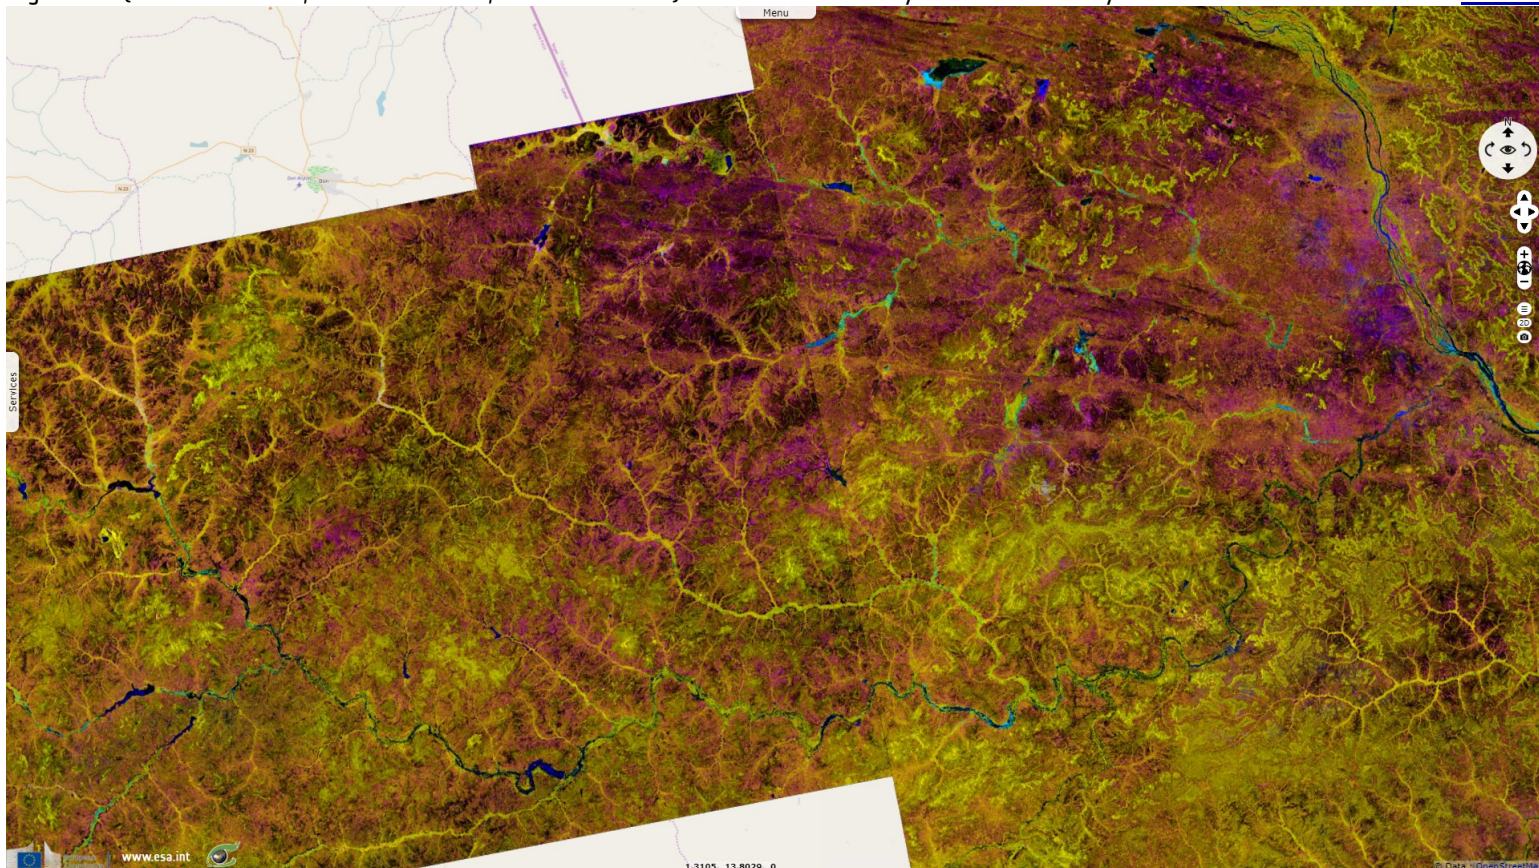
Fig. 6 - S1 (22 & 29.07.2020; 03 & 10.08.2020; 15 & 22.08.2020) - Flood of the Sirba system above Niamey.

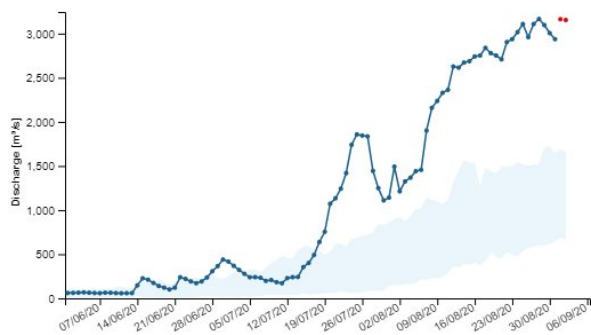
Station: Niamey

Left: Discharge of the Niger river in Niamey - Source: [Niger Basin Authority](#).

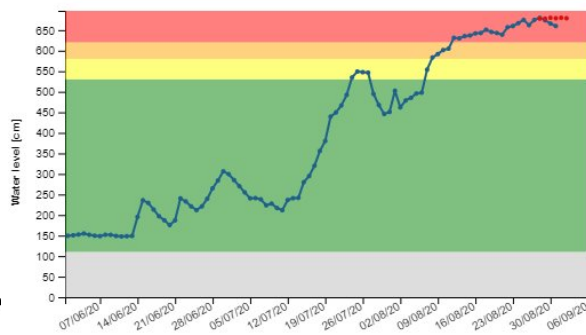
Station: Niamey

Right: Height of the Niger river in Niamey - Source: [Niger Basin Authority](#).

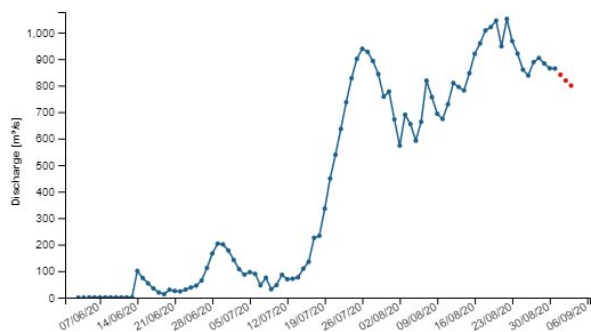
Station: Garbé-Kourou

Left: Discharge of the Sirba river in Garbé Kourou, upstream of the confluence with the Niger river - Source: [Niger Basin Authority](#).

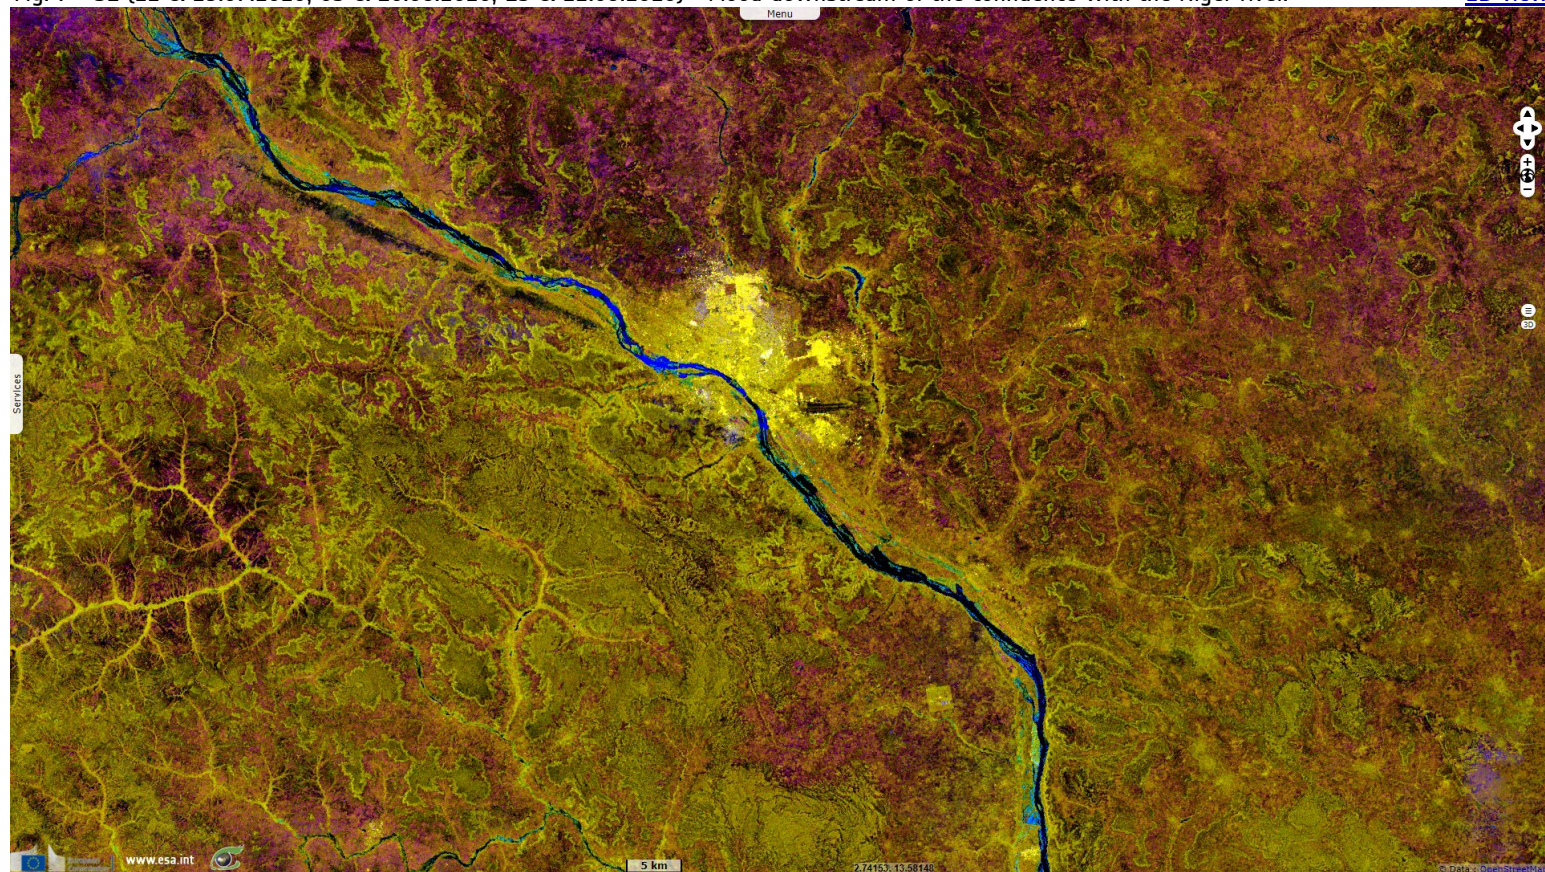
Fig. 7 - S1 (22 & 29.07.2020; 03 & 10.08.2020; 15 & 22.08.2020) - Flood downstream of the confluence with the Niger river.

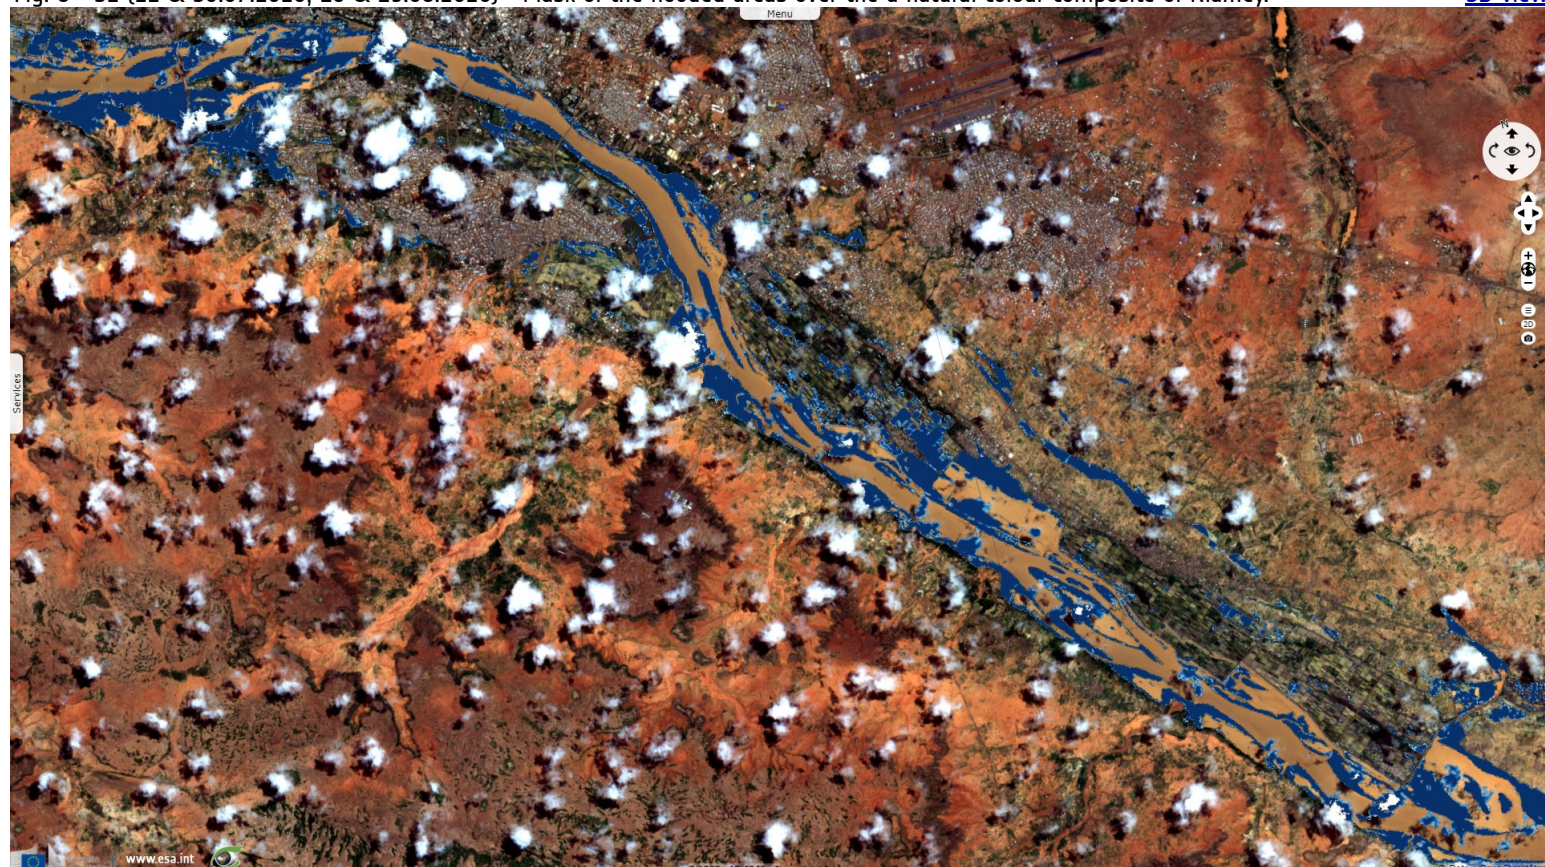
Fig. 8 - S2 (22 & 30.07.2020, 16 & 19.08.2020) - Mask of the flooded areas over the a natural colour composite of Niamey.

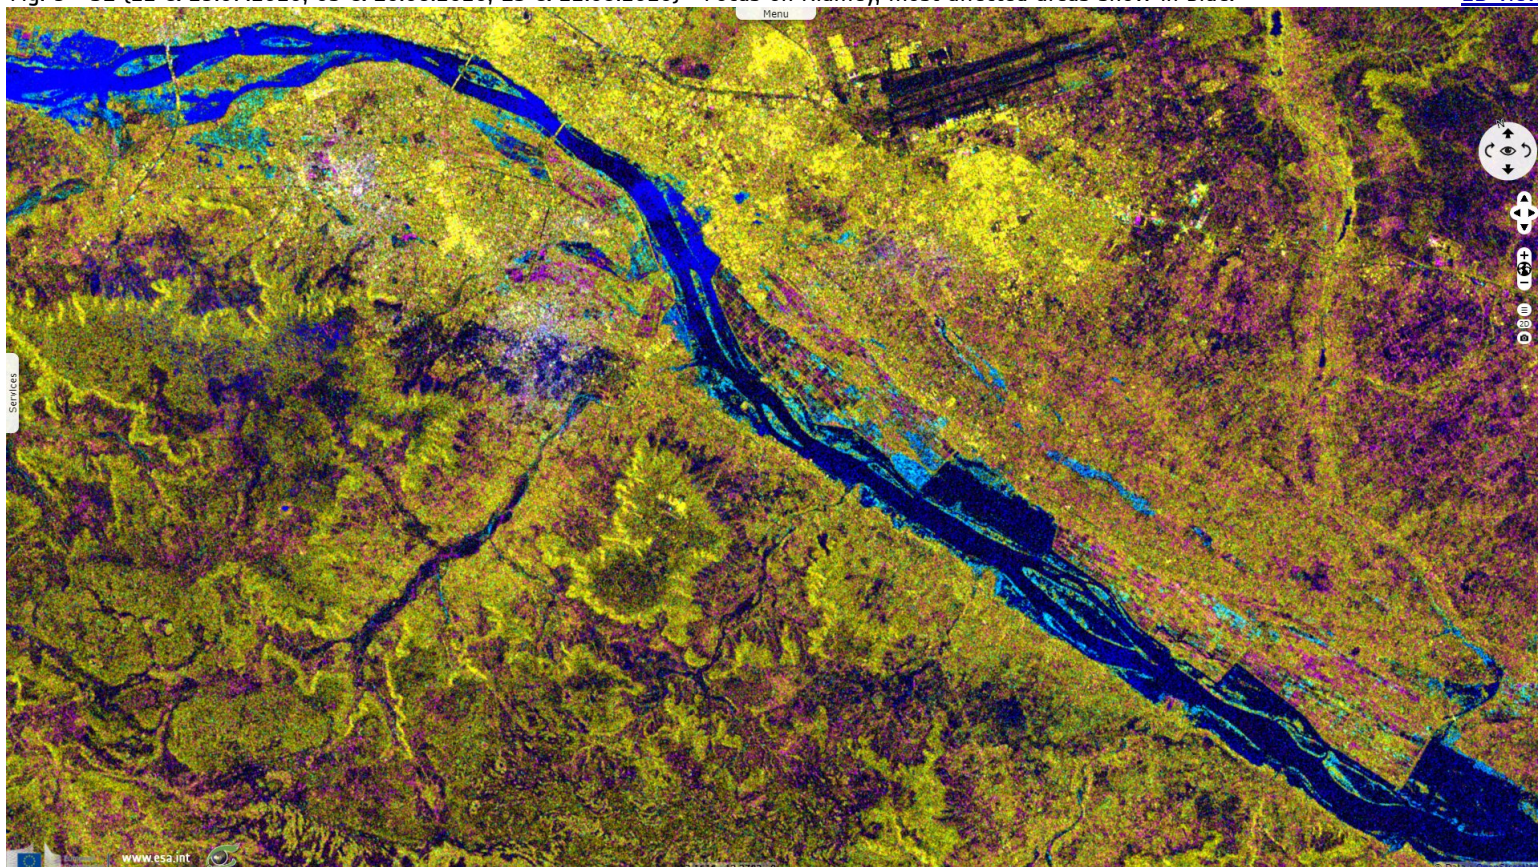
Fig. 9 - S1 (22 & 29.07.2020; 03 & 10.08.2020; 15 & 22.08.2020) - Focus on Niamey, most affected areas show in blue.

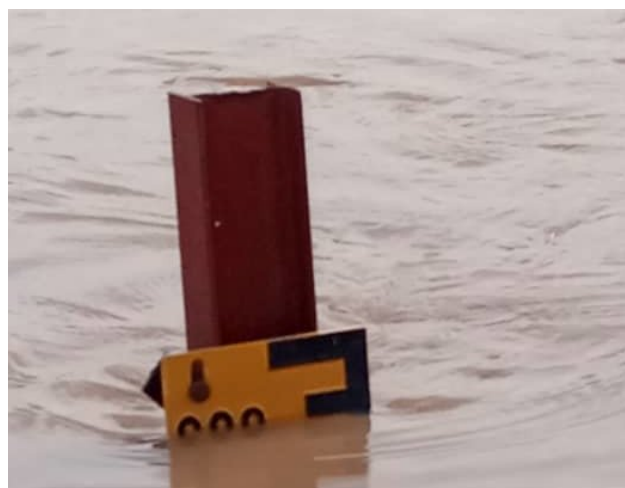
Indeed, ten days ago, the Niger Basin Authority (NBA) gave the red alert that the water level would be very high, with even high risks of flooding. The water level started to rise since 11th August 2020, going from 605 cm to 629 cm on 12th August 2020. This upward trend continued rapidly and reached the level 660 cm on Sunday 23rd August 2020, thus exceeding the 620 cm red alert level in Niamey. The heavy rains recorded between 18th and 24th August, 2020 in Niamey and Tillabéri regions and in the Burkina part of the Niger Basin accentuated the rapid rise in the water levels in Niamey, going from 660 cm to 675 cm on 25th August 2020. This recorded 675 cm water level, never observed before, is 55 cm higher than the 620 cm red alert threshold, which led to the river's overflow into flood-prone areas by submerging the protection dyke downstream of the Kennedy Bridge."

Left: The August 2020 flood broke the record level of the Niger river - Source: [SLAPIS](#)

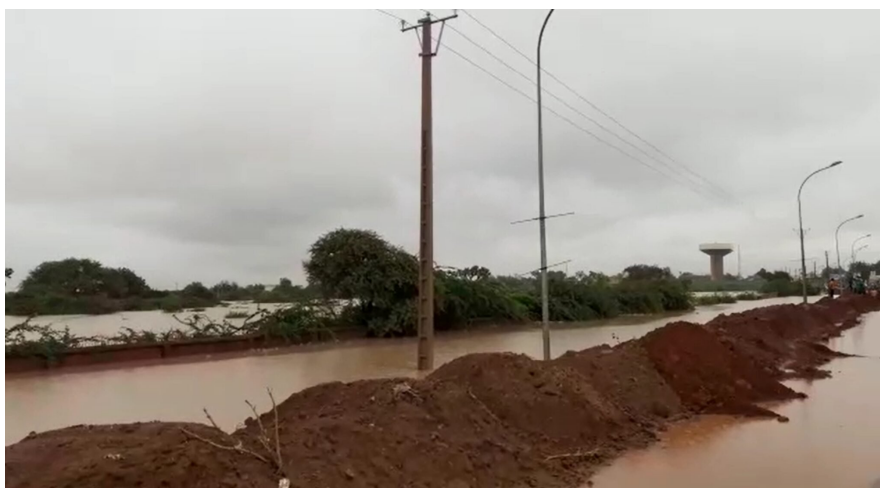
Right: The dikes were heightened but after several days of water rising beyond record levels, they were overflowed - Source: [SLAPIS](#)

*"It should be noted that the failure to continue the reinforcement of the dyke protecting the Niger River's right bank beyond the old Kennedy Bridge, further downstream, probably favoured the submersion of the dyke on that part, thus causing the flooding of the AGRHYMET Regional Centre and the NBA Technical Directorate, as well as the road passing in front of the Technical Directorate. In addition, the river bed was filled in or silted up, which is an aggravating factor for the floods. Also, actions by riparian populations, which block the natural ways of the river's water, have certainly helped in accentuating this flooding situation in the area."*

- Dikes should be regularly inspected and maintained, including their foundations,
- Dikes should be reinforced and heightened taking into account the changes in the Middle Niger regime,
- The upstream flood expansion zones must absolutely be preserved,

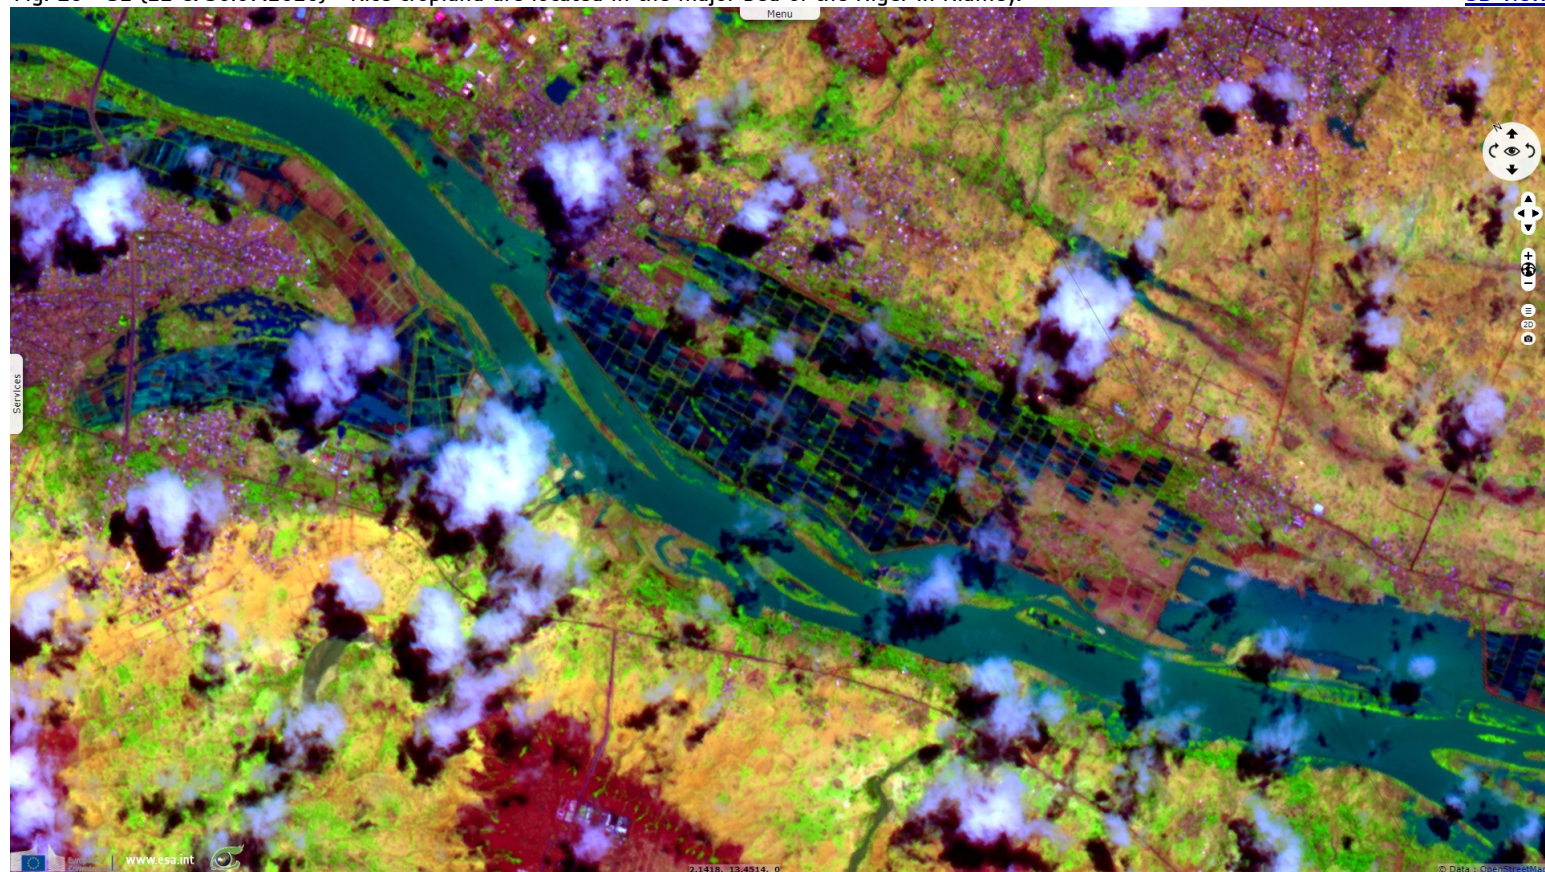
Fig. 10 - S2 (22 & 30.07.2020) - Rice cropland are located in the major bed of the Niger in Niamey.

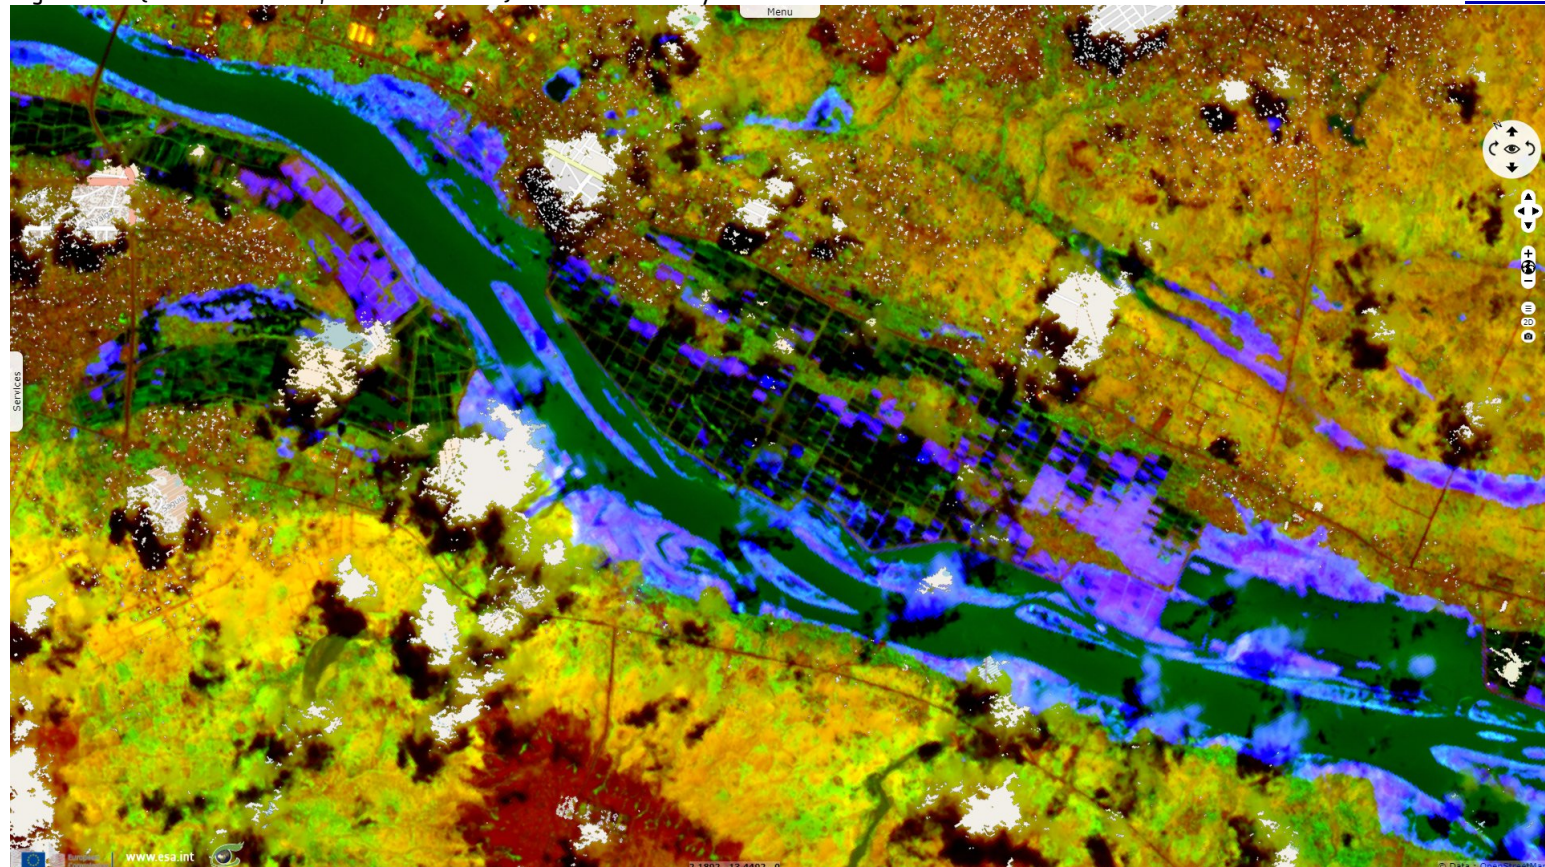
Fig. 11 - S2 (22 & 30.07.2020, 16 & 19.08.2020) - Areas affected by the flood show in blue.

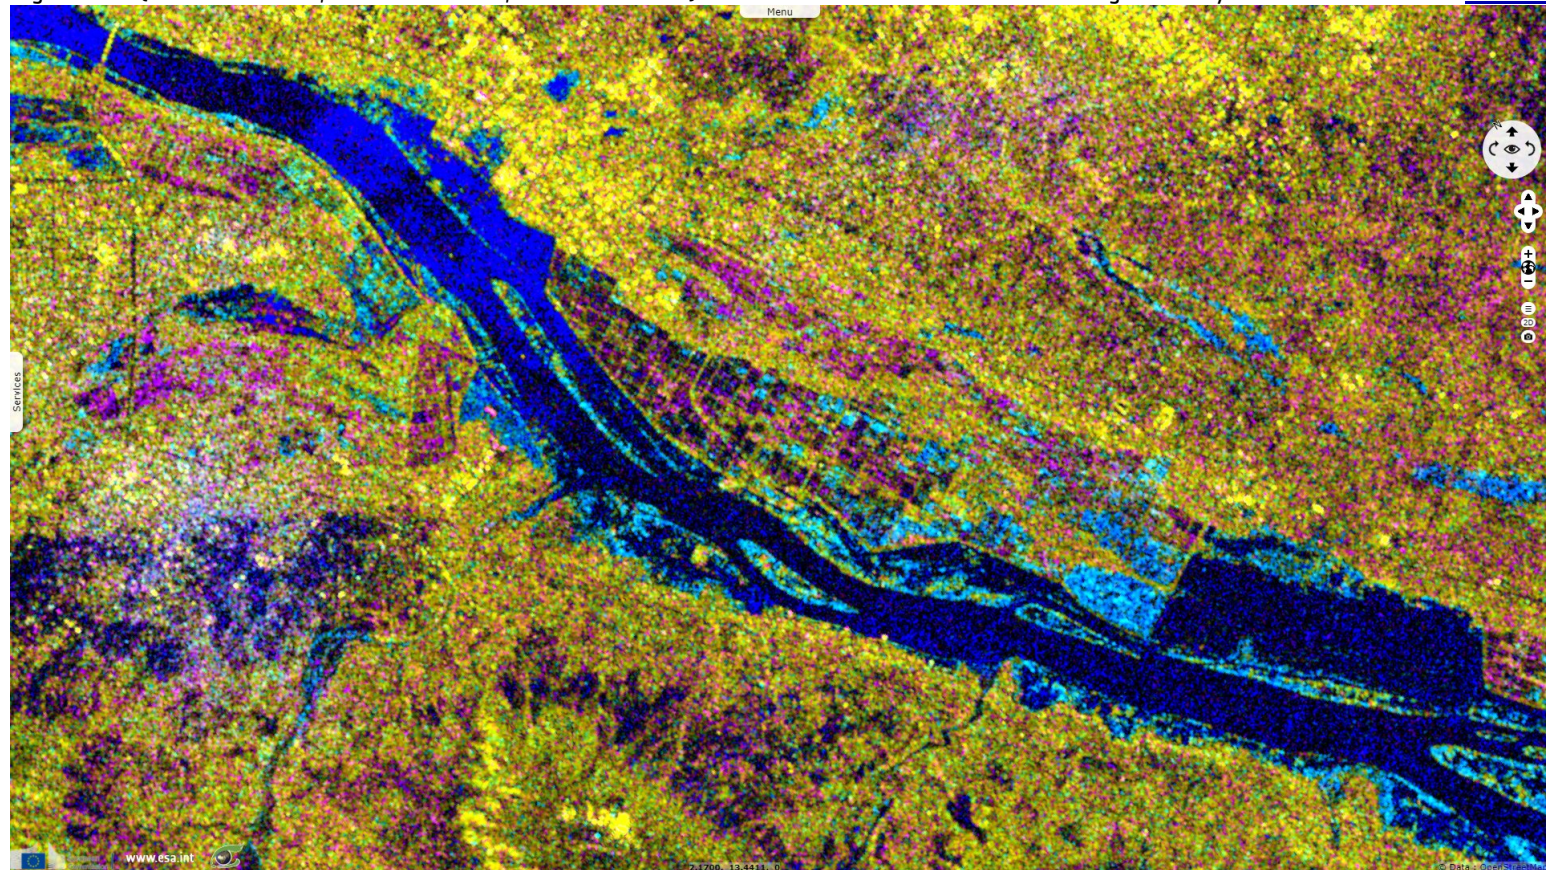
Fig. 12 - S1 (22 & 29.07.2020; 03 & 10.08.2020; 15 & 22.08.2020) - Zoom on the flooded areas below bridge Kennedy.
