# Timely evacuation before hundreds of landslides during heavy rainfall in 2019, China

Keyword(s): Emergency, natural disaster, geohazard, landslide, precipitation, rainfall, erosion, China

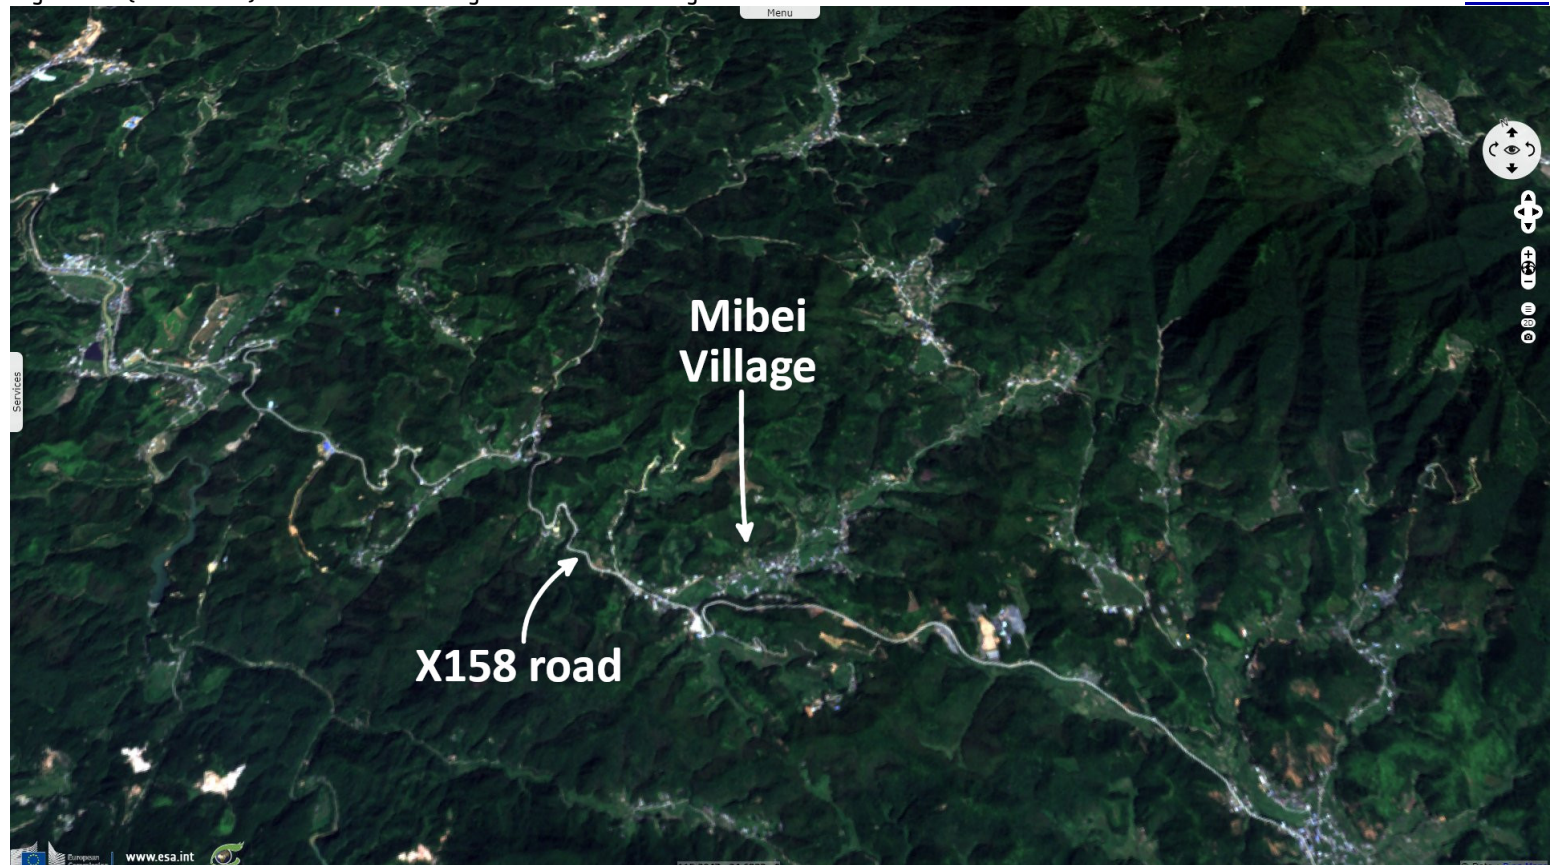
Fig. 6 - S2 (04.10.2018) - View of Mibei village and its surrounding in 2018.

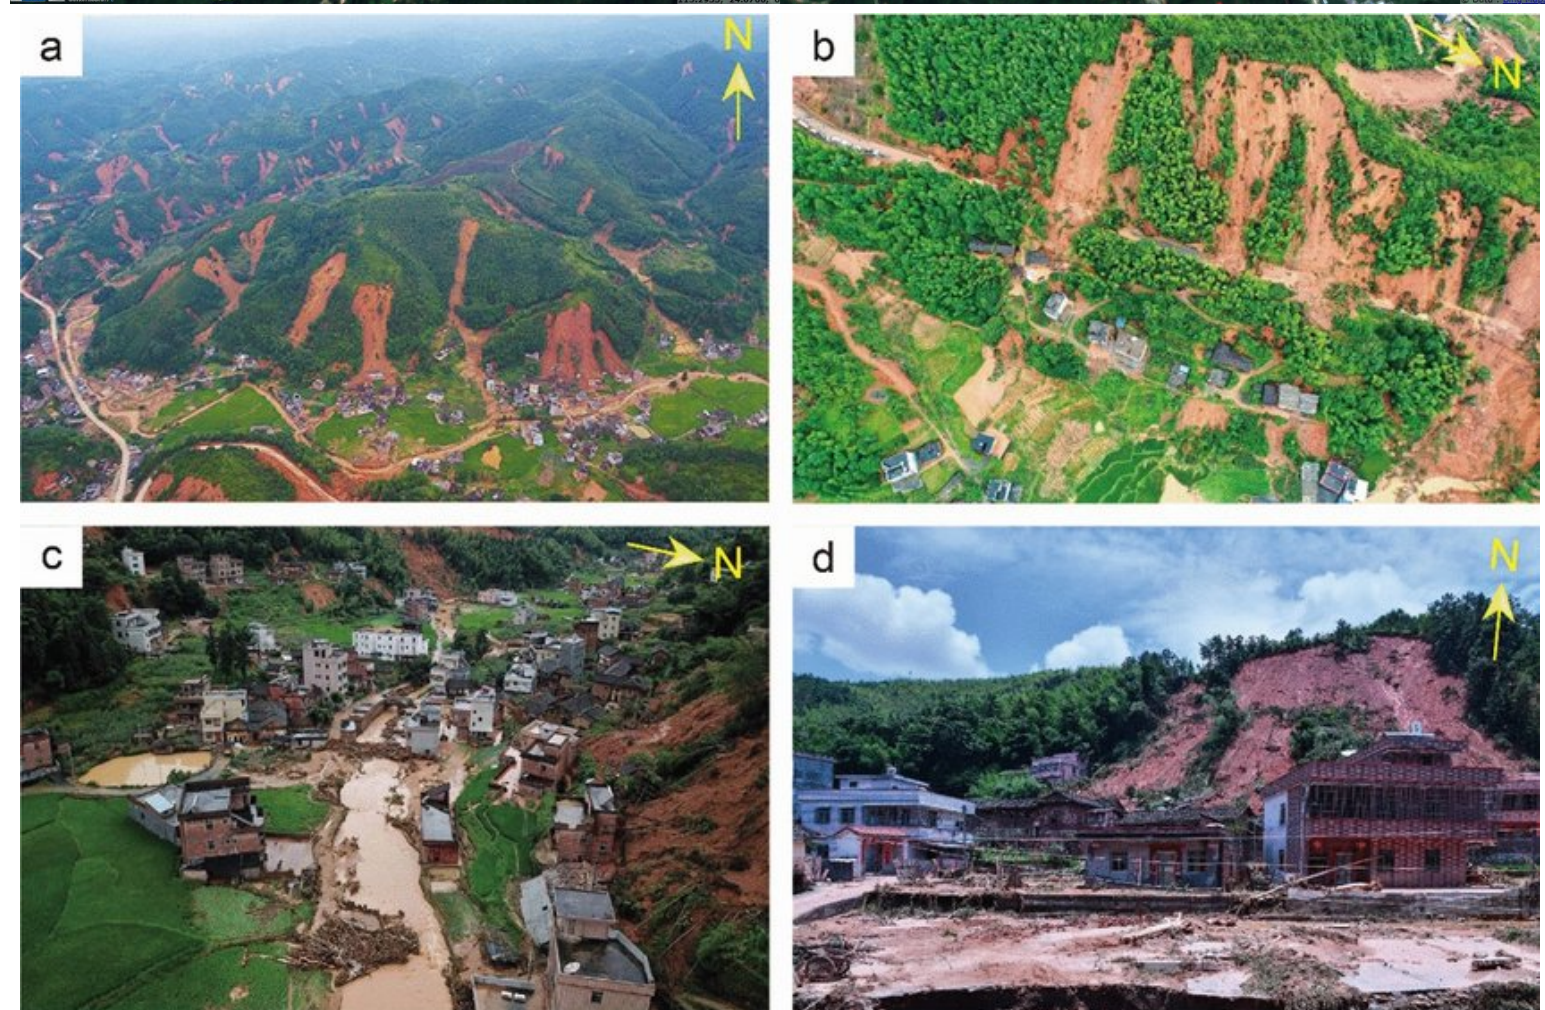
"Post-disaster photographs of Mibei Village (June 13, 2019) - Source: [Huilin Bai](#):"

- a: Aerial view of Mibei Village after the disaster - Source: Hua Zhang;
- b: the landslide characteristics along X158 road - Source: Xiangtao Zhang;
- c: buried roads, river, farmland - Source: Mingming Tang;
- d: the damage of landslide to houses - Source: Wei Xie."
