Water & natural resource management in Central Africa

Author(s): Sentinel Vision team, VisioTerra, France - svp@visioterra.fr

Keyword(s): Hydrology, water resources, water quality, wetland, water height, transport, flooding, Congo, DRC, Cameroon, Chad

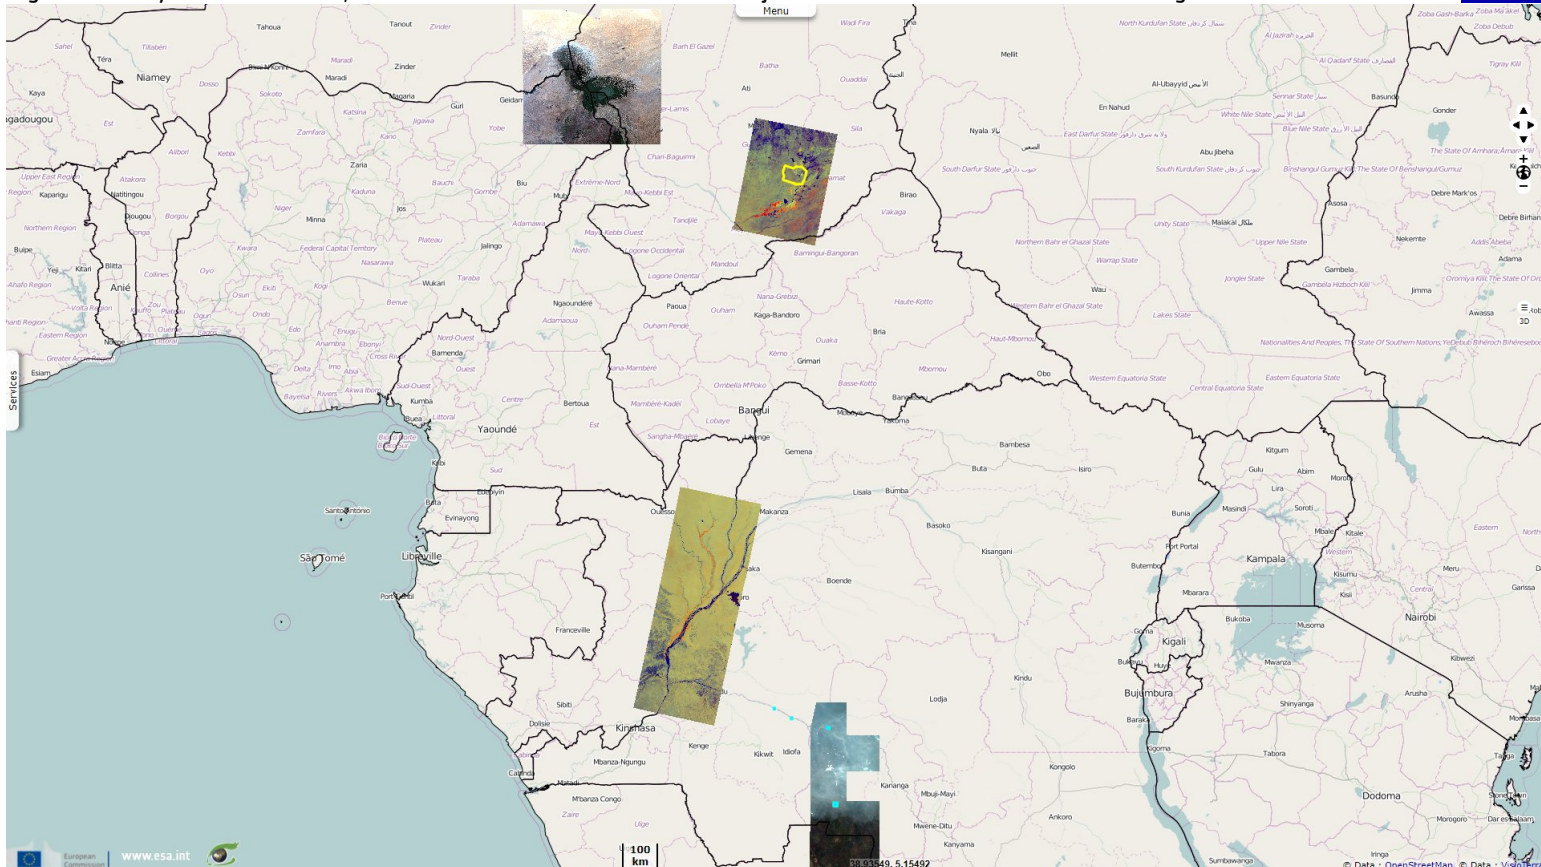
Fig. 1 - Back by GMES and Africa, the CICOS consortium works on the subject of Water and natural resource management in Central Africa. [2D view](#)

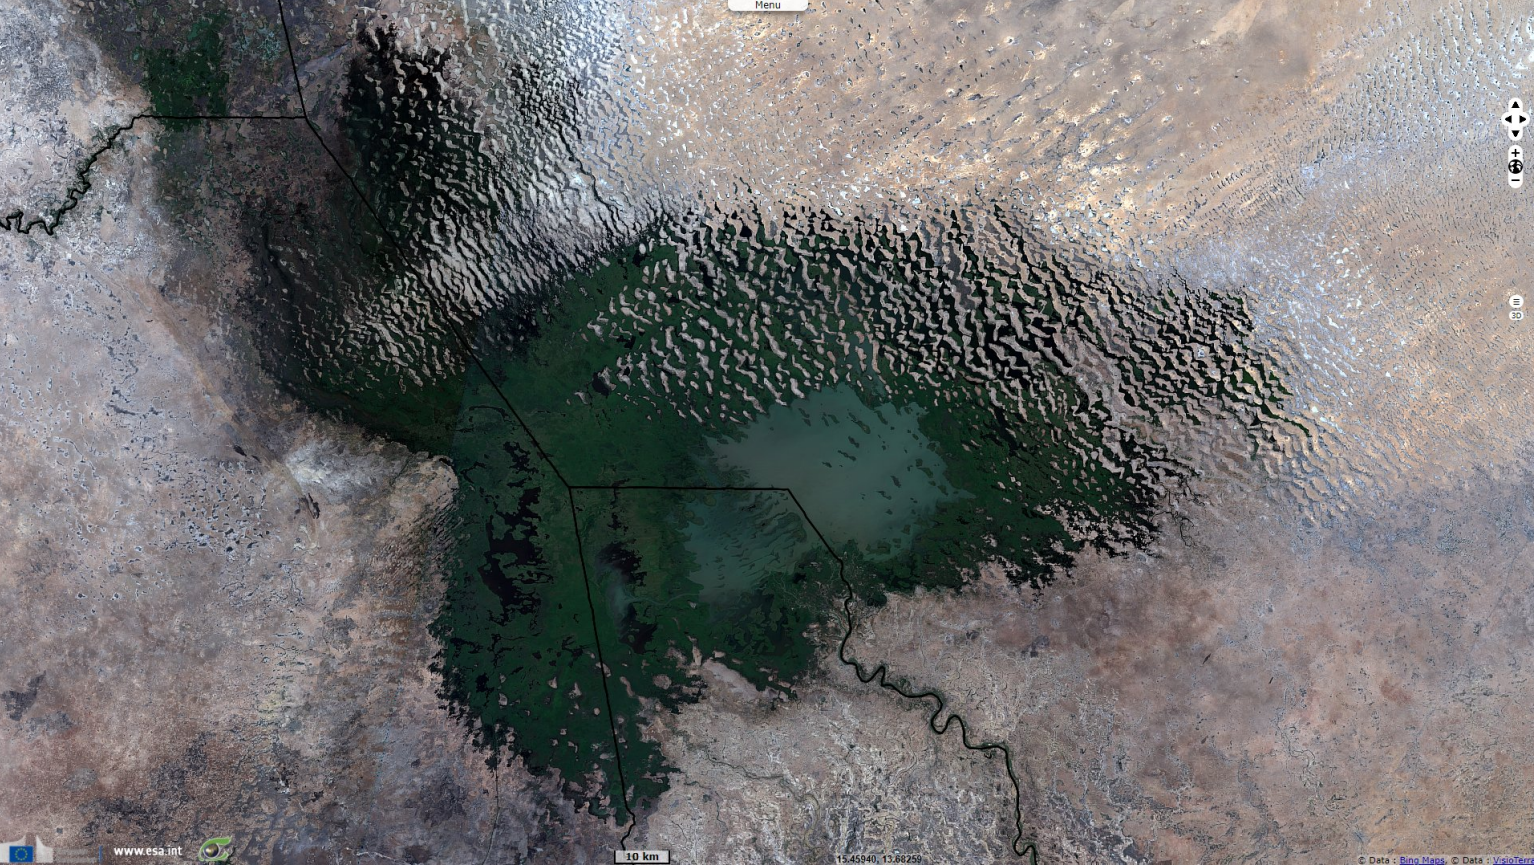
Fig. 2 - S2 (03 & 10.12.2016) - During winter, open water of Lake Chad remains mostly in Cameroon (south) and Chad (east).
